Model: STR-D565, STR-D665

No. 494

Subject: Noise in Rear Channel

Date: October 10, 1996

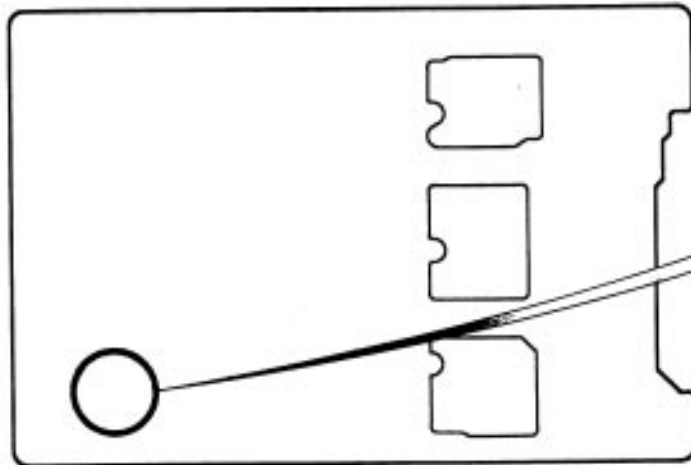
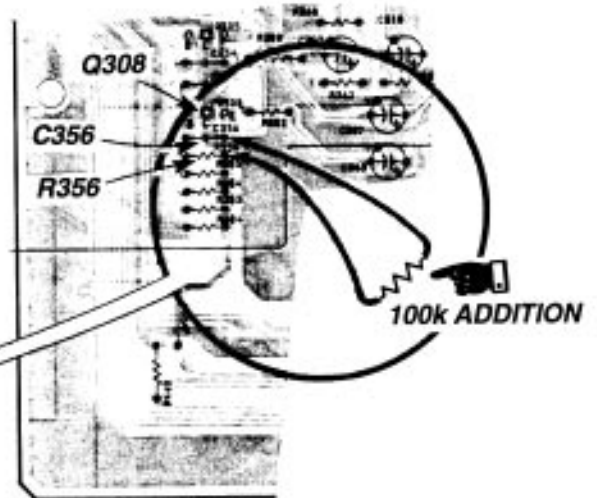
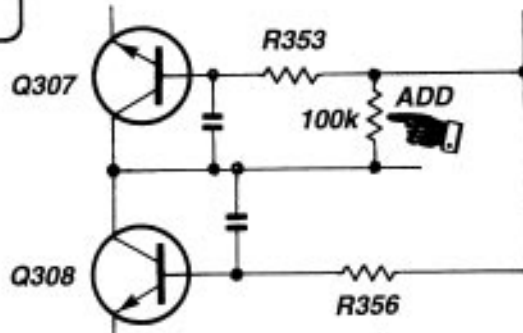
MAIN BOARD
— CONDUCTOR SIDE —

(154) The customer may complain of noise or distorted sound from the rear channel when the volume level is increased.

Solution: Add the following resistor as outlined below

| REF | DESCRIPTION | PART NUMBER |
|---|---|---|
| N/A | 100K OHM CARBON RESISTOR | 1-249-971-11 |
