Up date of CD Players A725

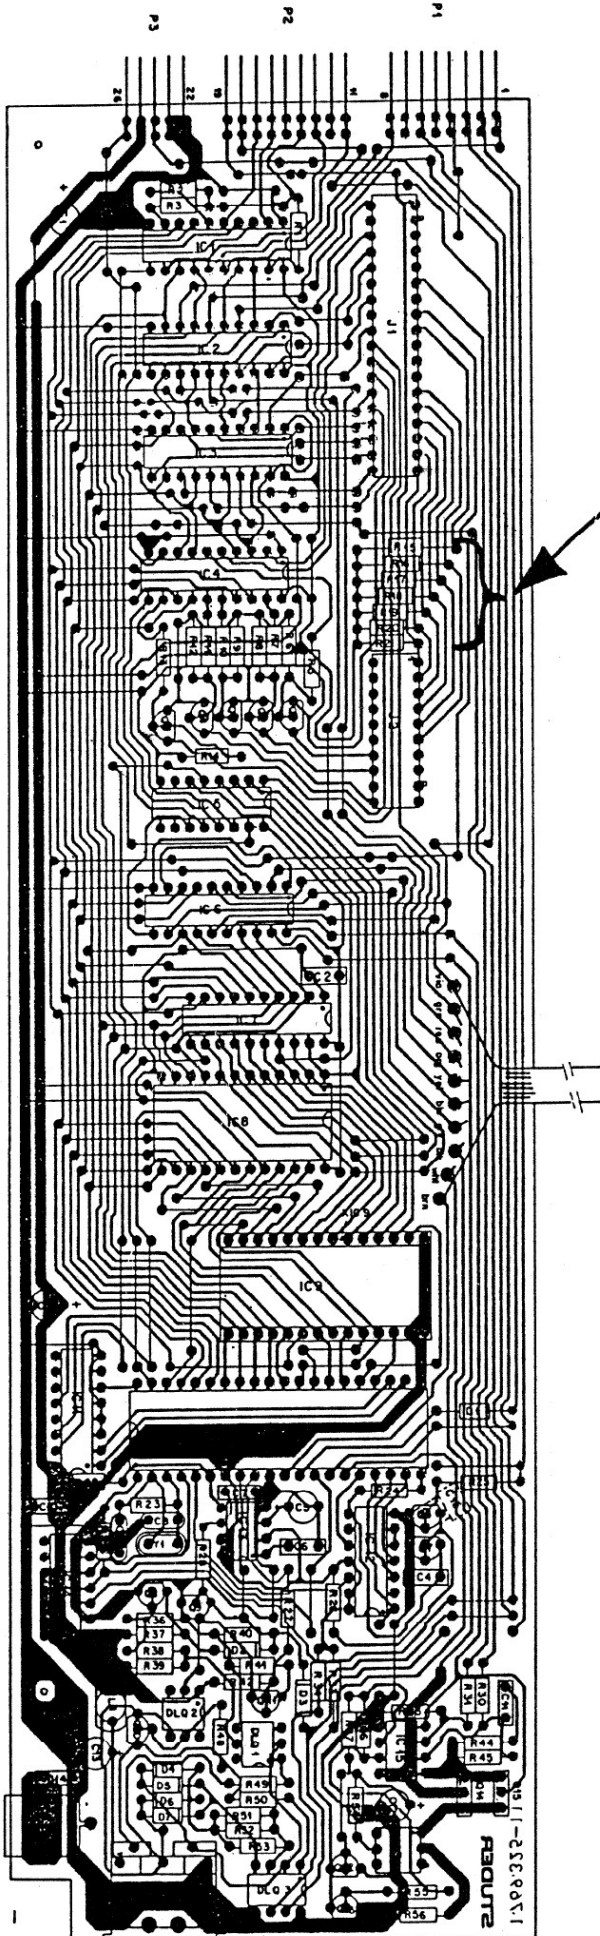
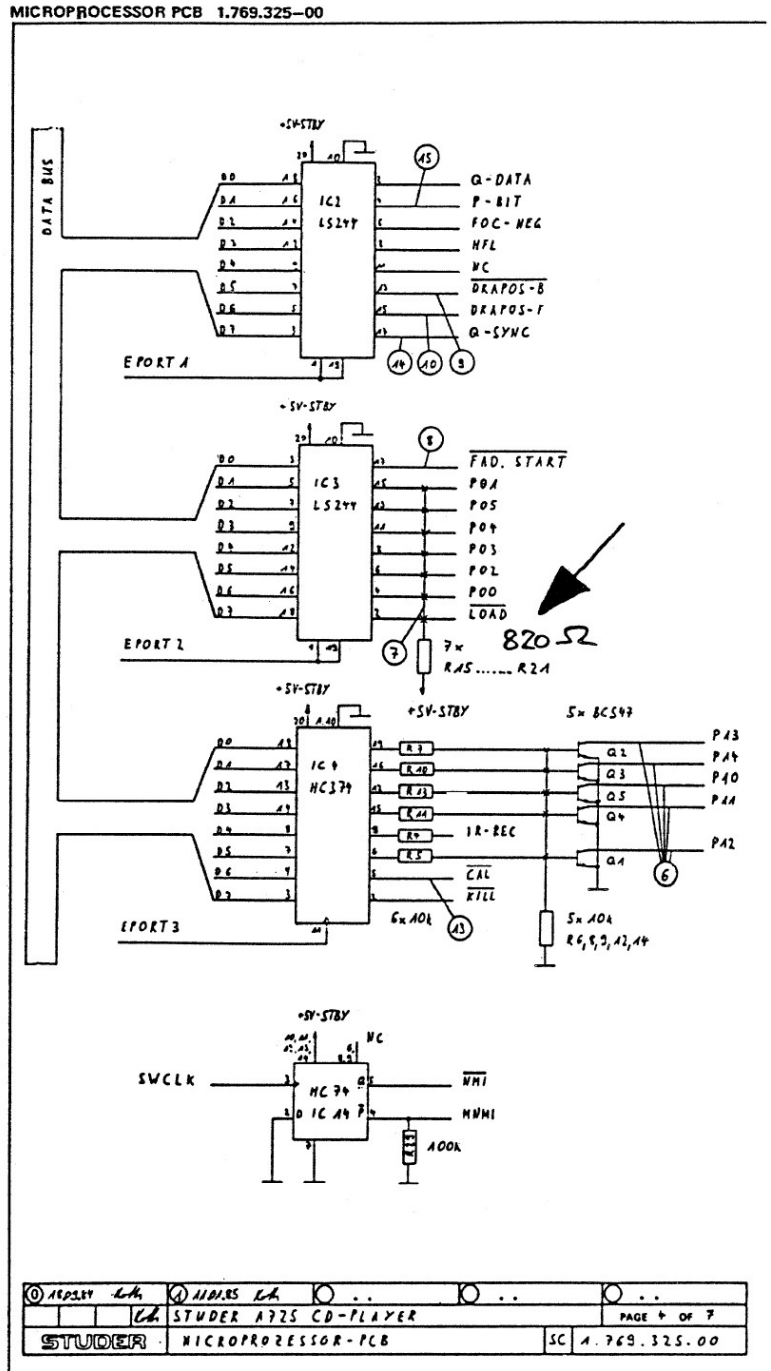
2.2. HIGH TEMPERATURE FAILURES OF A725

If CD-Players A725 happen to break down at high environment temperatures (above 40° C) in the way that they don't accept commands or reverse functions of push-buttons, you can replace the subsequently described 7 pull up resistors on μP pcb 1.769.325 by 820 ohm types instead of 4k7 types.

7x 820 Ω Ord. No: 57.11.4821
