SI 92/85

## Second up date of A725 CD Player

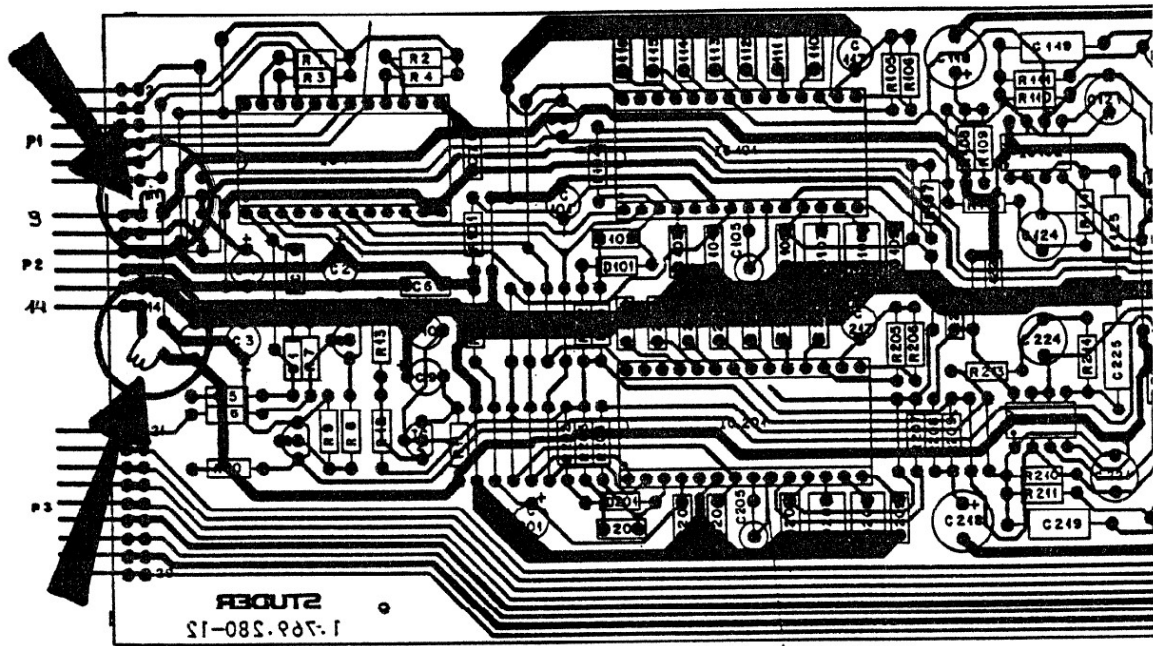
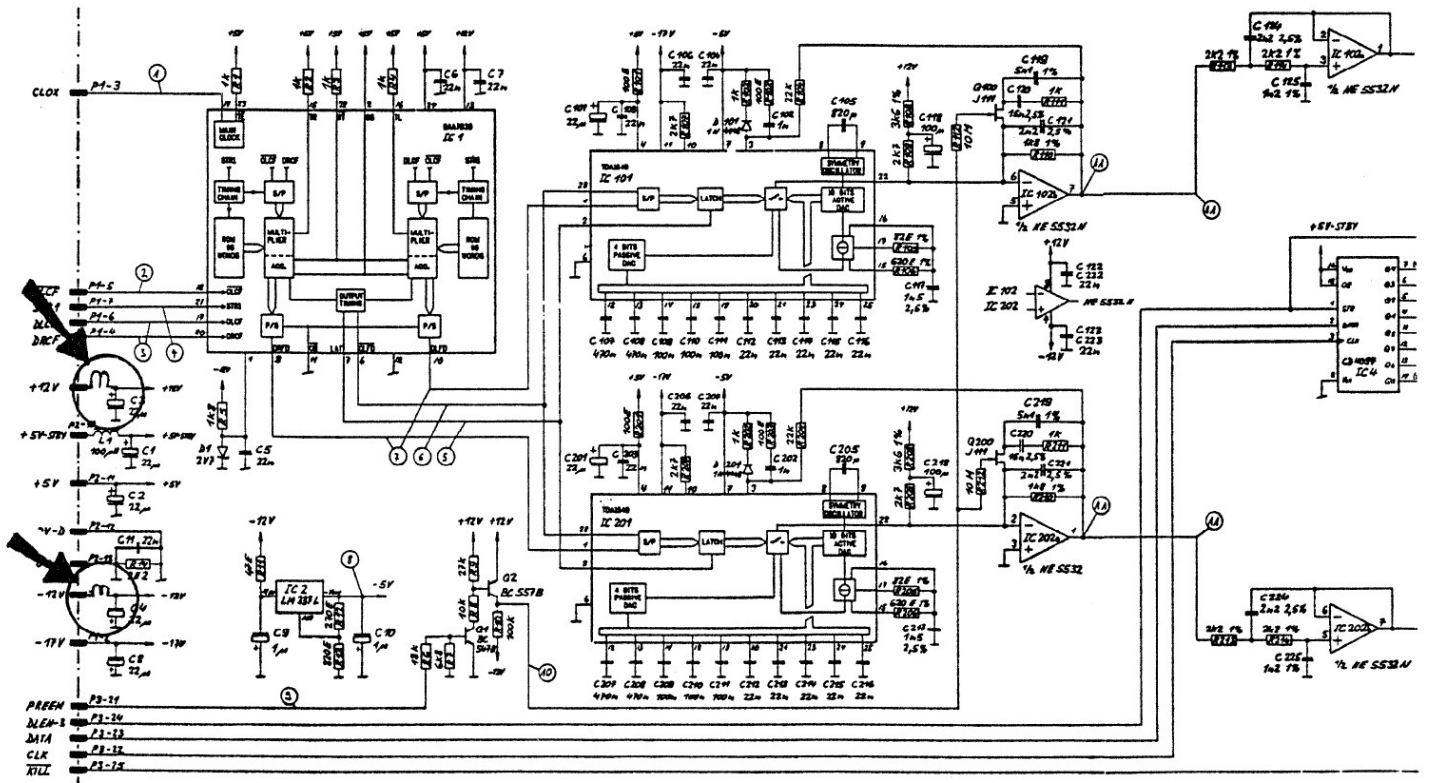
In Pause mode, low level disturbance may be audible on the audio outputs of the player. These are only audible if the audio signals are monitored at very high level.

The interference signal level peaks between 83.5 dB and 86 dB below maximum line level.

This interference is caused by peak currents drawn by the laser servo, as it moves back and forth in PAUSE mode.

This servo may take a maximum of 300 mA for an abrupt radial correction, and this causes spikes on the +/- 12 Volt power supply of the D/A Converter.

The interference signals are eliminated by inserting a coil in the + 12 V and the - 12 V power supply line.

(100 uH, max. 170 mA, ordering number of the coil is 62.02.3101).

On the DAC PCB (1.769.285) the circuit connection of at P2 pin 9 and at P2 pin 14 are to be interrupted, and the coils are to be inserted. The coils need to be inserted near the P2 connector, before the capacitors C3 and C4.
