# Hardware History D424

## Mother Board 1.866.120

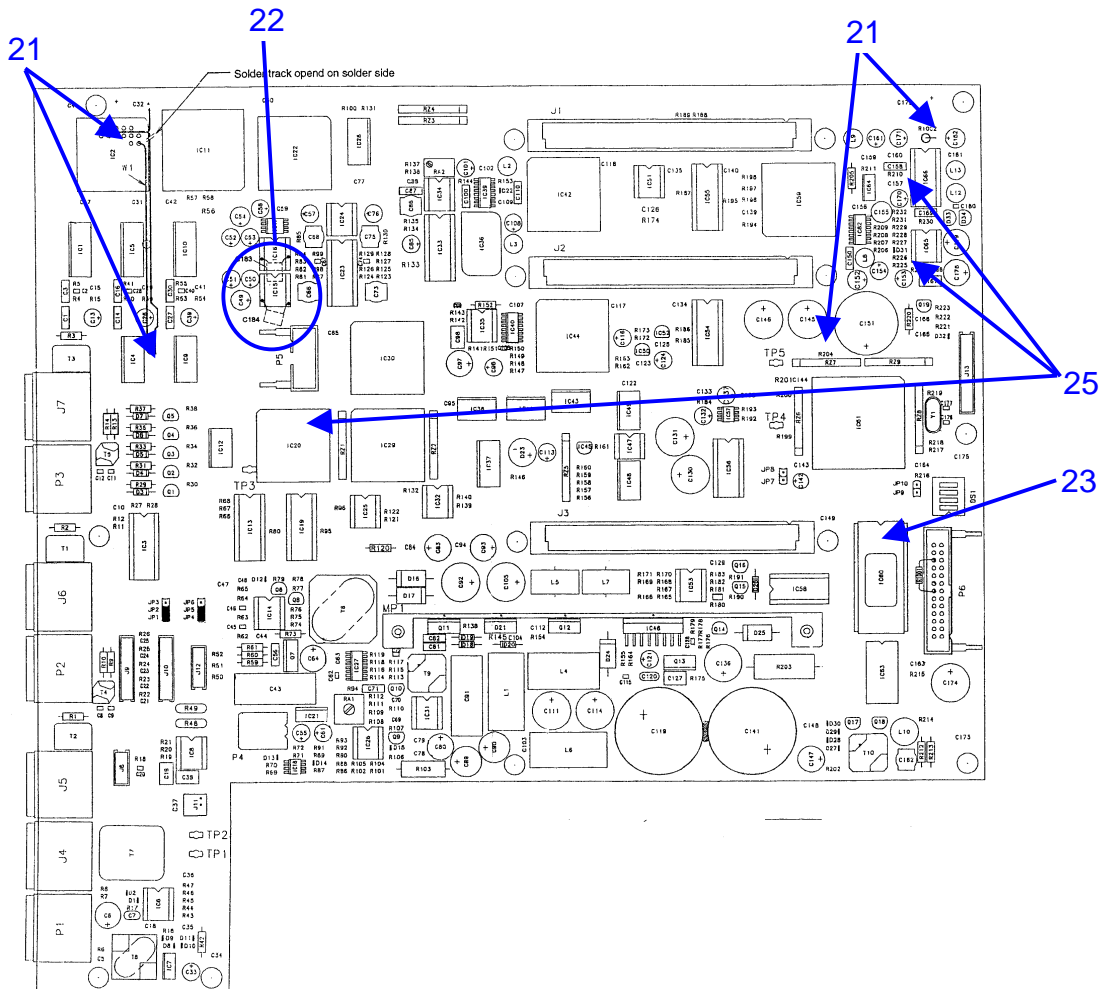
Index 25	22.6.1998 (S/N 1194	<p><i>improved clock jitter :</i></p> <p>R210: 3k3 -&gt; 1k, R226: 1k -&gt; 5k6</p> <p><i>improved TC readability :</i></p> <p>Software 120 MOTCC IC20: 1.866.915.20 -&gt; 21</p>

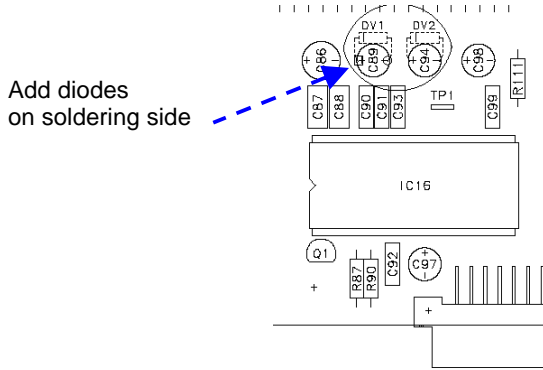
Index 20		
Rev A	22.3.2001	protection of AD Converter CS-5390 in power-up phase : - with additional zener diodes D10/11 (5.6V) in parallel to C89/C94 on soldering side

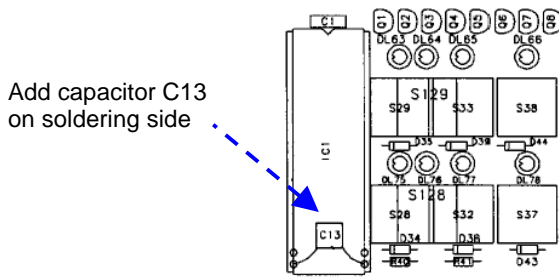
Index 00		
	8.6.1998	improved crosstalk immunity for reliable IC2 function (Key/Display I/O) with additional C13 (47pF) between IC1.20-21
