TEAC TECHNICAL INFORMATION

TASCAM DA-P1, No Operation with Battery Pack

8th September 1995

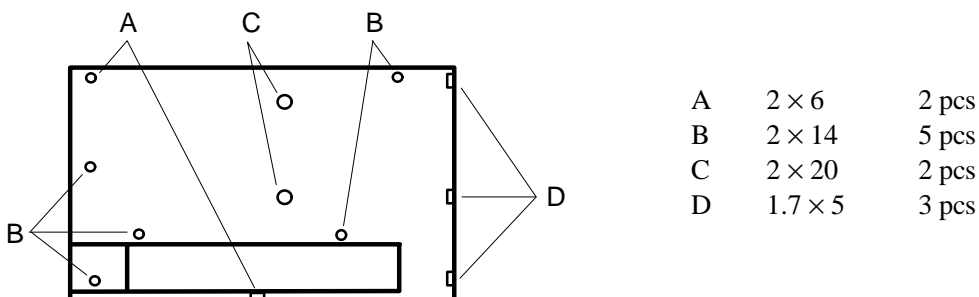
12 pcs Screws Fixing The Bottom Cover

The U5, D/A Converter IC PCM1710U, requires two different voltage supply, Vdd for digital and Vcc2 for analogue. In case a difference of both voltage exceeds a certain amount while powering up, the U5 may go to latch up state. Use of full-charged battery results in the highest prime voltage supply. And it causes a chance that the U5 enters such state. This state allows to draw a huge current of +5V supply circuit. Finally, the foldback current limiting function of the U325, 3 Prong Regulator IC, works and system control is unable to start.

Remove a bottom cover and make a short circuit on R20, 10 Ω chip resistor.

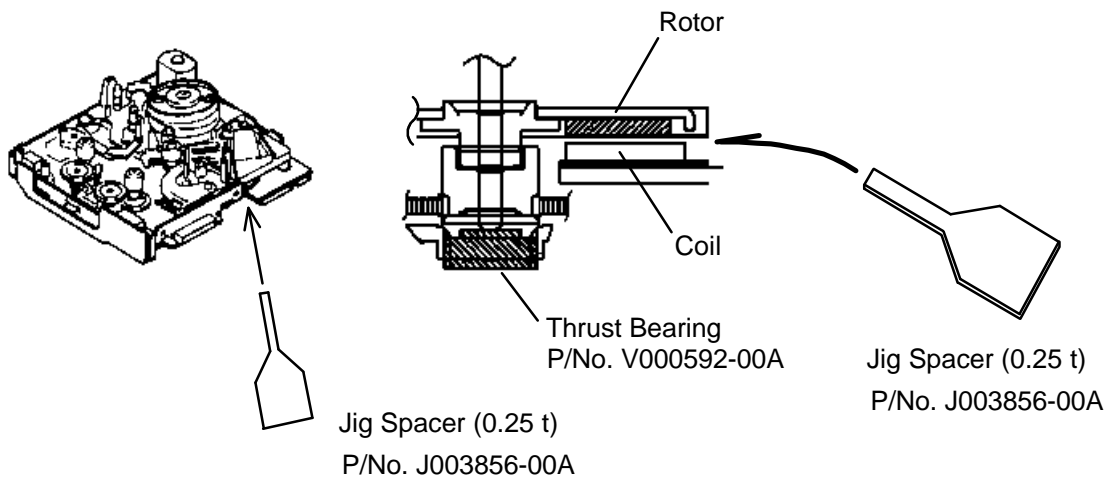
Symptom: Capstan motor does not rotate. Error 02 is indicated in the display window.

Cause: Wear of the capstan thrust bearing (Ref 4-37, S/M). The Rotor touches to the motor coil.

- 1 Dissolve the screw lock with alcohol.
- 2 Replace the old thrust bearing with new, **P/No. V000592-00A**.
 Note: Old part and new part can be identified by color difference.
 Old part is gray color and new part is black color.
- 3 Insert a jig spacer (0.25 t), **P/No. J003856-00A** between rotor and coil as shown below.
- 4 Adjust the height of the rotor by rotating the thrust bearing.
- 5 Pull out the spacer.
- 6 Secure the thrust bearing with screw lock.

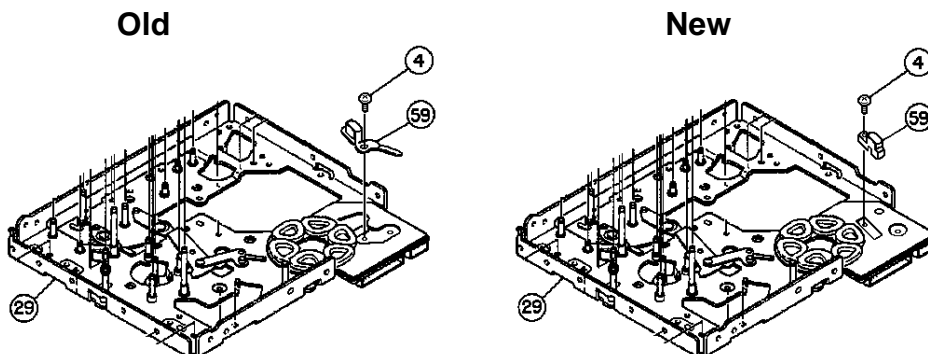
1 Sensor Block (FG Head)

To eliminate the mechanical position adjustment, Sensor Block (Ref 4-59, S/M) has been changed. Because of the shape of the new Sensor Block, Screw (Ref 4-4) and Chassis Base Block (Ref 4-29) have been changed simultaneously. Old and new parts are incompatible.

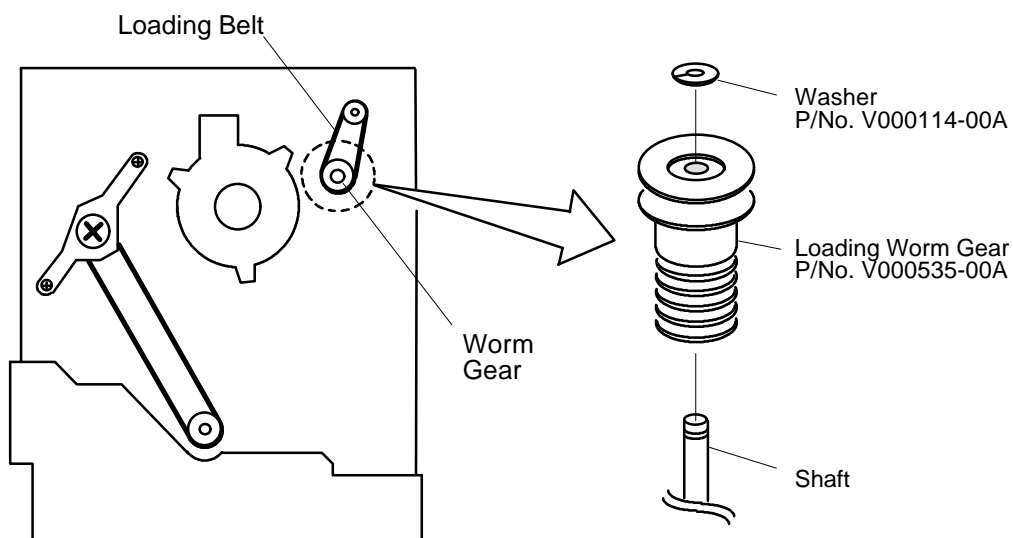
Mechanism Bottom View

Problem: Loading Belt (Ref 4-58) slips/comes off. Error 01 appears.

Cause: Swelling of Loading Belt. Grease applied to a loading worm gear affects the belt.

- 1 Remove and discard a swelled loading belt.
- 2 Remove and discard a washer fixing a loading worm gear.
- 3 Pull out the loading worm gear.
- 4 Fit a brand new loading worm gear (V000535-00A) which has been registered in spares.
(or original gear can be re-used if grease can be removed from the gear perfectly.)
- 5 Fix the loading worm gear by a brand new washer (V000114-00A).
- 6 Clean a motor pulley.
- 7 Fit a new loading belt (V000135-00B).

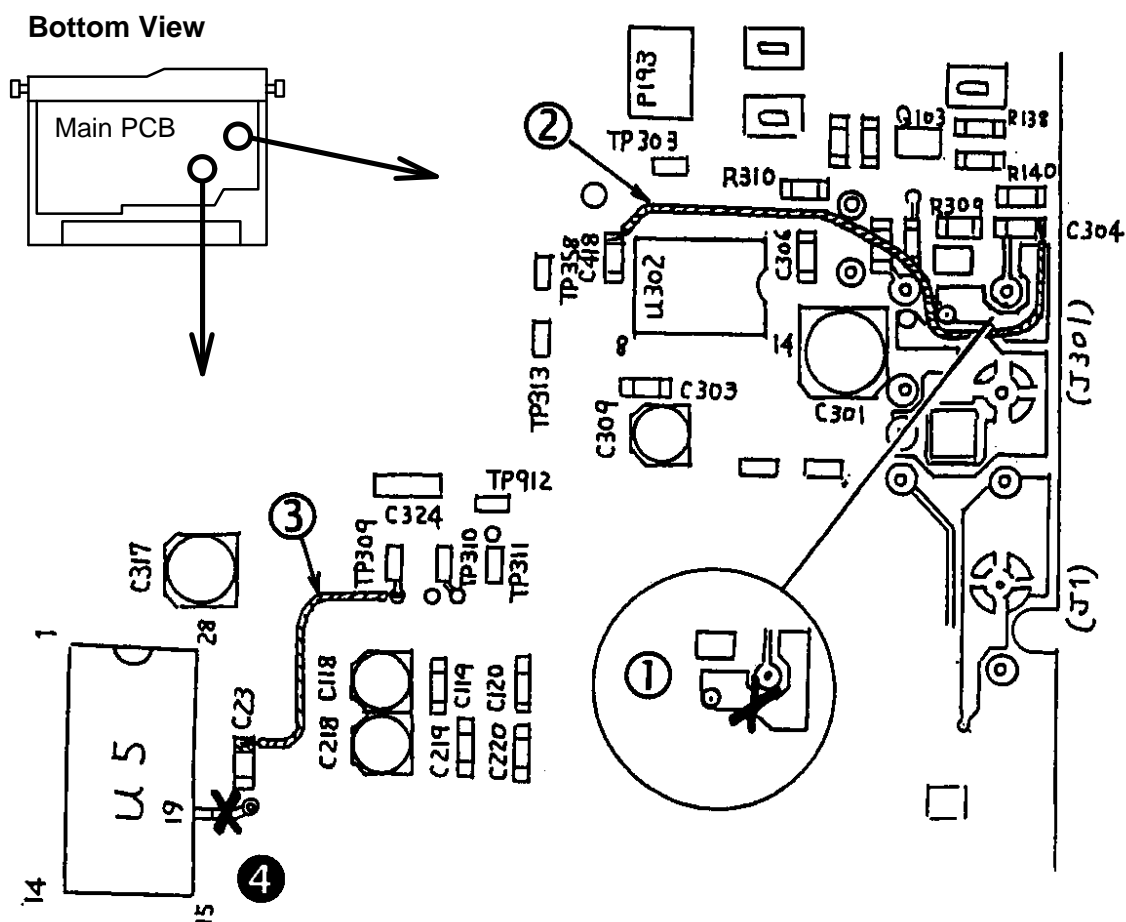
To improve the error rate, GND circuit on the Main PCB Assy has been changed on the products of S/No. 90001 and up.

- ① Cut of foil pattern.
- ② Jumper wire between C304 and C418.
- ③ Jumper wire between C23 and TP309
- ④ Removal of C34.

To locate the work point of ①, ② and ③, just remove the bottom cover.

C34 of ④ is mounted on the other side, then, Main PCB Assy should be removed/opened.

To facilitate the servicing, cut of the foil pattern shown as ④ is recommended. This is equivalent to removing C34 of ④.

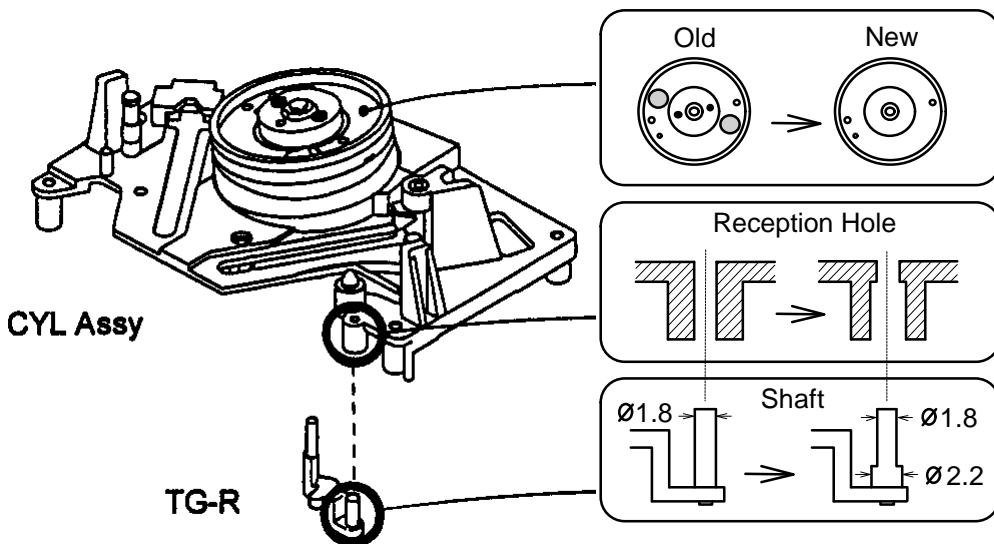
To improve the error rate on Long Play mode, track width of head A/B is securely paired.
 To improve the tape path on Shuttle Reverse mode, shaft of TG-R (Tape Guide-R) is rectified.
 Simultaneously, reception hole of CYL Assy is changed.

Note: In case old CYL Assy mounted on old unit is replaced with new (-00B), old TG-R should also be replaced with new (-00B) at the same time.

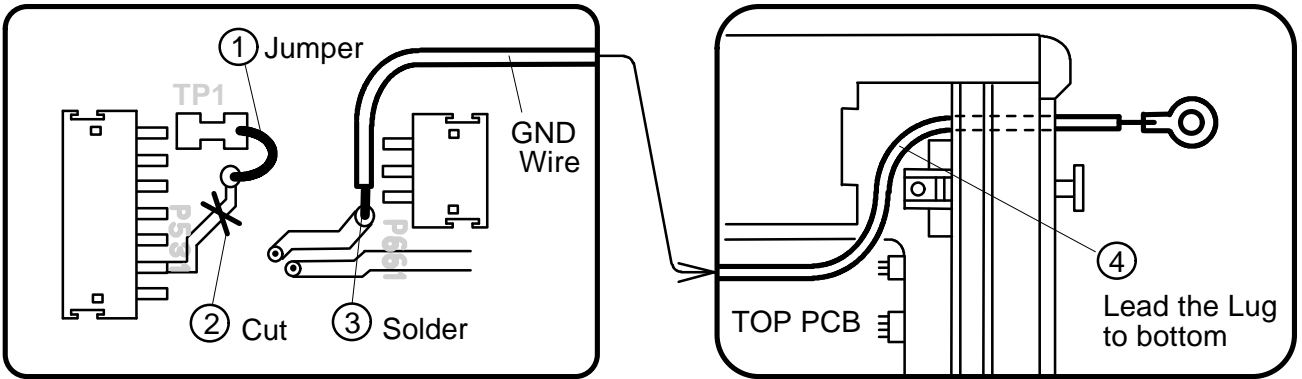
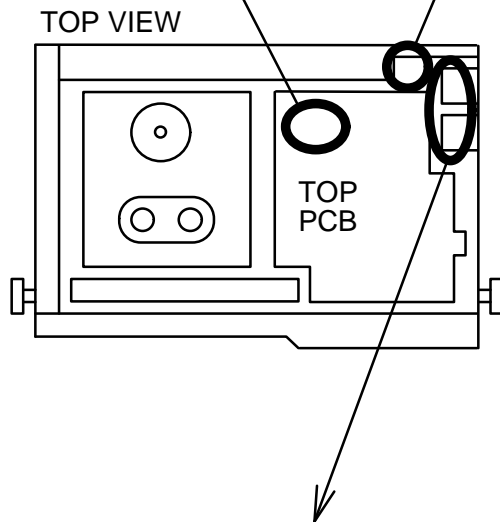
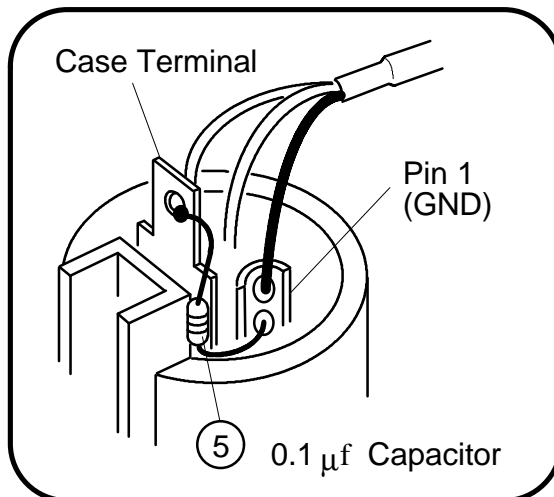
Top View on Page 2/3

High pitched (9.2 kHz) noise could be recorded on right channel when recording is made with certain microphones. This occurs only on use of the BP-D1 battery pack.

- ① Make a short circuit by an appropriate jumper wire.
- ② Cut a foil pattern.
- ③ Solder the one end of GND wire to the TOP PCB Assy.
- ④ Lead the other end, Lug Terminal to bottom side.
- ⑤ Solder 0.1 μ f ceramic capacitor to both XLR connectors.
