**TEAC****TECHNICAL INFORMATION****TASCAM CD-302 / X-9, Base, BLT-IN LED**No. **0220**

DATE 29th November 2002

**TEAC****TECHNICAL INFORMATION****TASCAM X-9, EXT EFFECT Noise**No. **0331**

# TECHNICAL INFORMATION

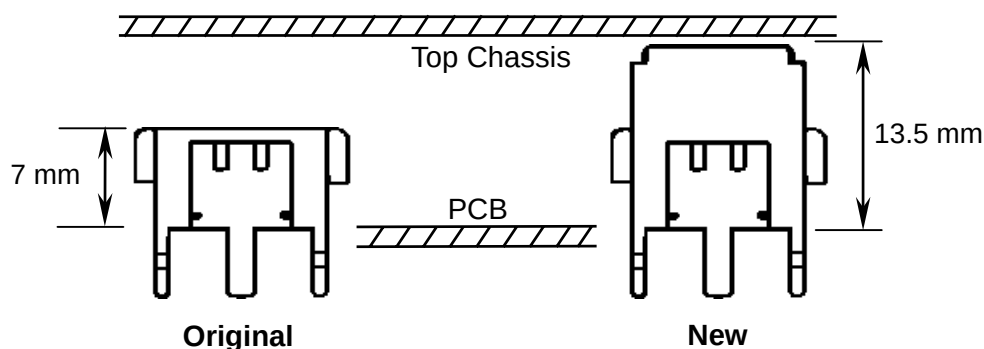
In rare cases, "Base, BLT-IN LED" comes off of PCB.

"Base, BLT-IN LED" is a base for a button mounted on the PCB as shown below.

With the new "Base, BLT-IN LED", its height has been increased to fill up the space between the top chassis.

| Original | New |
| Base, BLT-IN LED | Base, BLT-IN LED (13.5) |
| P/No. 92602994-00 | P/No. 92603960-00 |

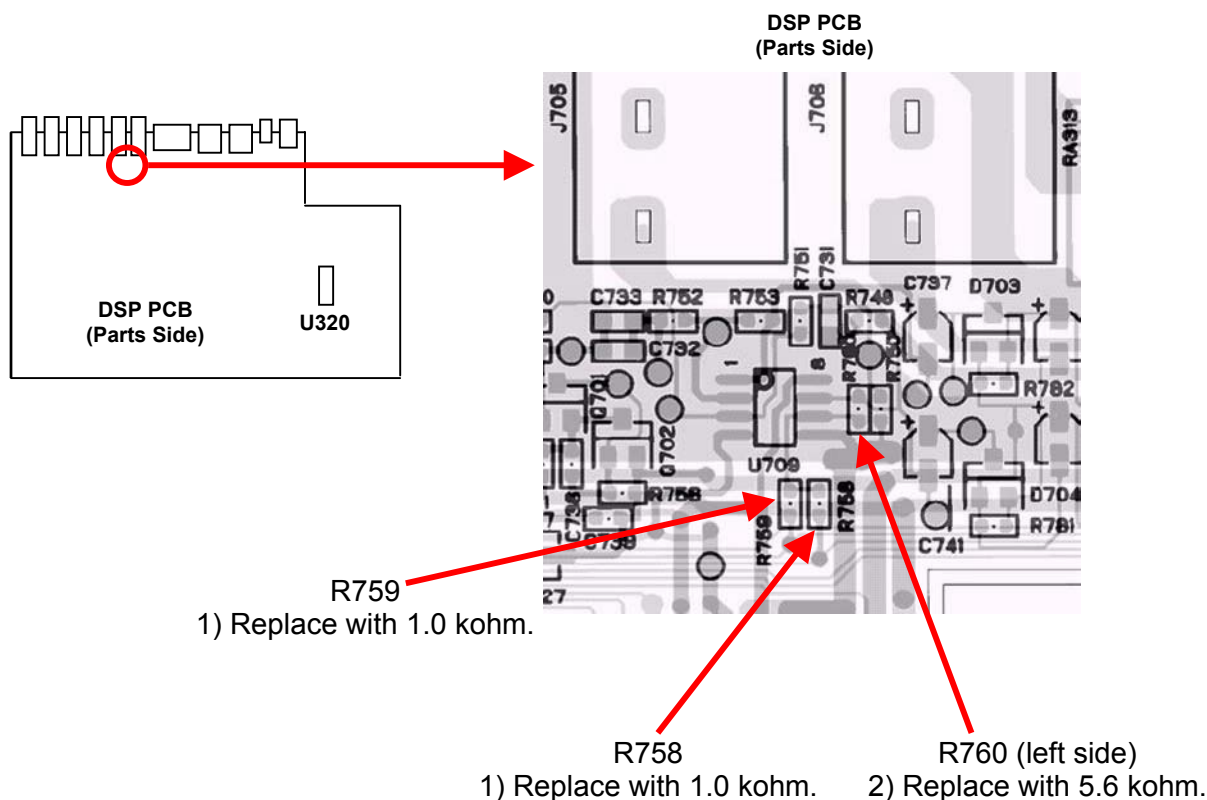
On DSP PCB

**Symptom:** Hi-pitched digital noise is heard when MIC or MST is selected to EXT EFFECT mode (EXT EFFECT button lights up) by EFFECT IN rotary switch.

- 1) Replace two R758/759 (33 kohm) resistors with 1.0 kohm (P/No. 91132730-30).
- 2) Replace a R760 (150 kohm) resistor with 5.6 kohm (P/No. 91132910-30).
