Hi-Fi Audio	Quick Service Manual		Ref. No.: HA-99-219
			Date: 10. May. 1999
	Model: SL-PD667 Series/SL-PD10 SL-PD788, SL-PD888	Frequency: C	Cases reported (country) USA

Subject: The Tray Problem

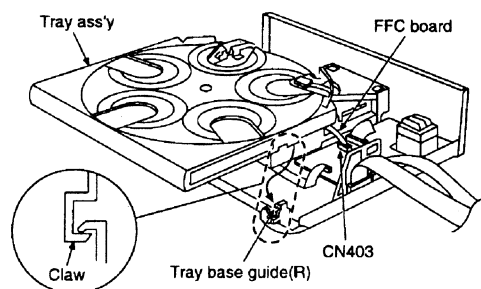
Symptom: The abnormal sound occurs when Tray opens and shuts, or Tray doesn't close.

Cause: It will be occur due to one tooth of the Drive Gear(1):RDG0271(Ref.No.102) is shifted.

Remedy: Please make sure the positioning between the limiter claw on the tray ass'y and the teeth of the drive gear(1) as below.
<Reinstallation of the tray ass'y>

1. Fit the claws on the right side of the tray ass'y underneath the claws on the tray base guide(R).
