Hi-Fi Audio	Quick Service Manual		Ref. No.: HA-99-219
			Date: 10. May. 1999
	Model: SL-PD667 Series/SL-PD10 SL-PD788, SL-PD888	Frequency: C	Cases reported (country) USA

Subject: The Tray Problem

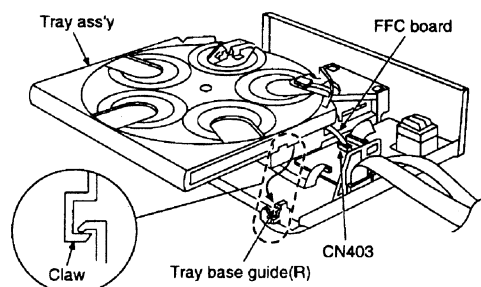
Symptom: The abnormal sound occurs when Tray opens and shuts, or Tray doesn't close.

Cause: It will be occur due to one tooth of the Drive Gear(1):RDG0271(Ref.No.102) is shifted.

Remedy: Please make sure the positioning between the limiter claw on the tray ass'y and the teeth of the drive gear(1) as below.
<Reinstallation of the tray ass'y>
