AUDIO SERVICE

08 - 81

SUBJECT: CR-2020

PROBLEM: Power Supply Failure

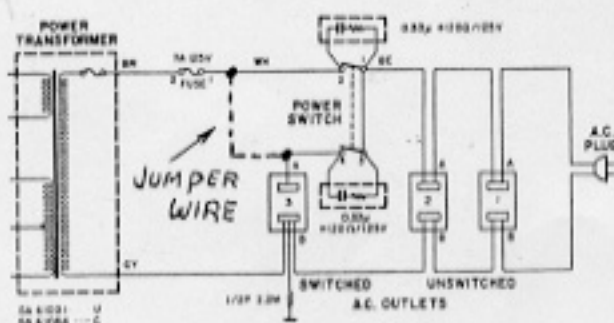
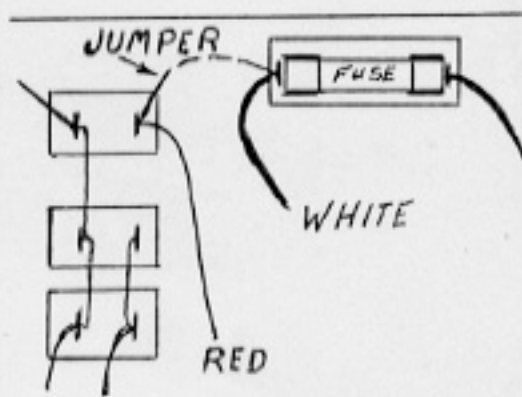
Problem: Power switch failure.

Cause: Pitting and burning of switch contact due to high current spike when set is switched off. (Back E.M.F. from power transformer).

Remedy: Replace power on/off switch (KA200630).
Install a jumper wire between the fuse holder (white wire) and the switched AC outlet (red wire).

Install the jumper wire on all units received for service that have not been modified.
