# AUDIO SERVICE

BULLETIN NO.: 07-81

DATE: August 1981.

SUBJECT: CR-2020

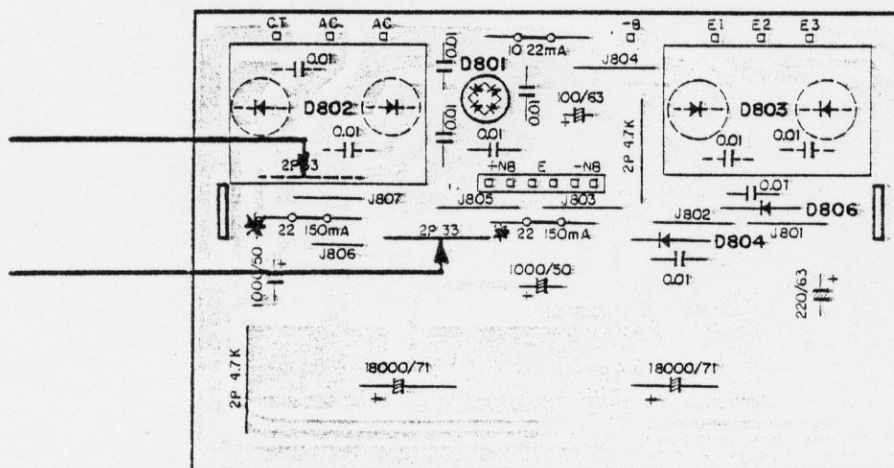
### ELECTROLYTIC CAP. C. BOARD

Problem: Intermittent power supply.  
Receiver goes on and off, speaker relay clicking.

Cause: R 801 and R 802 (33 ohm) in electrolytic capacitor circuit board get hot and unsolder themselves.

Location of resistors:

Remedy: Remove both resistors and install new 33 ohm, 3 $\frac{1}{2}$  watt wire wound resistors.

Mount the resistors approximately  $\frac{1}{4}$  inch away from the circuit board.

We suggest to use Ohmite #4374. These resistors are available from Yamaha Canada Music, Parts Department.

\* Also replace the 22 ohm 150 mA fuse resistors with Ohmite #4369 22 ohm 3 $\frac{1}{2}$  watt resistors.
