# AKG

SERVICE

**D 112 E**

2220 Z000

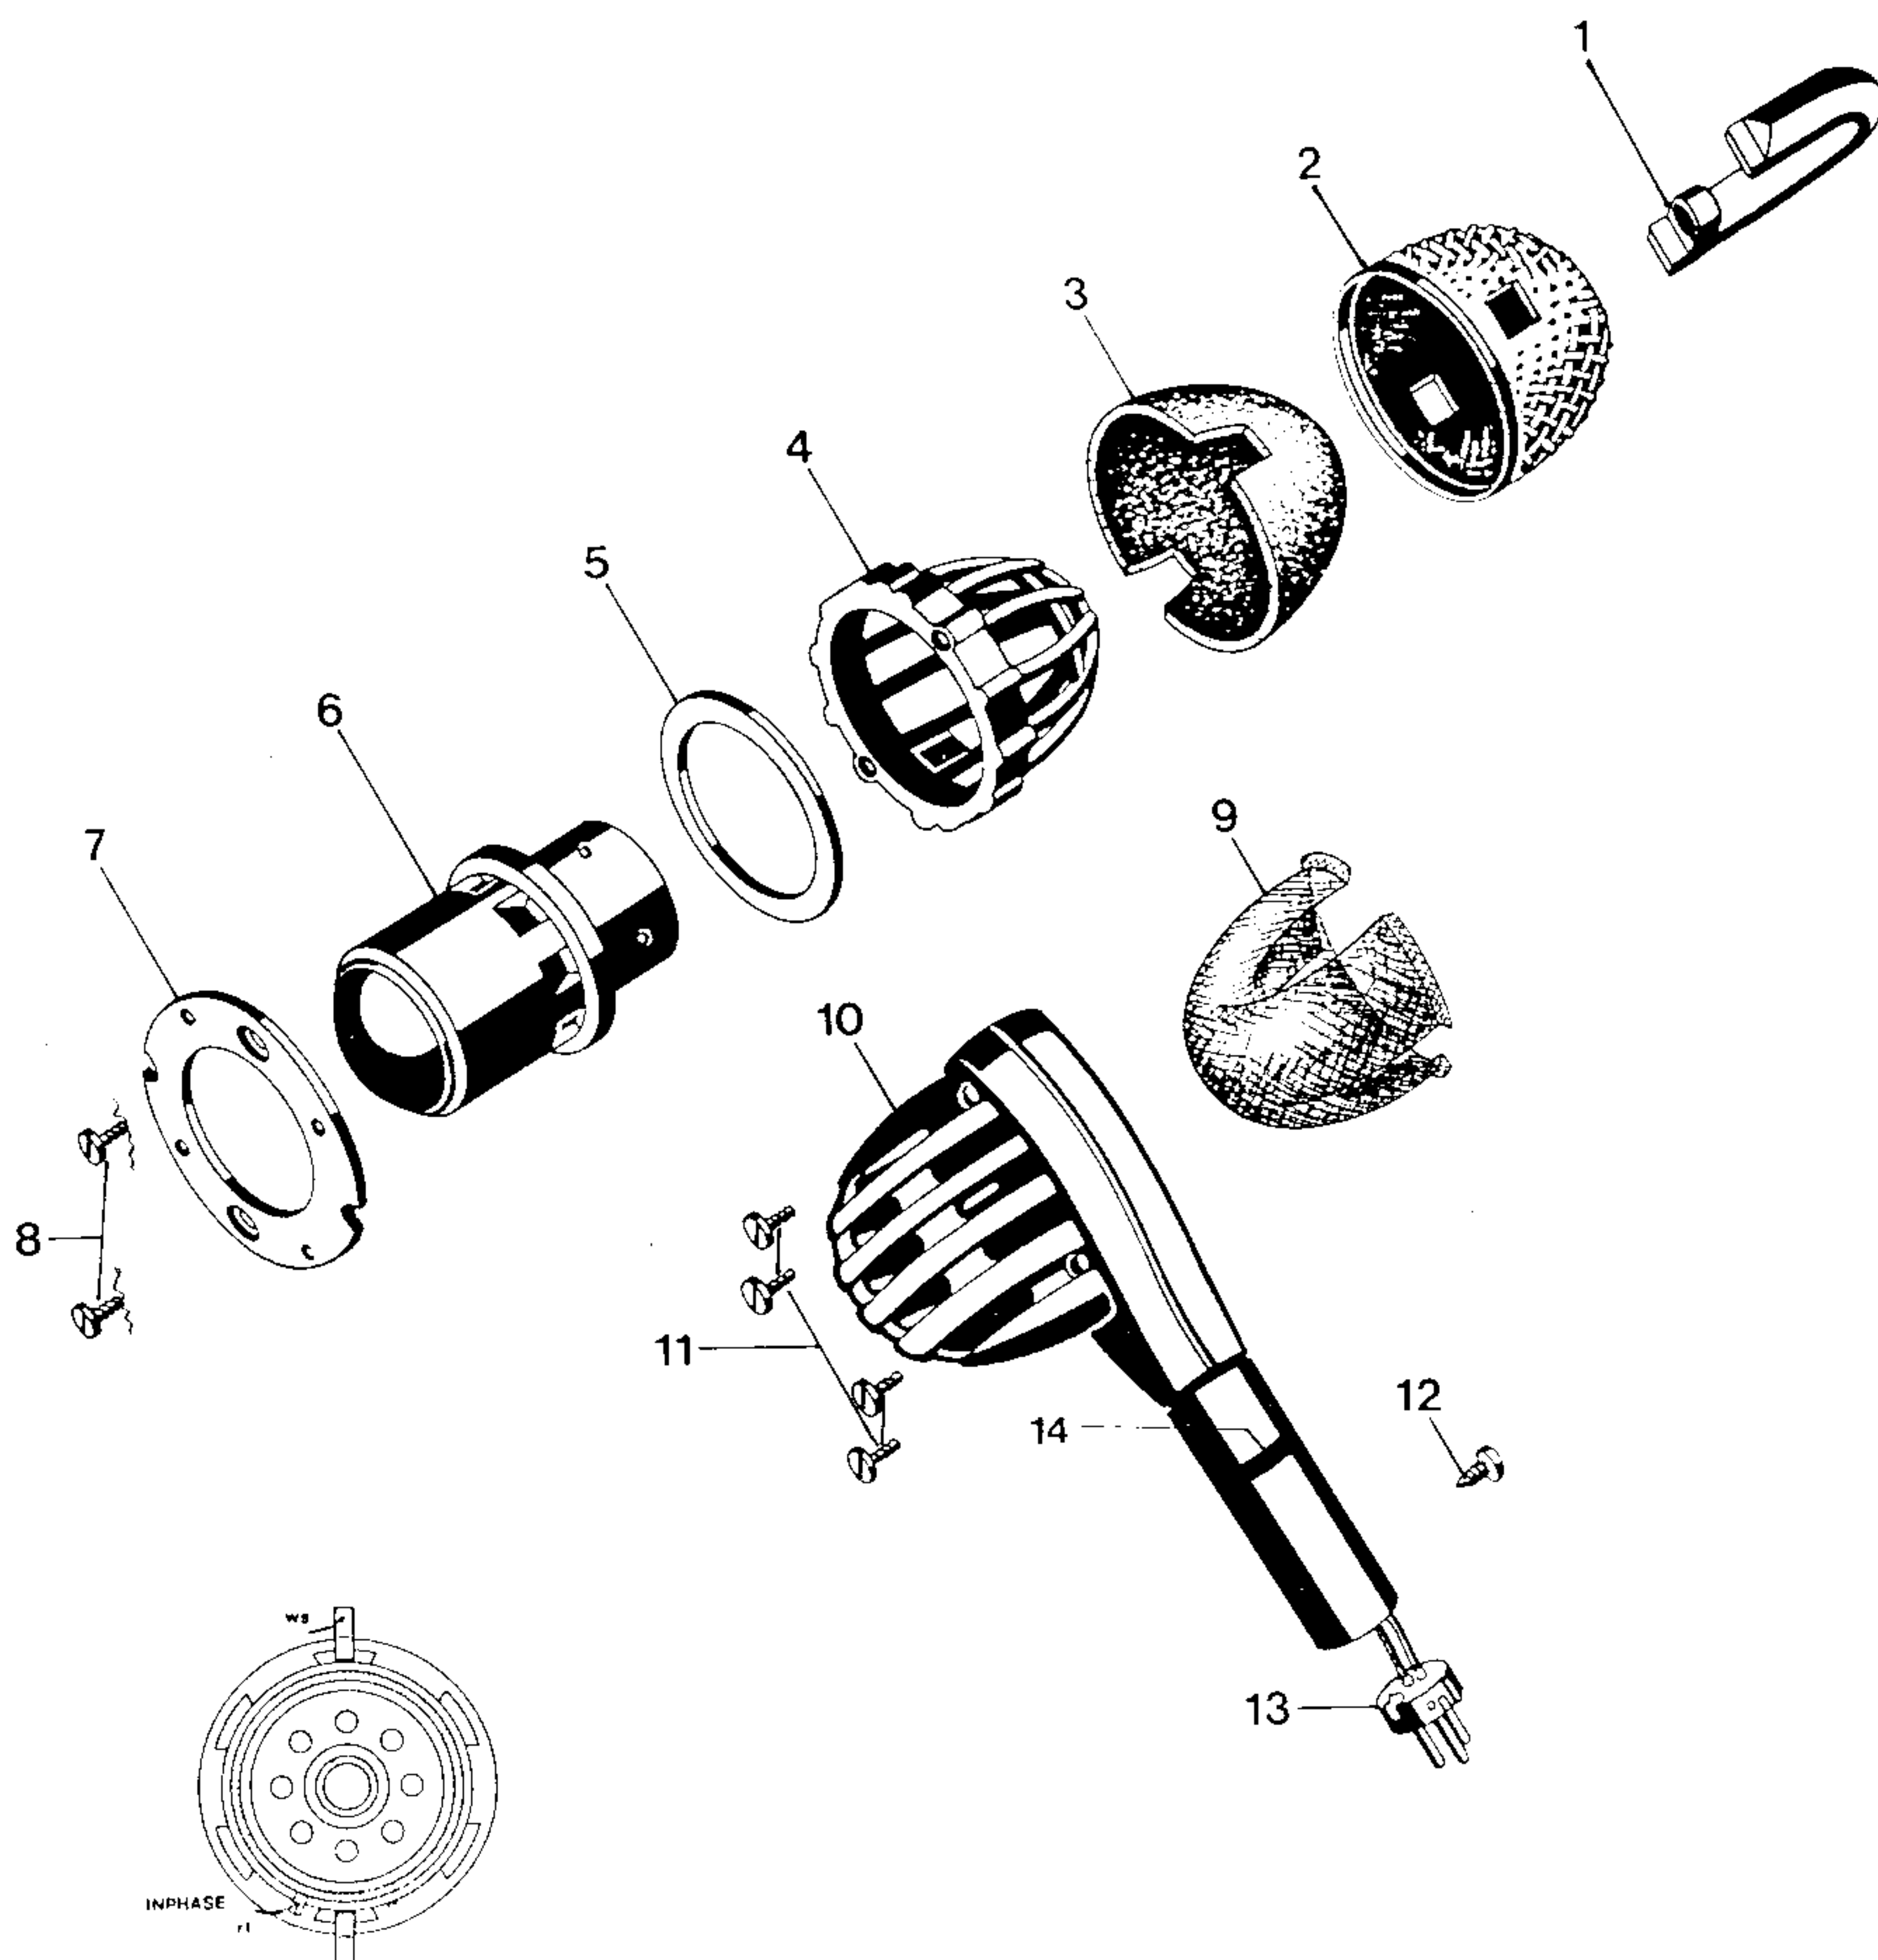
When assembling a dismantled D 112, the plug insert 13 has to be removed. The litz wires have to be tightened. Then the microphone can be put together. Only after that the plug can be remounted. This procedure prevents crushing of litz wires between housing 10 and ring 7. Microphones returned with errors like "hum", "noisy", "crackling sound" will most likely have the litz wires damaged. In that case please test performance of microphone with attached phantom powering. This will reveal any shortcircuit to the housing.

Recently ring 1 is fixed with selftapping screws. Screws 0084D3020 belong to the former ring version 2220M0301 with metal thread inserts, while for the new ring 2220Z0901 screws 0099N3004 are necessary. Also screws 11 have been changed to selftapping versions (0099N3000 was an intermediate variation). At the same time the ring 7 was modified (2220Z1201 instead of 2220Z1101).

\*) 1830N0423 is the copper strip to connect the housing 10 to the plug insert.
