Service Manual CD Stereo System

SA-AK340P SA-AK340PC SA-AK340PL SA-AK340E SA-AK340EB SA-AK340EB SA-AK340EG

Subject : Additional Contents (F61 troubleshooting)

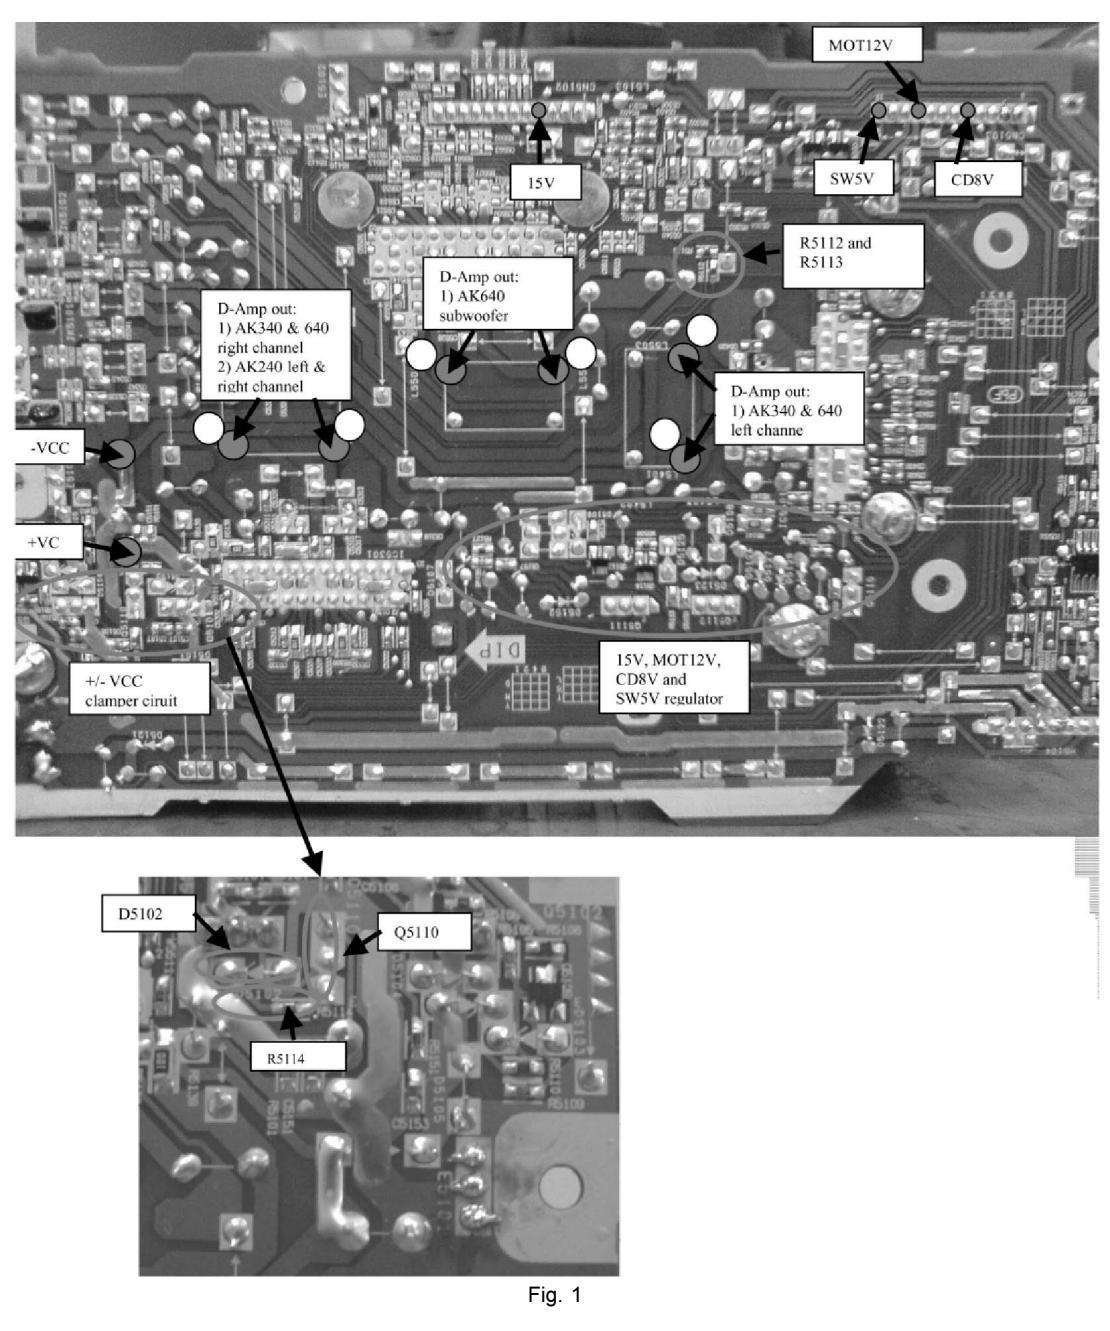
1.2.1. Location of Resistors (R5112, R5113 & R5114), Transistors (Q5110, Q5111 & Q5112) & Diode (D5102)

Power ON for a while then only trigger F61. (Symptom always happen)	 Check the fan connection to the Main P.C.B. If the fan not proper connected, F61 will trigger when the volume increase. Check +/- VCC supply balance The +/- VCC supply should be balance. + VCC = +29V and - VCC = -29V. If the supply is balance, try to reduce the AC supply by 10%. 	 Re-connect the fan to CN2810. It is due to the resistor tolerance and the DC Det circuit setting is too sensitive to trigger F61. Countermeasure: Change R5112 & R5113 value as below: For AK340 change to 390kΩ (Part No. ERJ3GEYJ394V) 	Refer to Fig 1.
	If the symptom does not appear, that means the DC Det line mis-trigger the F61.

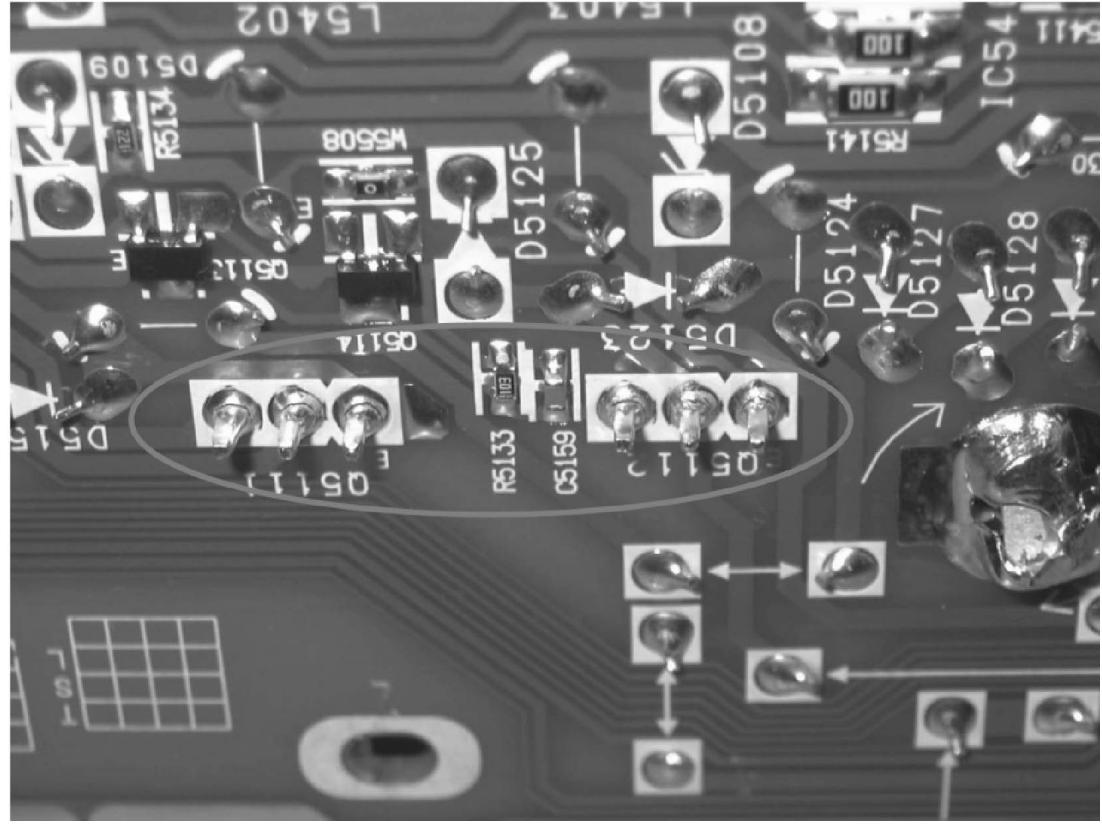
Fig. 2

Symptom	Checking Items	Repair Items	Remarks
FL display blinking with abnormal segment when power ON the set or F61	Check the solderbility condition of the Power P.C.B. Is there any solder crack at transistor area? (Q5101, Q5102, Q5111 & Q5112)	Touch-up the solder crack area.	Refer to Fig 2.
First power ON display immediate show "F61".	 Check all the supply line +/- VCC if more than +/- 29V, check clamper circuit components especially Q5110, R5114 & D5102. Check 15V, MOT12V, CD8V, SW5V supply line. 	 Change the defective parts. Q5110 = B1GACFGA0002 R5114 = ERJ3GEYJ1R8V D5102 = B0BA02600018 	Refer to Fig 1.
	Check speaker output by using multimeter • If there is a DC voltage around +/- 29V, check on the pcb, +/- VCC point with every channel output of D-Amp IC, if shorted, that means D-Amp damage already.	 Change the defective D-Amp IC. point 1 or 2 short to +/- VCC = change IC5301 point 3 or 4 short to +/- VCC = change IC5401 point 5 or 6 short to +/- VCC = change IC5501 IC part no.:C1AA00000755. +VCC = C5101 (+ve leg) - VCC = C5104 (-ve leg)
