## SERVICE TECHNICAL INFORMATION

REF. NO.: SI-94-024

MODEL: NSX-340

SUBJECT: Noise occurs when the power is turned off.

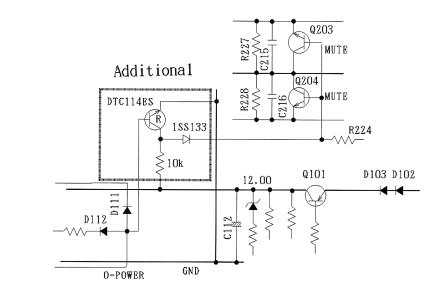
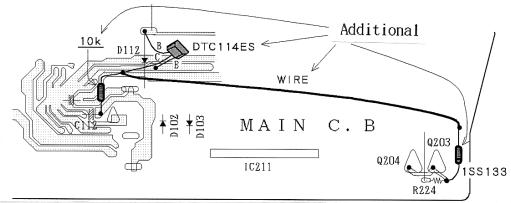
SYMPTOM: A humming sound is heard from the speaker about 5 seconds after the power is turned off. This

happens only when the power is turned off immediately after switching from the CD function to

another mode while the T-BASS is on.

REMEDY : Add the circuit described below so that muting starts immediately after the power is turned off.

Affix supplementary parts on the circuit board with adhesive.

Ref.	Part Name	Part Number
	TR. DTC114ES	87-026-245-010
	DIODE, 1SS133	87-020-465-080
_	RESISTOR, 1/8W-10K	88-121-103-010
	WIRE UB5-14-3	89-935-140-110
