## SERVICE TECHNICAL INFORMATION

REF. NO. : SI-96-018

MODEL : NSX-V800. CX-NK80. NAV80

SUBJECT : CD dropout, speaker box moves

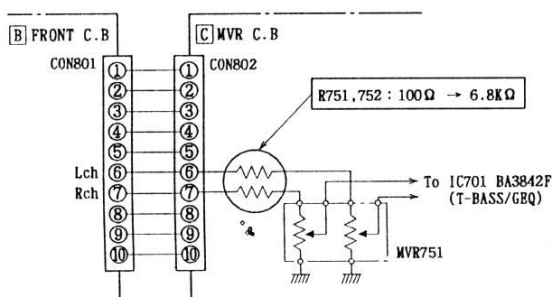
Fig. 1

CONTENTS : While playing the CD with T-BASS ON, BBE ON, GEQ ON (Rock or Disco), and with the volume beyond the 10 o'clock position, errors such as CD dropout or movement of the SP BOX occur.

| Ref. | | Parts No. | REMARK |
|---|---|---|---|
| R751, 752 | C-RES, 100Ω-1/10W → C-RES, 6.8KΩ-1/10W | 88-118-682-080 | Fig-1 |
