## SERVICE TECHNICAL INFORMATION

### ONE POINT REPAIR

MODEL : HS-JX808/807/804

SUBJECT : Noise is produced when DSL is on.

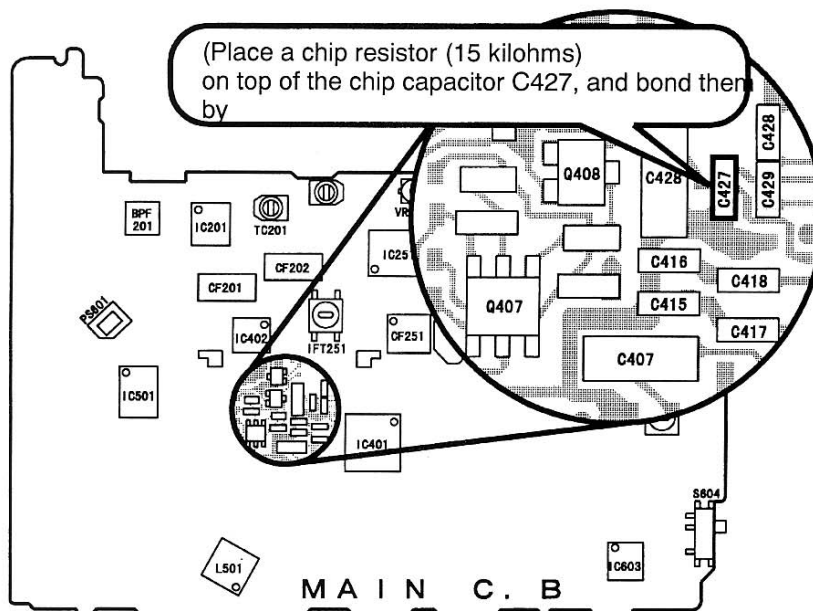
CONTENTS : With the DSL turned on, low frequency noise may be heard when the sound level is small or when there is no sound. If such a low frequency noise is pointed out by the customer, perform the following remedy:

REMEDY : Place a chip resistor (15 kilohms) on top of the chip capacitor C427 (0.15 microfarad), and bond them by soldering.
