AIWA CO., LTD  
UTSUNOMIYA FACTORY

## SERVICE TECHNICAL INFORMATION

MODEL : NSX-A303 and A304

SUBJECT : Addition or replacement of relay circuit

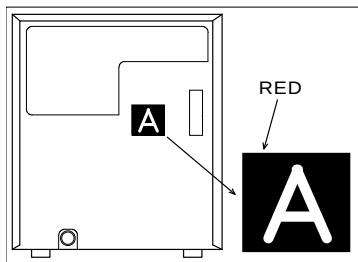
#### 1. Identification method

Relay circuit has been added to the units with "A" mark (white "A" letter on red) labels put on rear panel.

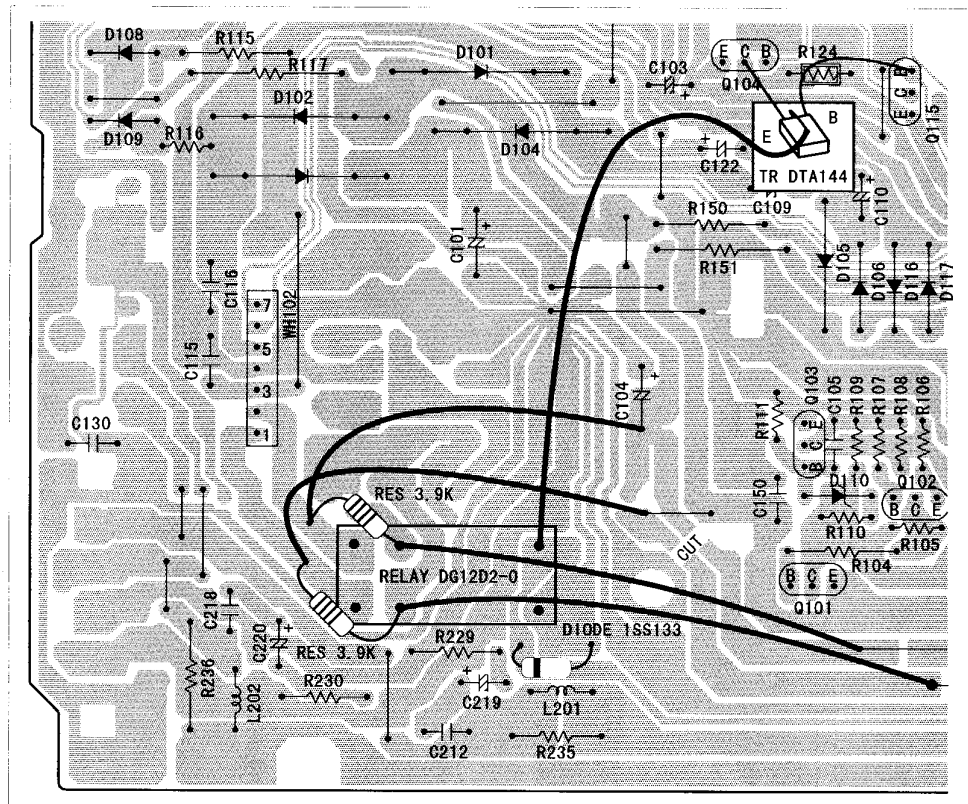
#### 2. Pattern diagram

Relay circuit has been added to some of the products of the above models.

Before repairing, refer to the following identification method and circuit diagram, pattern diagram, and replacement parts list for details.
