SERVICE TECHNICAL INFORMATION

ONE POINT REPAIR

UTSUNOMIYA, DECEMBER 30, 1997
REF. NO.: SI-97-059
CUSTOMER RELATIONS & SERVICE DIV.

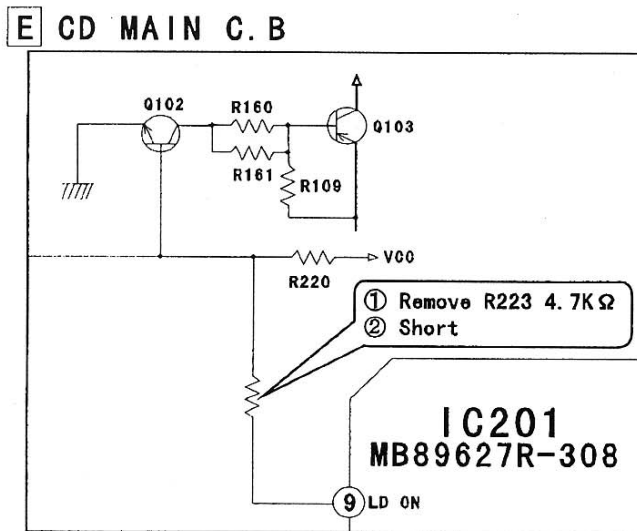
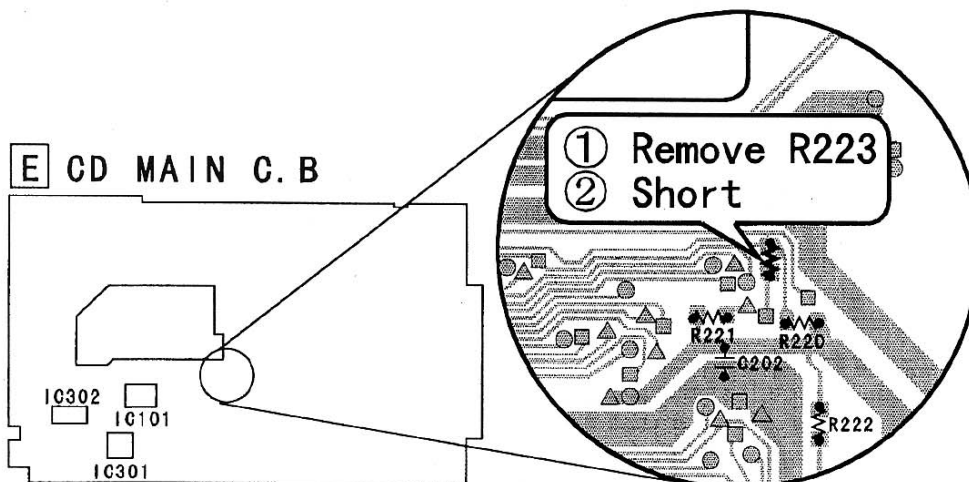
- MODEL S : XR-AKH100, NSX-KH9, AKH8
SUBJECT : The laser pickup is always on.
DESCRIPTION : During the CD function, it is found that the laser pickup is always on regardless of CD STOP.
When repairing the aforementioned models, take the following countermeasures.
REMEDIES : 1) Remove R223 shown in the circuit diagrams (CD MAIN C.B) indicated below.
2) Short the patterns on both sides of R223.
