## SERVICE TECHNICAL INFORMATION

UTSUNOMIYA, AUGUST 30, 1997  
 REF. NO.: SI-97-028  
 CUSTOMER RELATIONS & SERVICE DIV.

### ONE POINT REPAIR

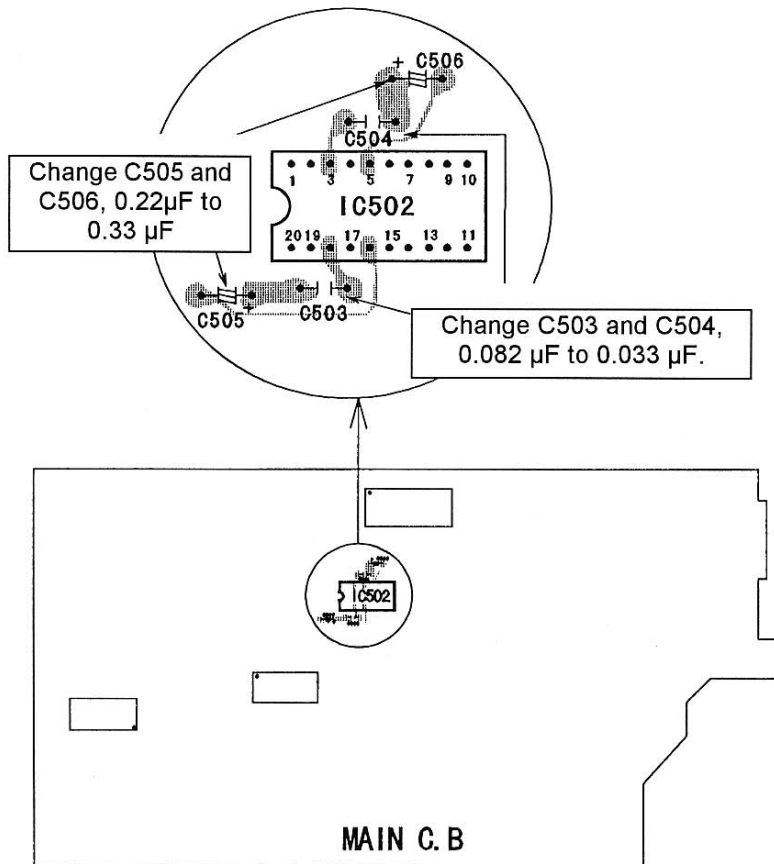
- MODEL : NSX-V210  
 SUBJECT : No T-BASS effect  
 SYMPTOMS: When it is indicated that even if T-BASS is turned ON, no T-BASS effect is produced, take the following countermeasure.  
 REMEDIES : Change the following capacitors as shown below.
- 1) C503 and C504, 0.082  $\mu$ F to 0.033  $\mu$ F
  - 2) C505 and C506, 0.22  $\mu$ F to 0.33  $\mu$ F

Ref.	Part Name	Part No.
C503, 504	CAP, 0.033-25	88-266-840-810
C505, 506	CAP, 0.33-50	88-707-789-010
