## SERVICE TECHNICAL INFORMATION

### ONE POINT REPAIR

REF. NO. : SI-96-018

MODEL : NSX-V800. CX-NK80. NAV80

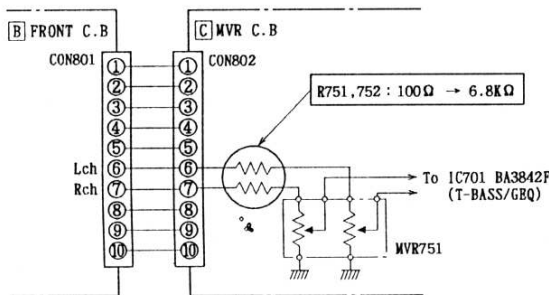
Fig. 1

CONTENTS : While playing the CD with T-BASS ON, BBE ON, GEQ ON (Rock or Disco), and with the volume beyond the 10 o'clock position, errors such as CD dropout or movement of the SP BOX occur.

Ref.		Parts No,	REMARK
R751, 752	C-RES, 100 $\Omega$ -1/10W	$\rightarrow$ C-RES, 6.8K $\Omega$ -1/10W	Fig-1
C221, 222	CAP, 1 $\mu$ /50V	$\rightarrow$ CAP, 0.1 $\mu$ /50V	Fig-2
C229, 230	CAP, 10 $\mu$ /50V	$\rightarrow$ CAP, 2.2 $\mu$ /50V	Fig-2
