Beomaster 7000

Beomaster 6500

Corrections

10-91 3538794 Indklæbes i Serviceanvisningen Beomaster 6500 (3538751)
Paste into Service Manual Beomaster 6500 (3538751)
In Serviceanleitung Beomaster 6500 (3538752) einkleben
A coller le Manuel d'entretien pour Beomaster 6500 (3538752)

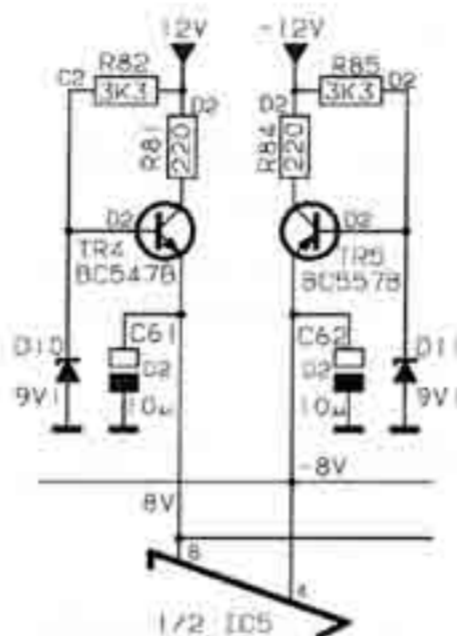
3R81 and 3R84 5010092 220Ω 5% 1/4W has been added:

7TR2 BC338 is an NPN transistor. Emitter to the ground.
