# SUPPLEMENT

## Model 1800V Professional Stereo Power Amplifier

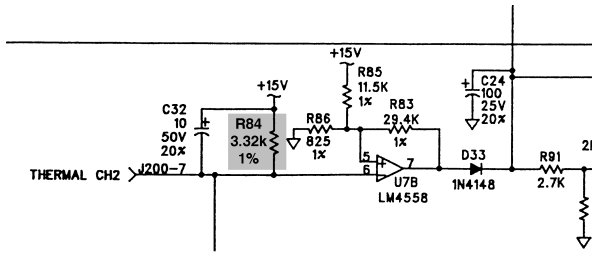
**New Thermistor**

The thermistors RT100 and RT200 used in the 1800V protection circuit have changed. The resistors R41 and R84 had to be changed to match the new thermistors. The thermistors RT100 and RT200 are located on the amplifier PCB. The resistors R41 and R84 are located on the I/O PCB. Refer to the 1800V service manual, part number 181812, for disassembly procedures, schematics, and PCB layouts. Refer to the figures on the back of this page for the location of the thermistors and resistors. The tables below list the proper resistor and thermistor combination. It is not necessary to change these components unless they have failed. Insert this supplement into the 1800V service manual, part number 181812 REV 00.

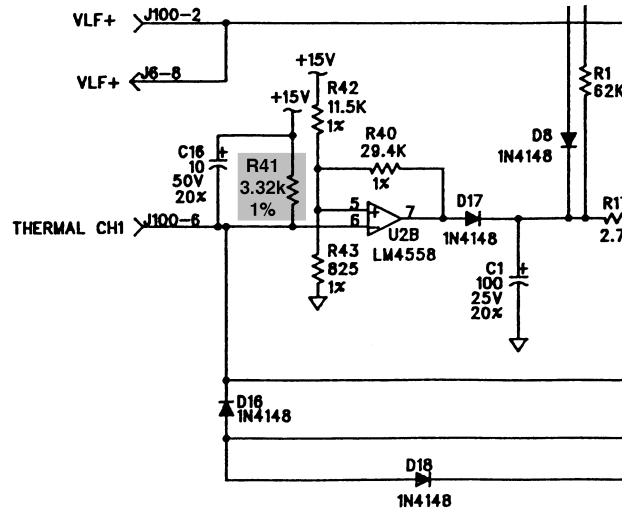
**Old Thermistor**
