Figure correction in service manuals

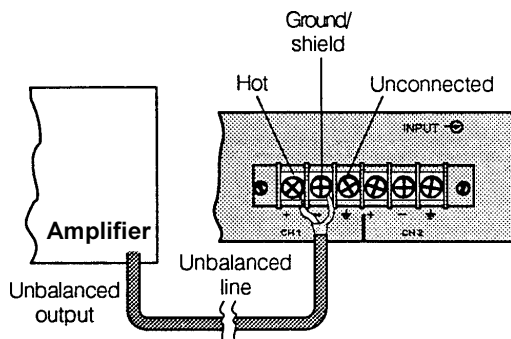
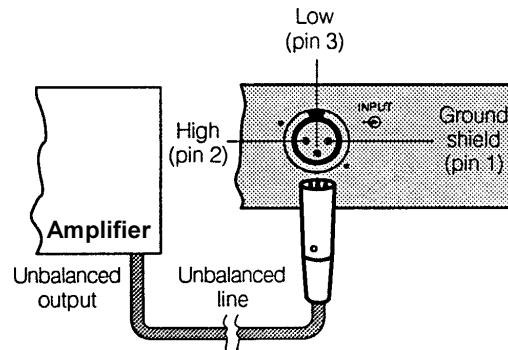
FROM:

The unbalanced connection diagram in the Test Procedures section of the Panaray (502) service manual, P/N 170310, and in the 402/802 II service manual, P/N 174785, is incorrect. **Figure 19 on page 33** of the 502 service manual and **Figure 24 on page 23** in the 402/802 II service manual should be changed as follows (only a partial figure is shown):

The input device was incorrectly identified as an amplifier. It should be a signal generator or audio oscillator.
