Cambridge Audio 'P' series amplifiers.

The P40 appeared in 1969, followed by the P50 in 1970, the P60 in 1975 and then the later P110. Output power was indicated in the model numbers, eg; P40 - 20+20W, etc. The P50, to some, was rather crude but a solid build with a surplus of connecting wires and large components whilst the P60 had a rather more professional finish with everything mounted on a single PCB with no modifications, both being hand built. The P50 also had an unusual active volume control using variable feedback in the first stage of the preamp giving high overload margin and low noise, an approach often seen in guitar preamps, which was retained in later designs. This was useful for matching a variety of input levels.

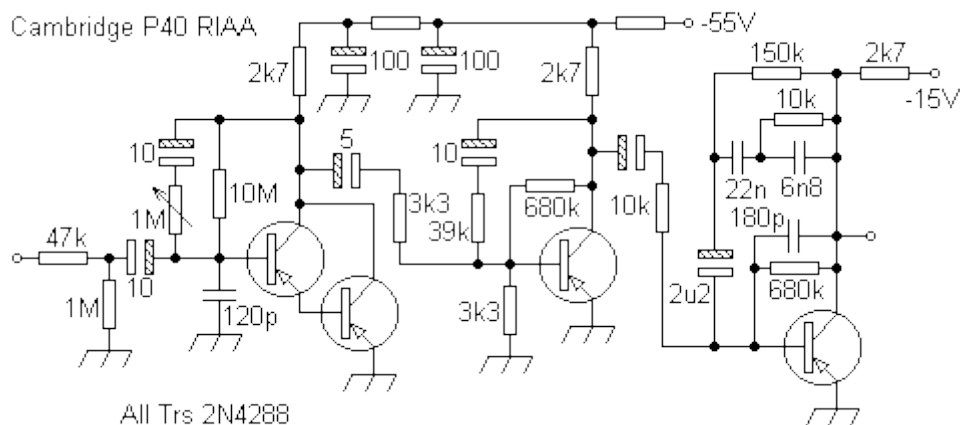
The P40's RIAA stage differed from the norm having a high impedance, flat, inverting, variable gain input ($>x21$ max). This was followed by an eq stage ($x15$ DC) that remained virtually unchanged in later models, the common emitter configuration being a fundamental building block in these amplifiers.

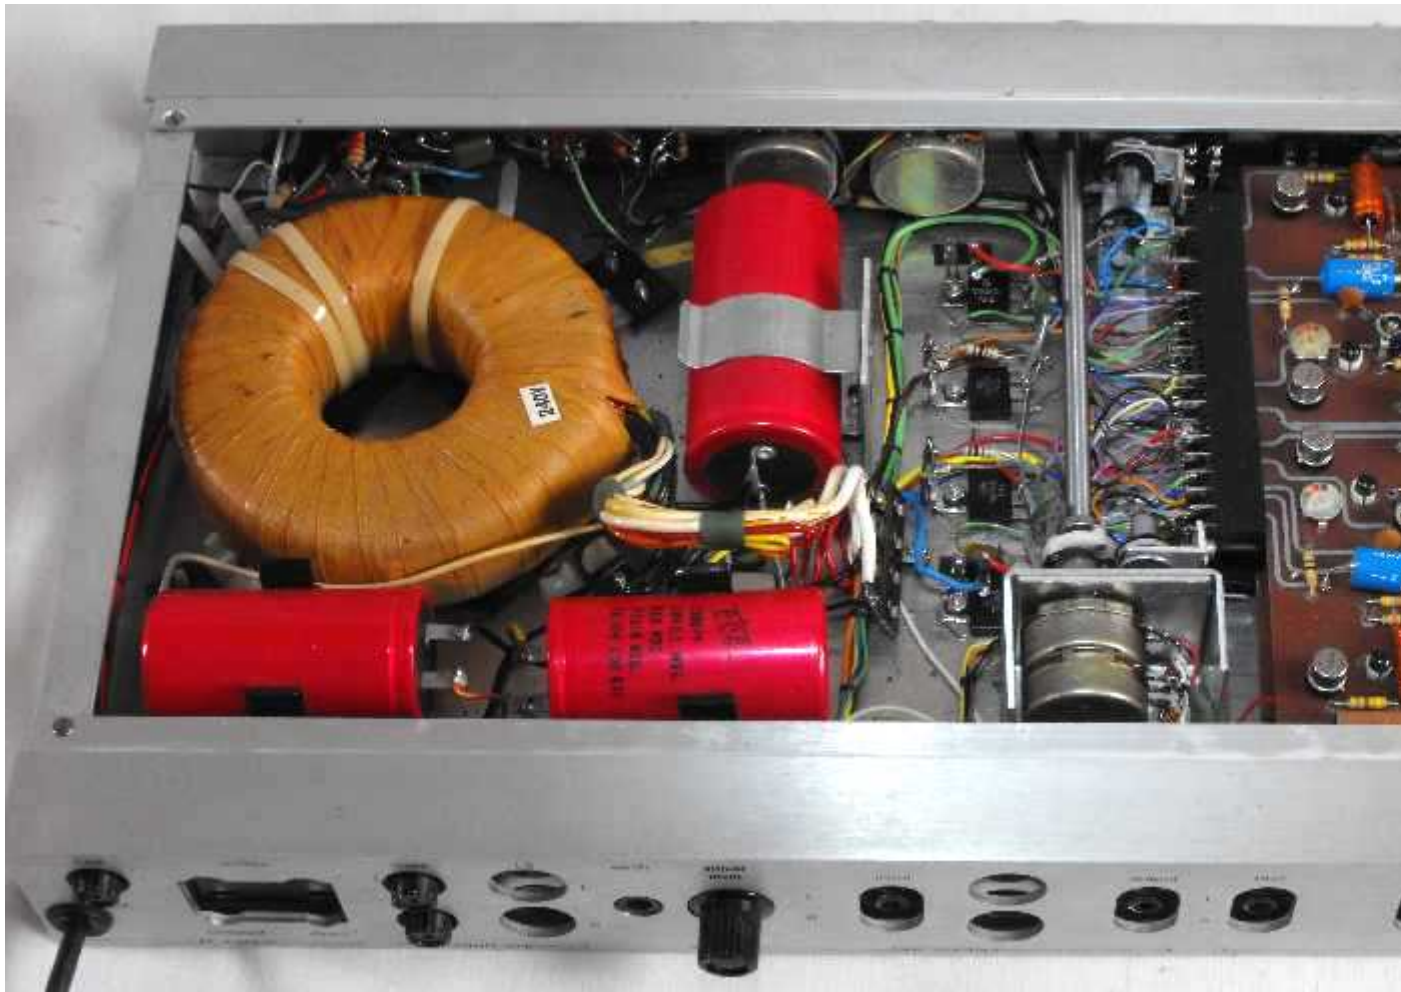
Note virtual absence of heatsinking and 'complex' wiring of output stage when the output device packages were specifically intended for direct PCB mounting. The words 'baby' and 'bathwater' come to mind. With no ventilation of the case high internal operating temperatures can be expected reducing component life. The thermal resistance of a thin sheet of metal will be far higher than a thicker bar. As a consequence, a distinct hotspot was created around the output devices. The short red wires on the outermost ones are the current sensing elements for the over-I trip circuitry (not much help when the transistor chips have melted). The bias diodes are *glued* to the chassis between the output pairs.

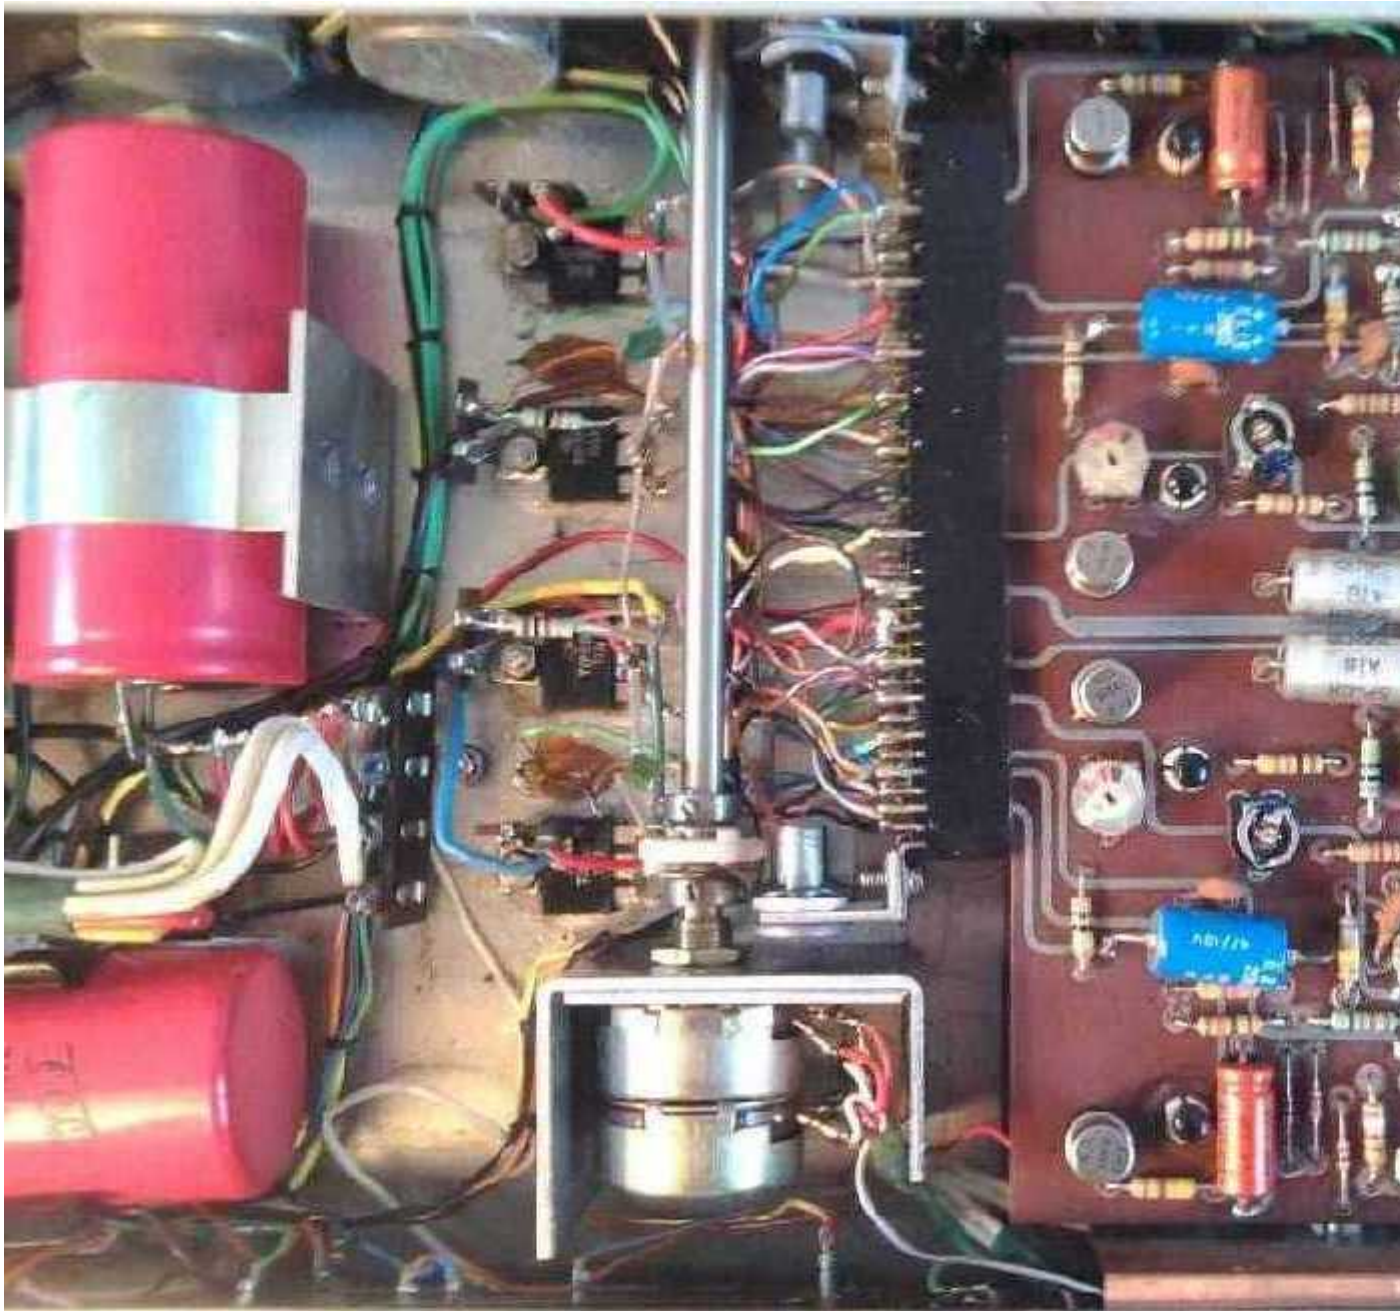
Whilst an emphasis was put on the use of a toroidal mains transformer to cut down case height and weight, any advantages given were, it is felt, overridden by ignoring other thermal issues that then compromised reliability. At the same time, the somewhat fragile mounting prevented the transformer from being rotated to reduce hum if necessary.

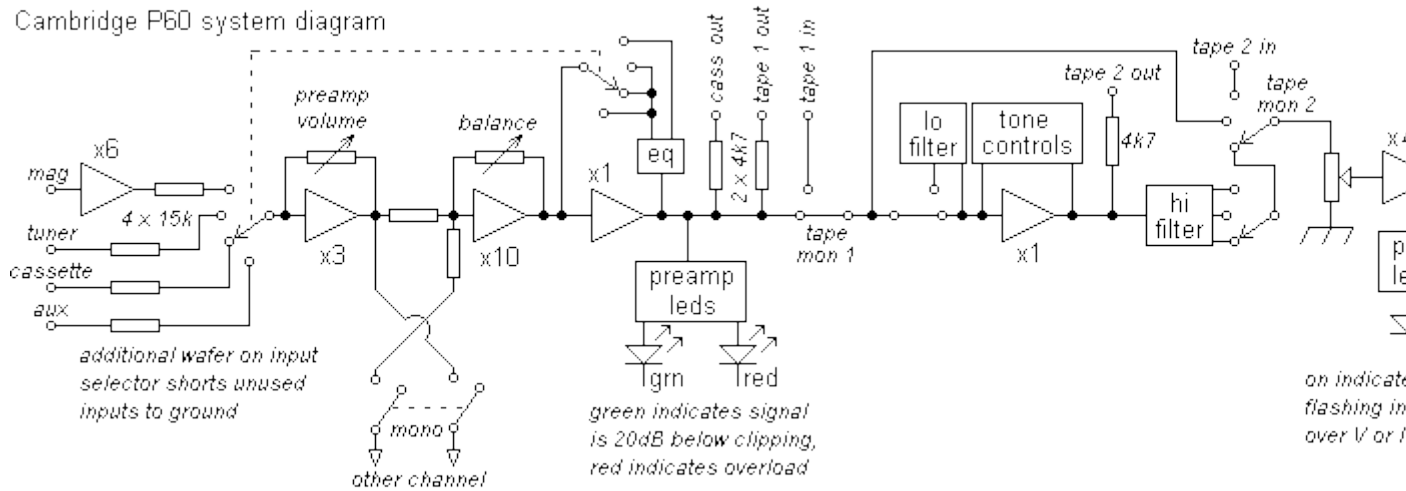
Cambridge P60 system diagram

An unconventional but high quality build, some considered the placement of volume, balance and mono controls before the tape outputs as inconvenient. However, the facility for up to three tape decks to be used, the tape 2 output following the lo-filter and tone controls, could be useful.

The main preamp differences between these and the P50 include additional volume control and signal/peak indicators but no decoder, mains and phono sockets then reducing flexibility considerably which was the P50's strong point. Specifications for this model are given as

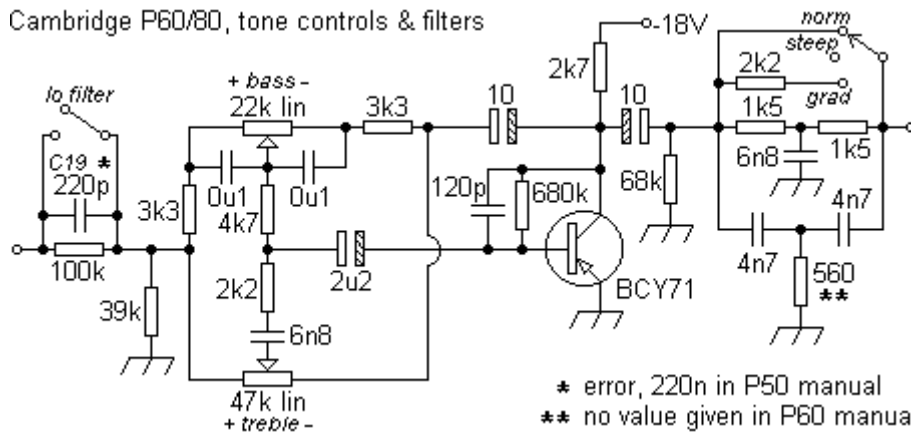
Cambridge P60/80, tone controls & filters

Care was taken to ensure that prior to any switching, a resistor grounded the decoupling capacitors so that no DC shift, due to leakage, produced

The other fault was a little harder to track down. Following signals in the tone control section (which necessitated removal of the front bezel to get at the potentiometer connections on the circuit board) showed one channel consistently quieter than the other. I could not find a fault in this channel and eventually realised that the fault was in the channel with the louder signals! This brought me to the conclusion that it was probably C22 at fault since in normal operation the path through Q6 would attenuate the signal in the tone control circuit. Checking C22 showed that it was open circuit.

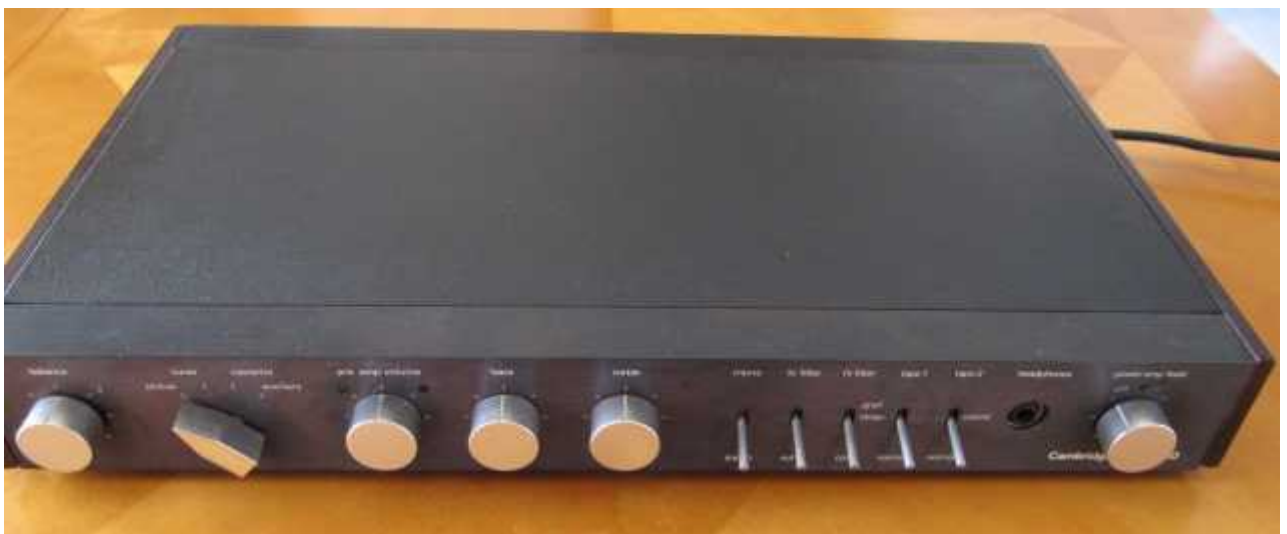
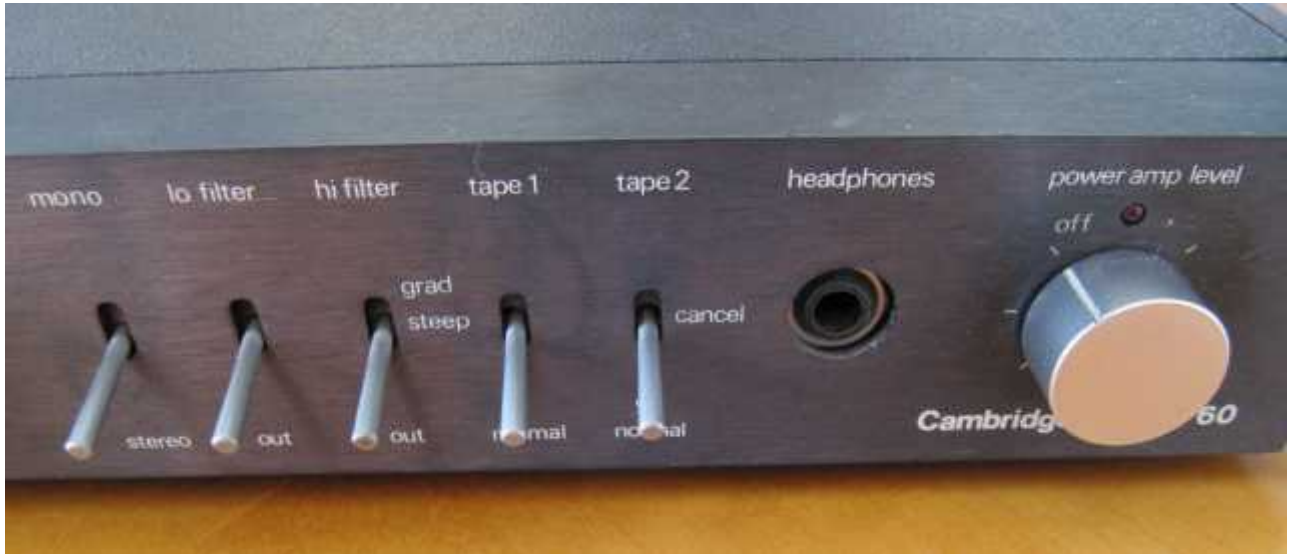
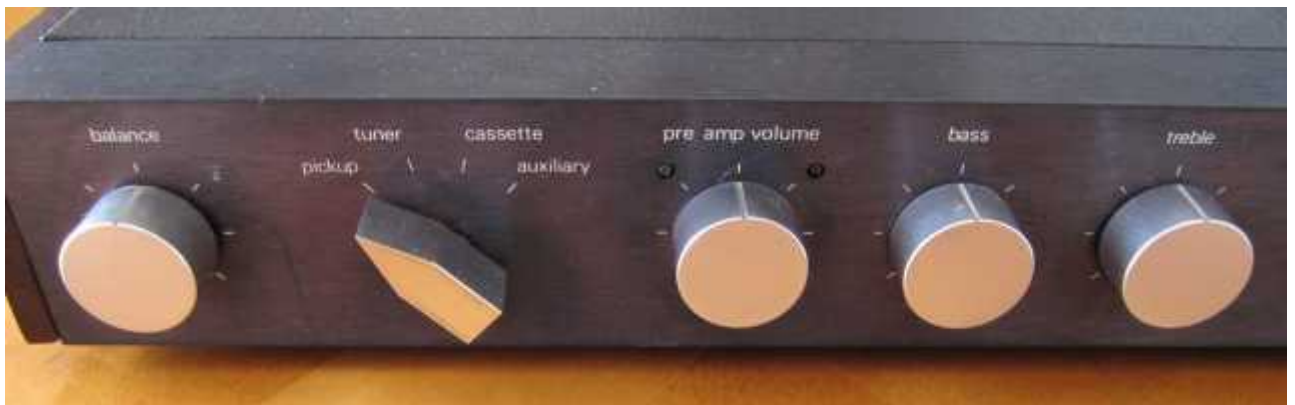
The distinctive input selector knob was supplemented by the unique indicators on the preamp level. The colour scheme changed from polished aluminium and black lettering. In a later version (PCB iss 3) the polished finish was retained.

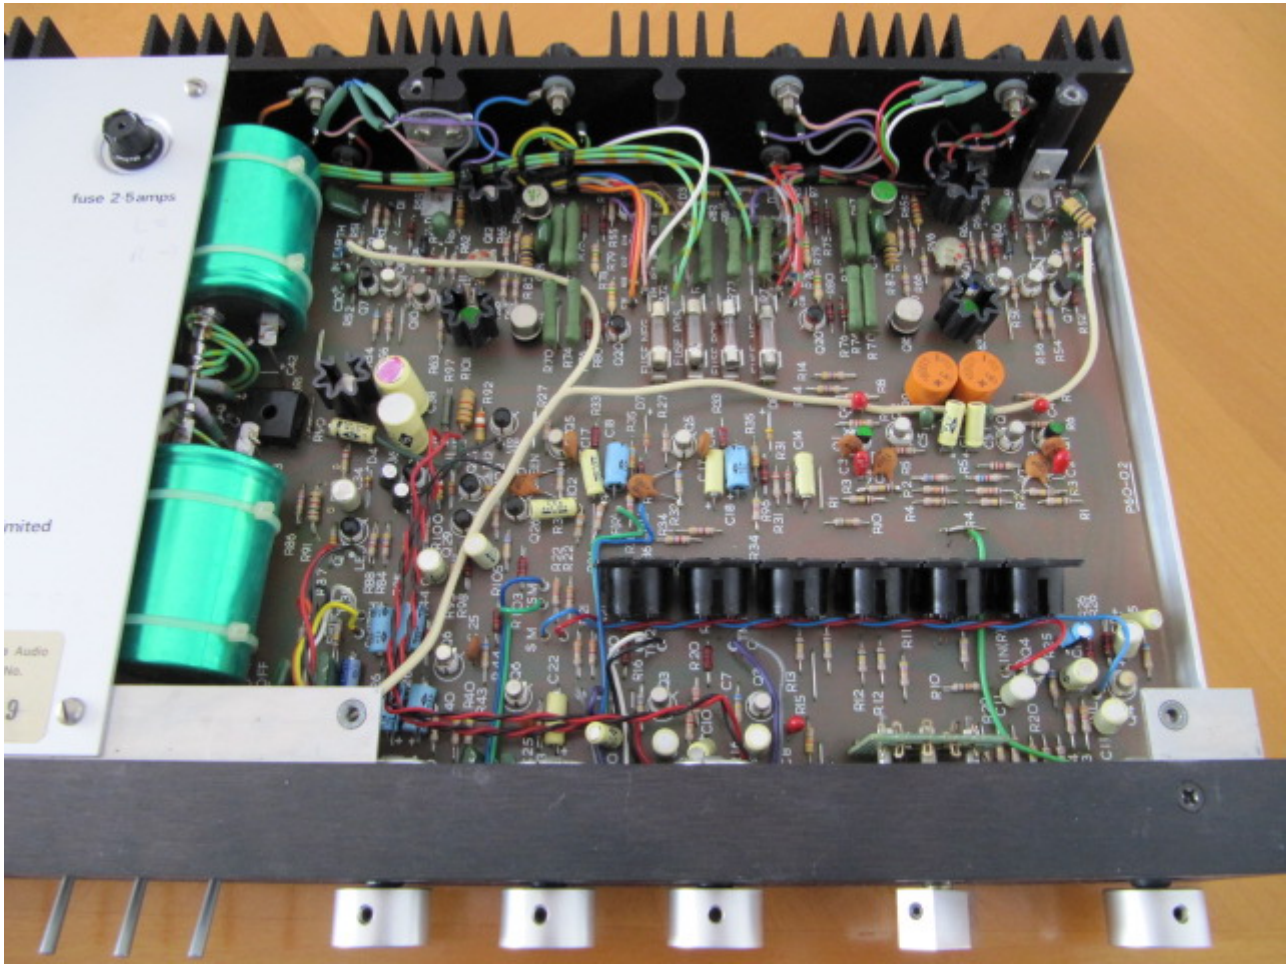
The PCB's 'upside-down' position was determined by there being no room on the rear panel for the input sockets this been taken up almost entirely by the heat-sinking for the output pairs (now very sensibly radiating *outside* the unit). It is arguable that internal air-flow around the components would be reduced, but this was essentially limited anyway.

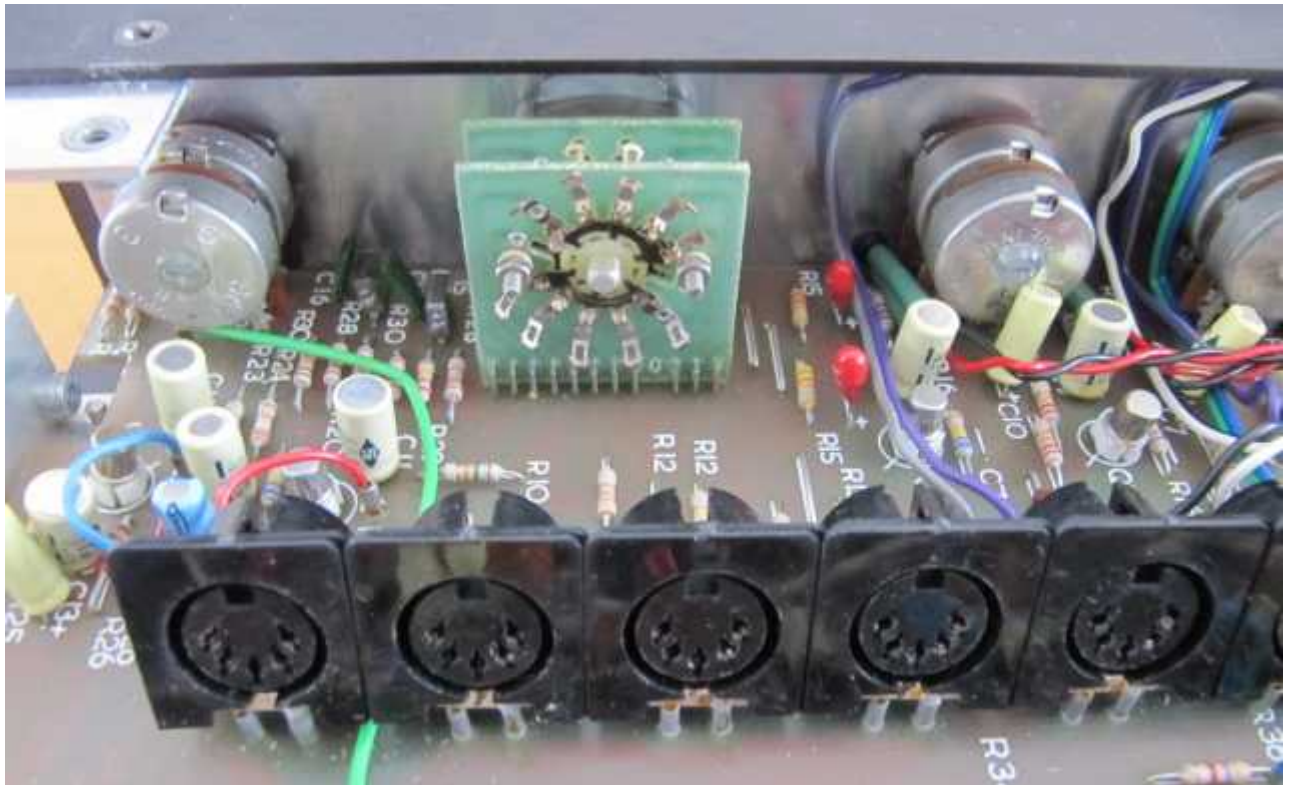
This arrangement with the input sockets directly mounted on the PCB rather than the chassis, whilst reducing wiring, could prove problematic with the plastic sockets prone to breakage if care was not taken fitting connectors. From an aesthetic point of view these further disappointed since identical sockets could be found on far cheaper Thorn (eg; Bush, Ferguson, etc) products and, frankly for the price, one expected better. A similar arrangement was used in the complex Beomaster 6000 making access more awkward, the (hefty) unit then having to be lifted when change was required. I recall one unhappy customer whose precious wooden top had been deeply scratched by the metalwork when doing this.
