Service Bulletin

No. : MZ00-002

Model: CC870

Subject: FLD shows "JAMMED" and CD mechanism will not move to CD stored position.

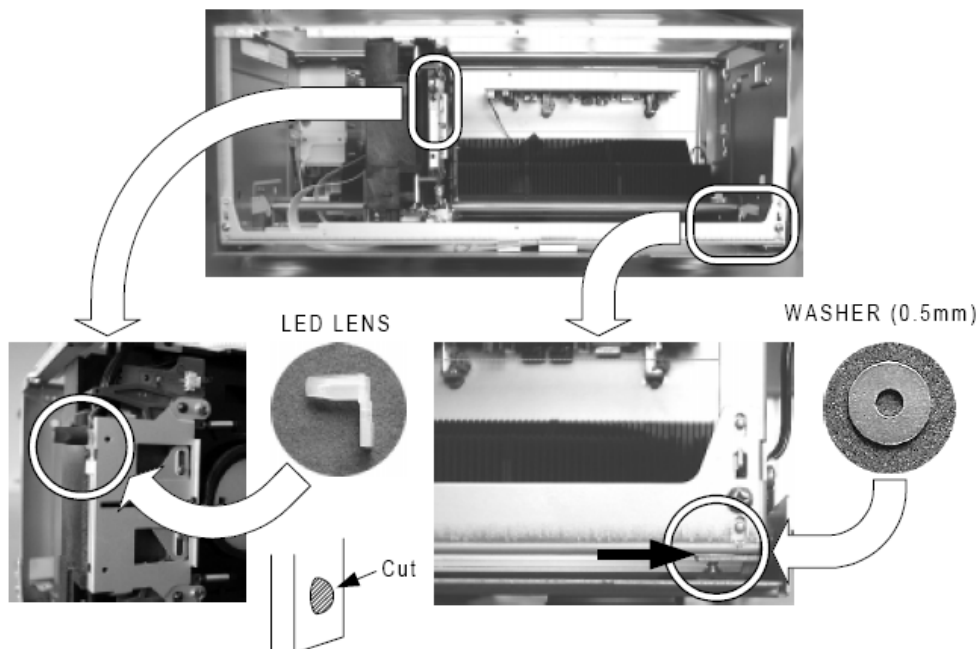
Symptom: The CD position indication LED LENS touches the front panel.

Solution: Cut the small boss on the LED LENS. Put the 0.5mm washer at the position shows on following picture. Note: When removing the CD position indication LED LENS take care not to damage the LED and read wires.
