**Service Bulletin**

No.: MZ08-052

Model: MM8003

**Subject:** The supplier of the (BALANCE INPUT PWB) XLR female connectors has been changed.

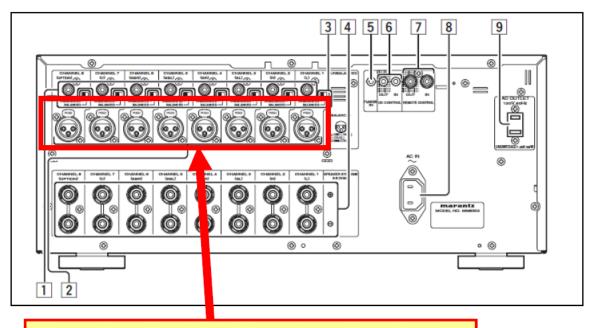
JK50/JK51/JK60/JK61/JK70/JK71/JK80/JK81

**Symptom:** Due to the XLR cable (male connector) varying in quality and also due to wear, some XLR female jacks manufactured by Dongbo Industries Ltd are not tight enough to lock when the XLR connectors are inserted.

**Solution:** Replacement parts for POS NO. <u>JK50/JK51/JK60/JK61/JK70/JK71/JK80/JK81</u> (BALANCE INPUT PWB) XLR female connectors will be switched from Dongbo Industries Ltd to Jyetai Precision Industrial Co., Ltd..
