8.2 Main Amp/Power Supply (P701) Schematic Diagram and Component Locations

PM-64

PM-54

12. SCHEMATIC DIAGRAM

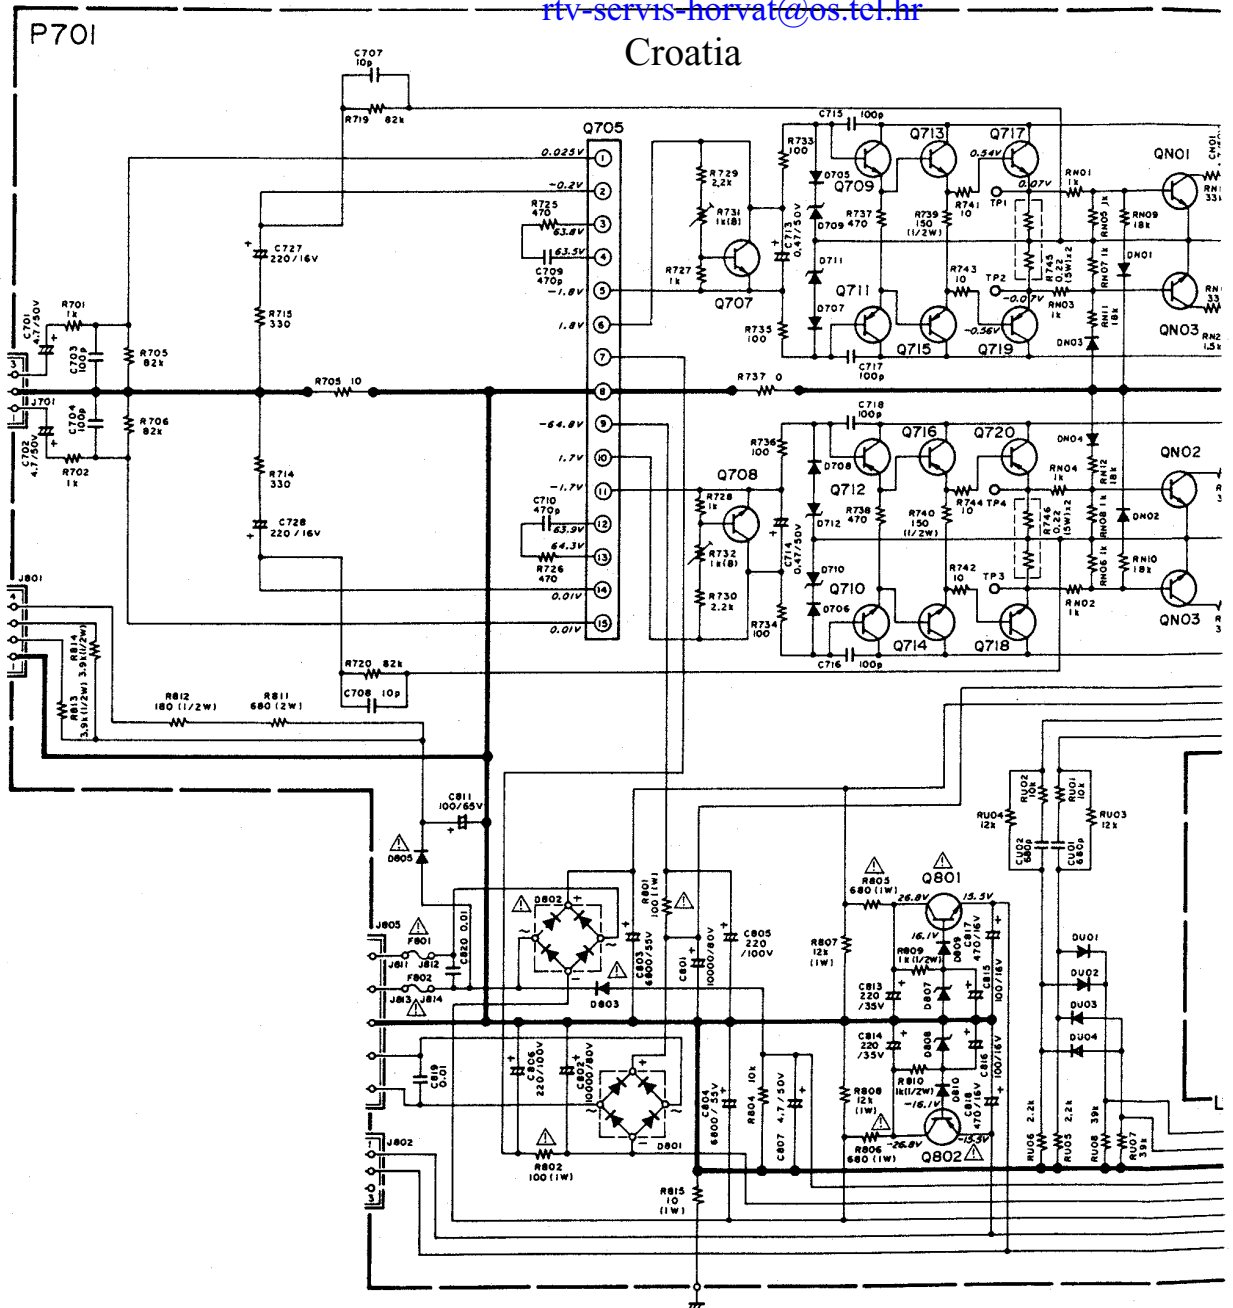
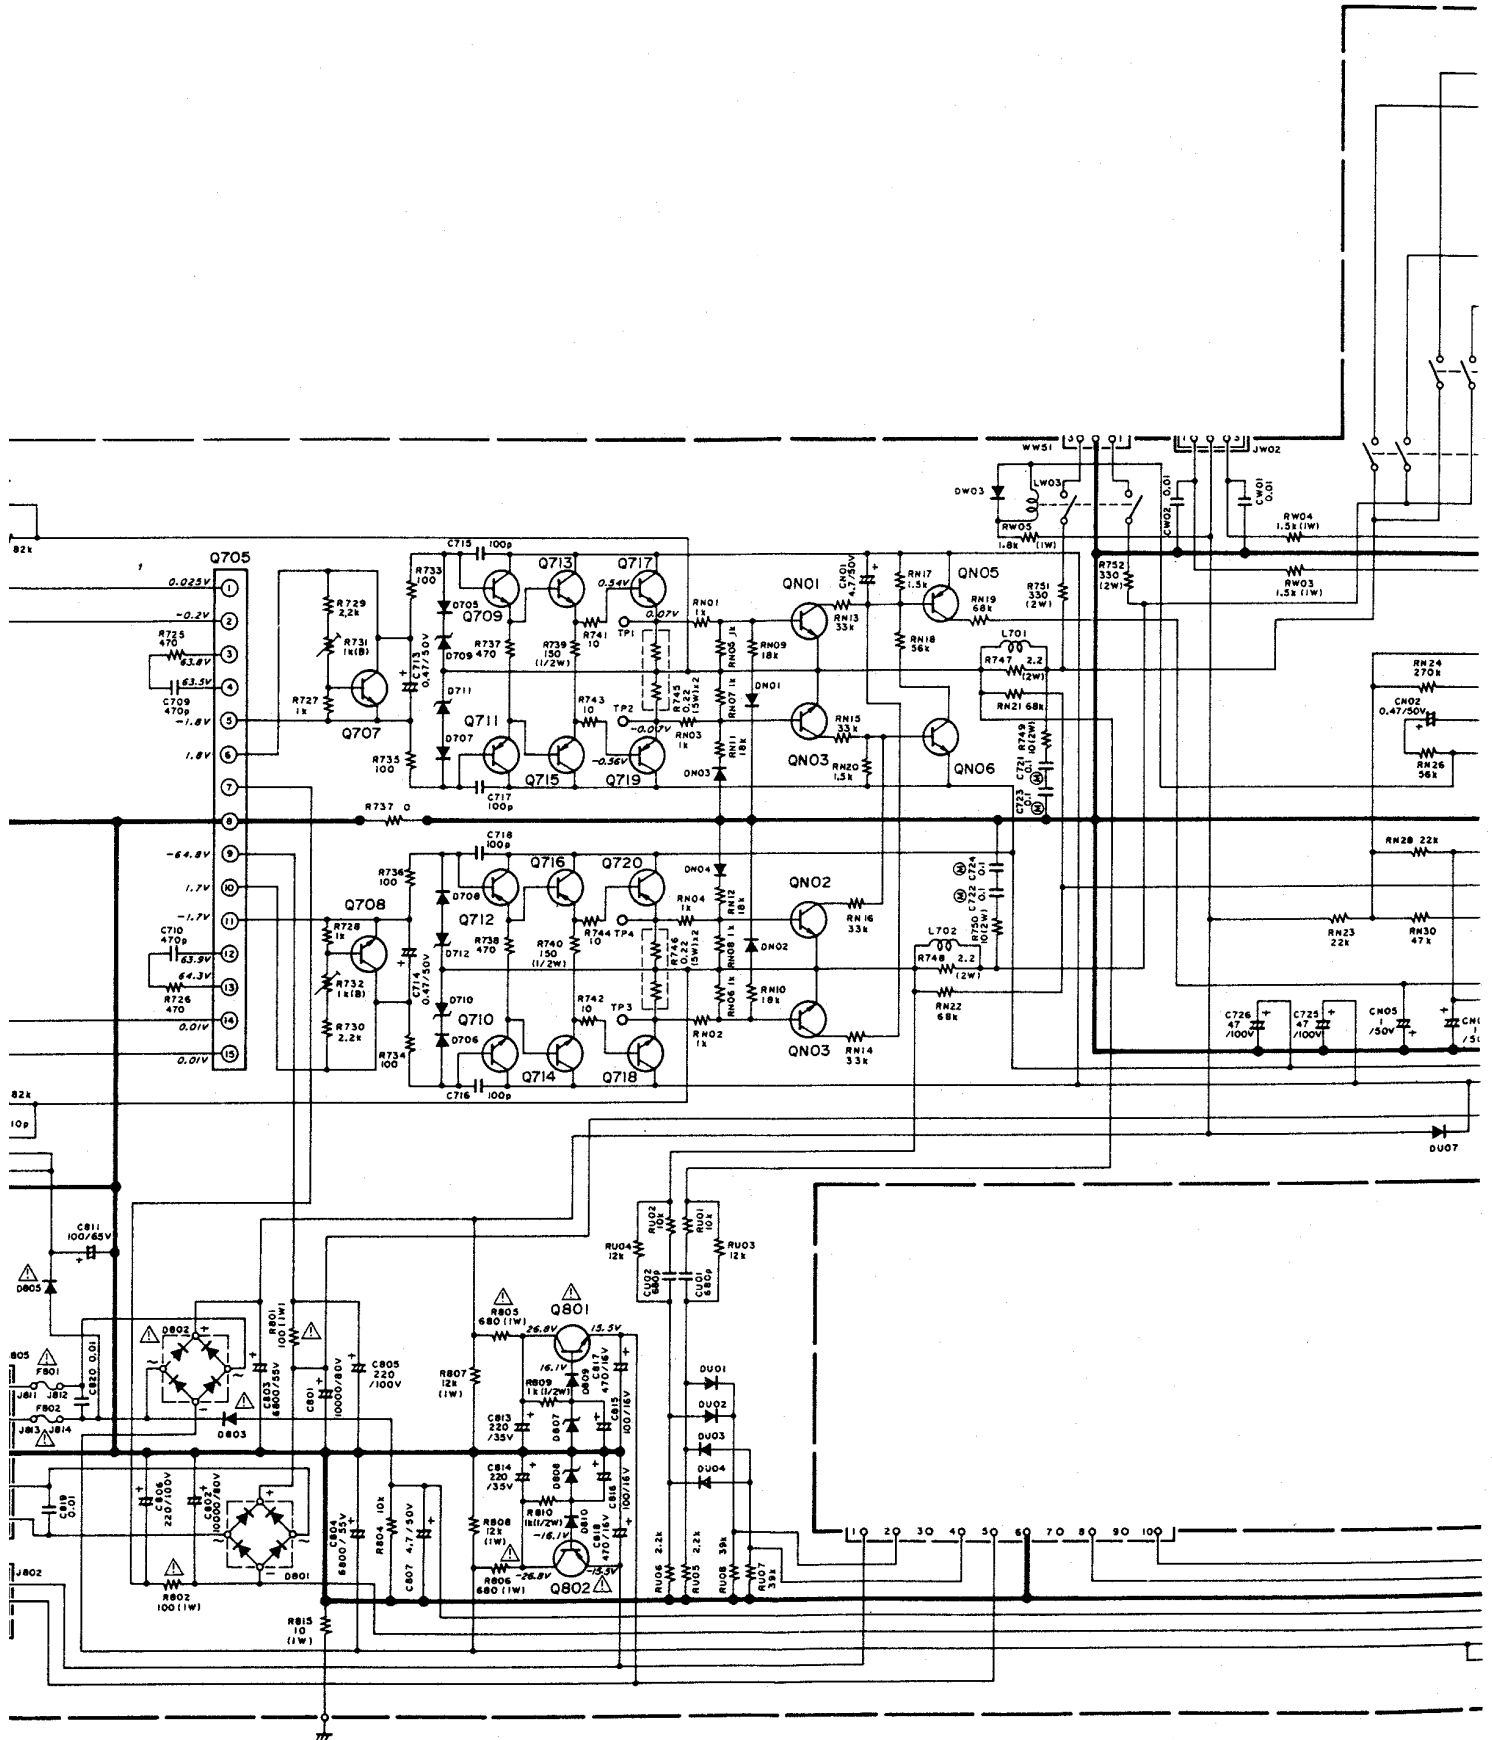
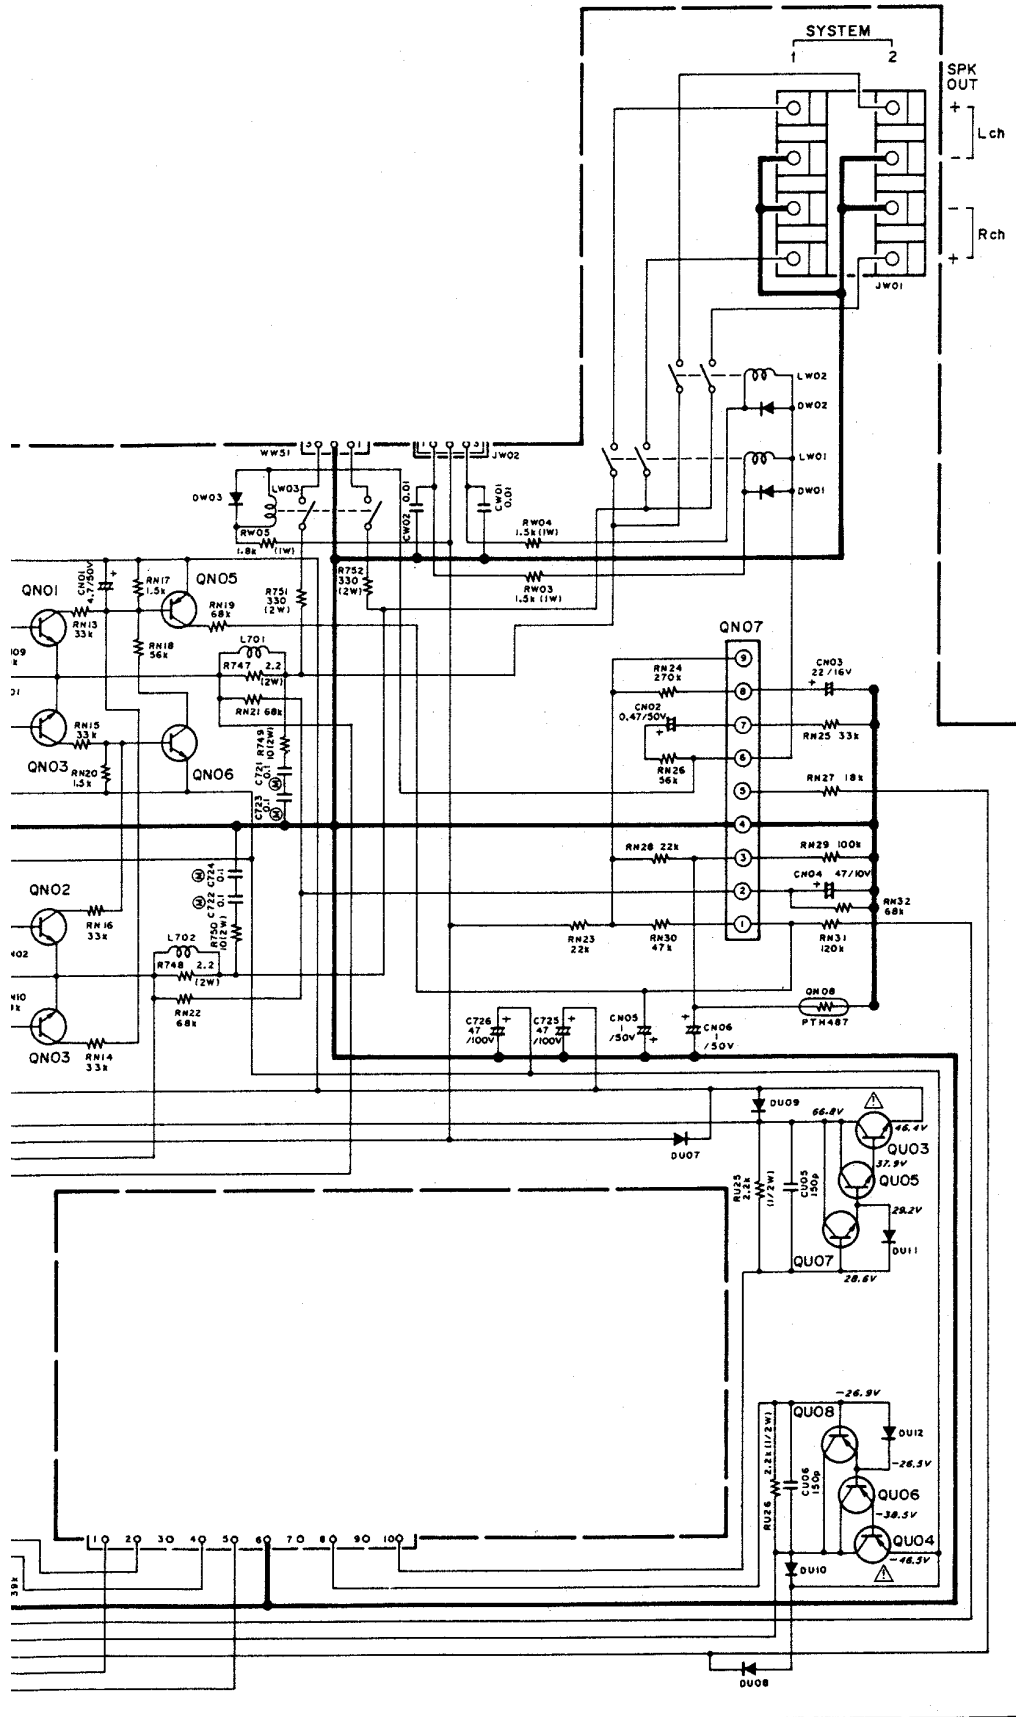
Diagram and Component Locations

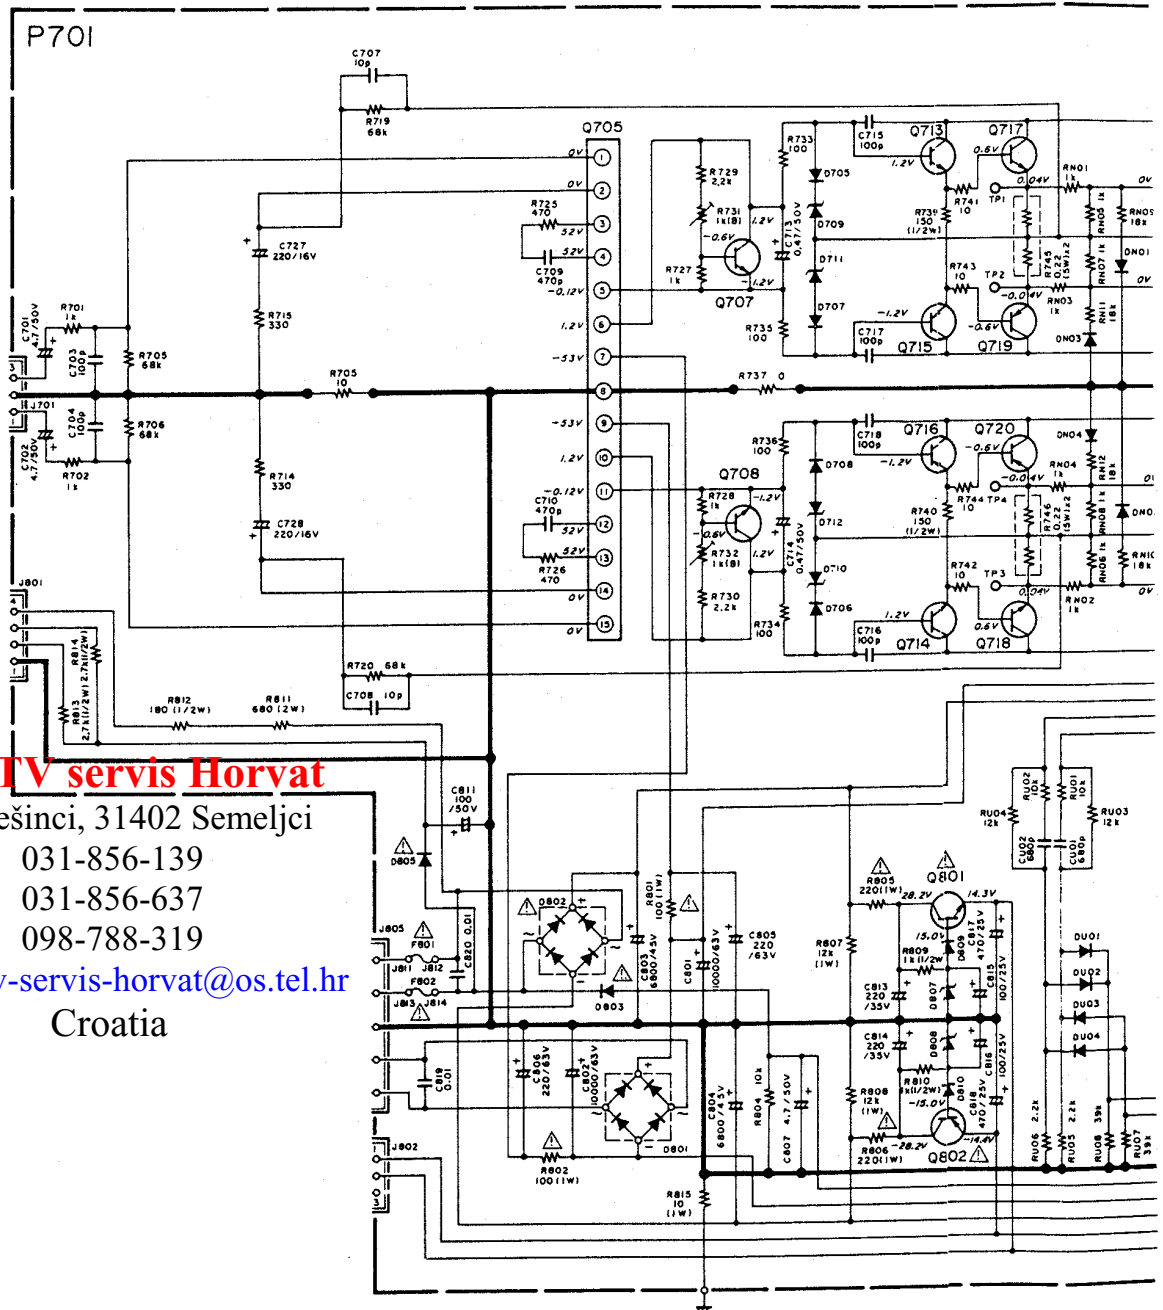
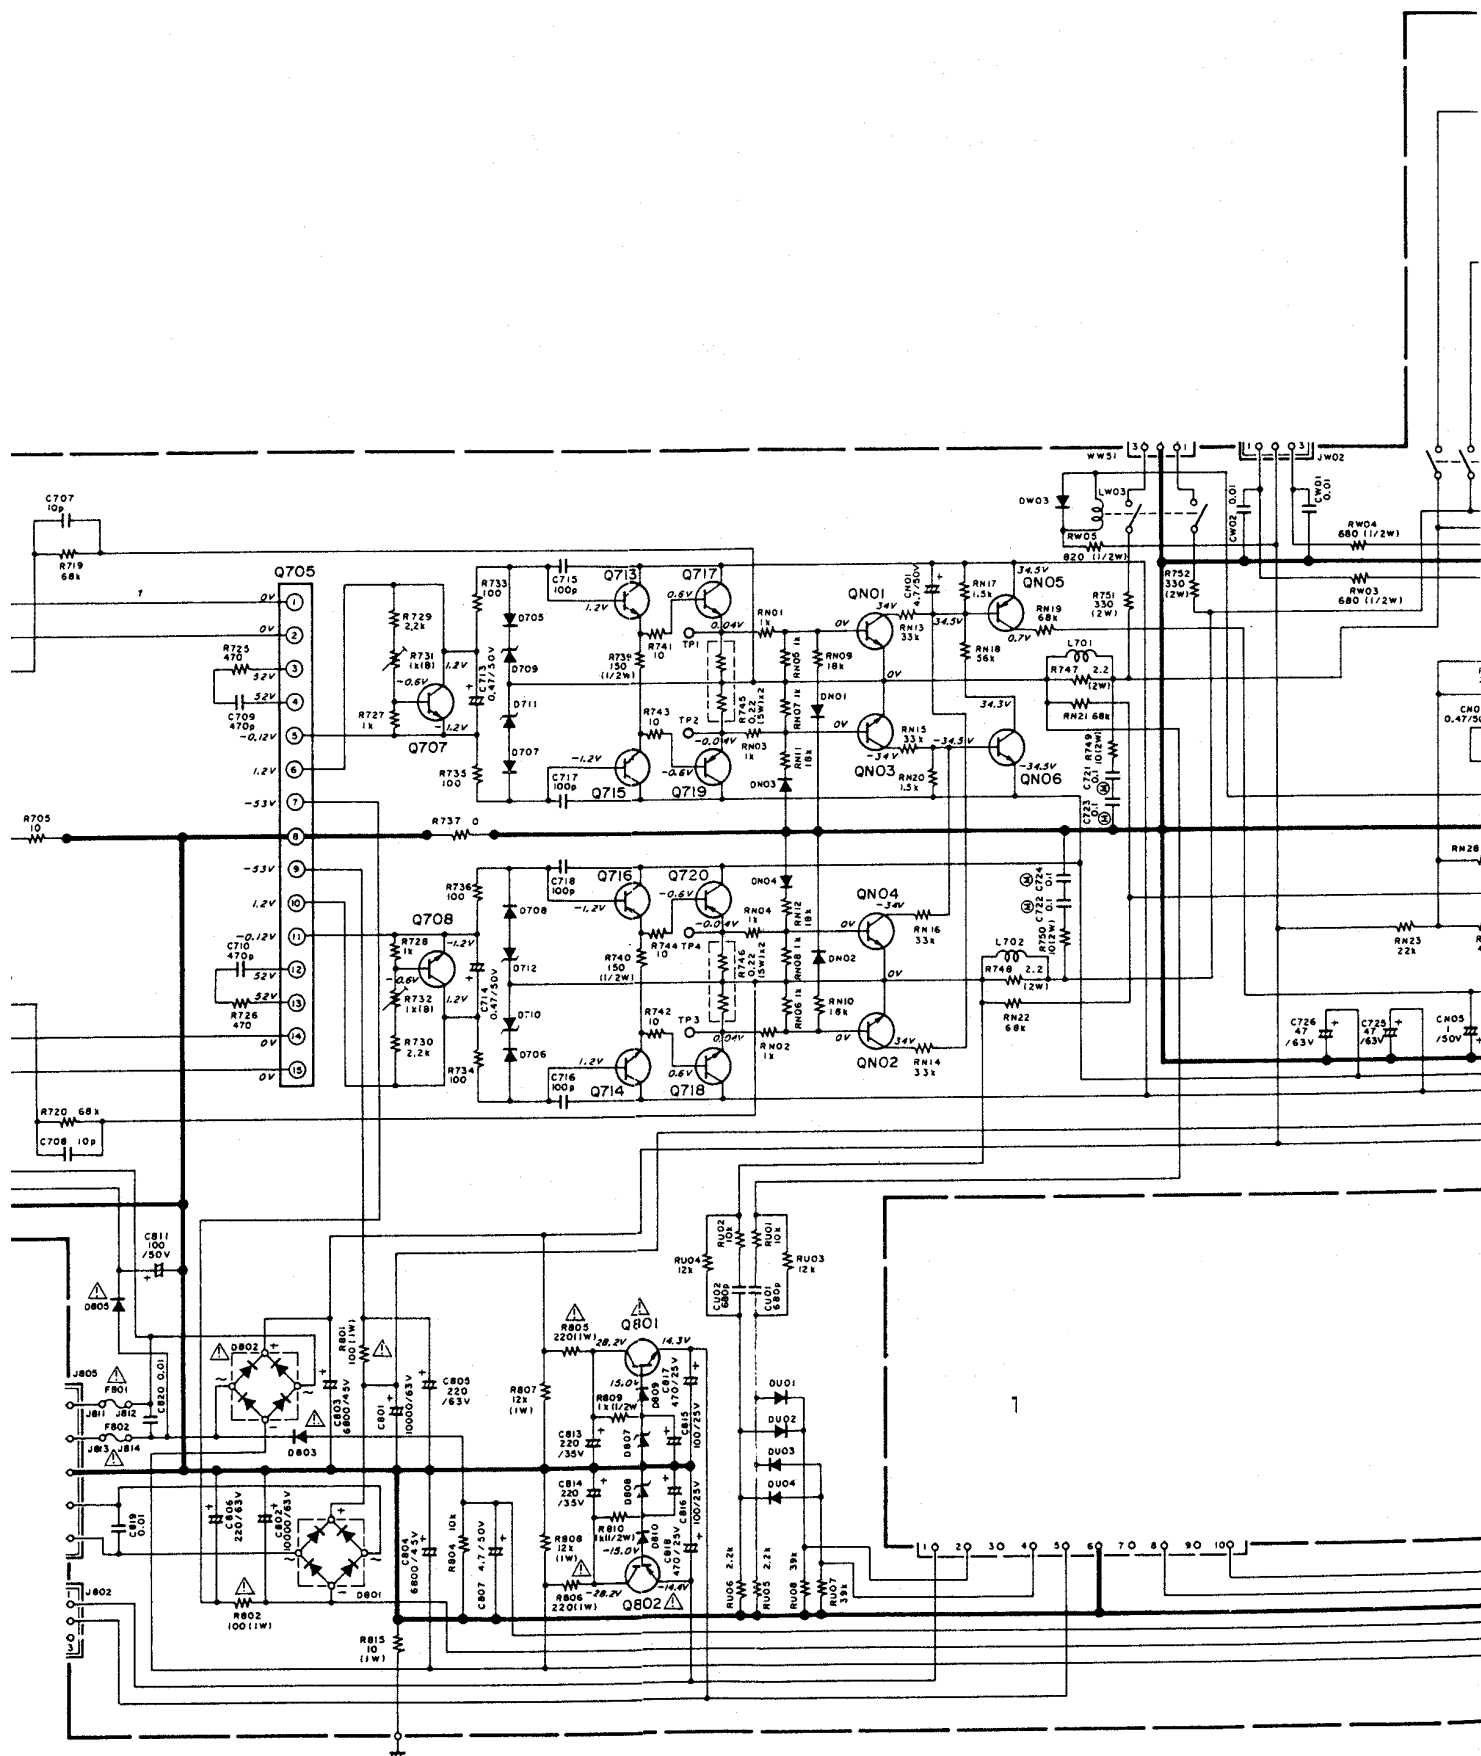
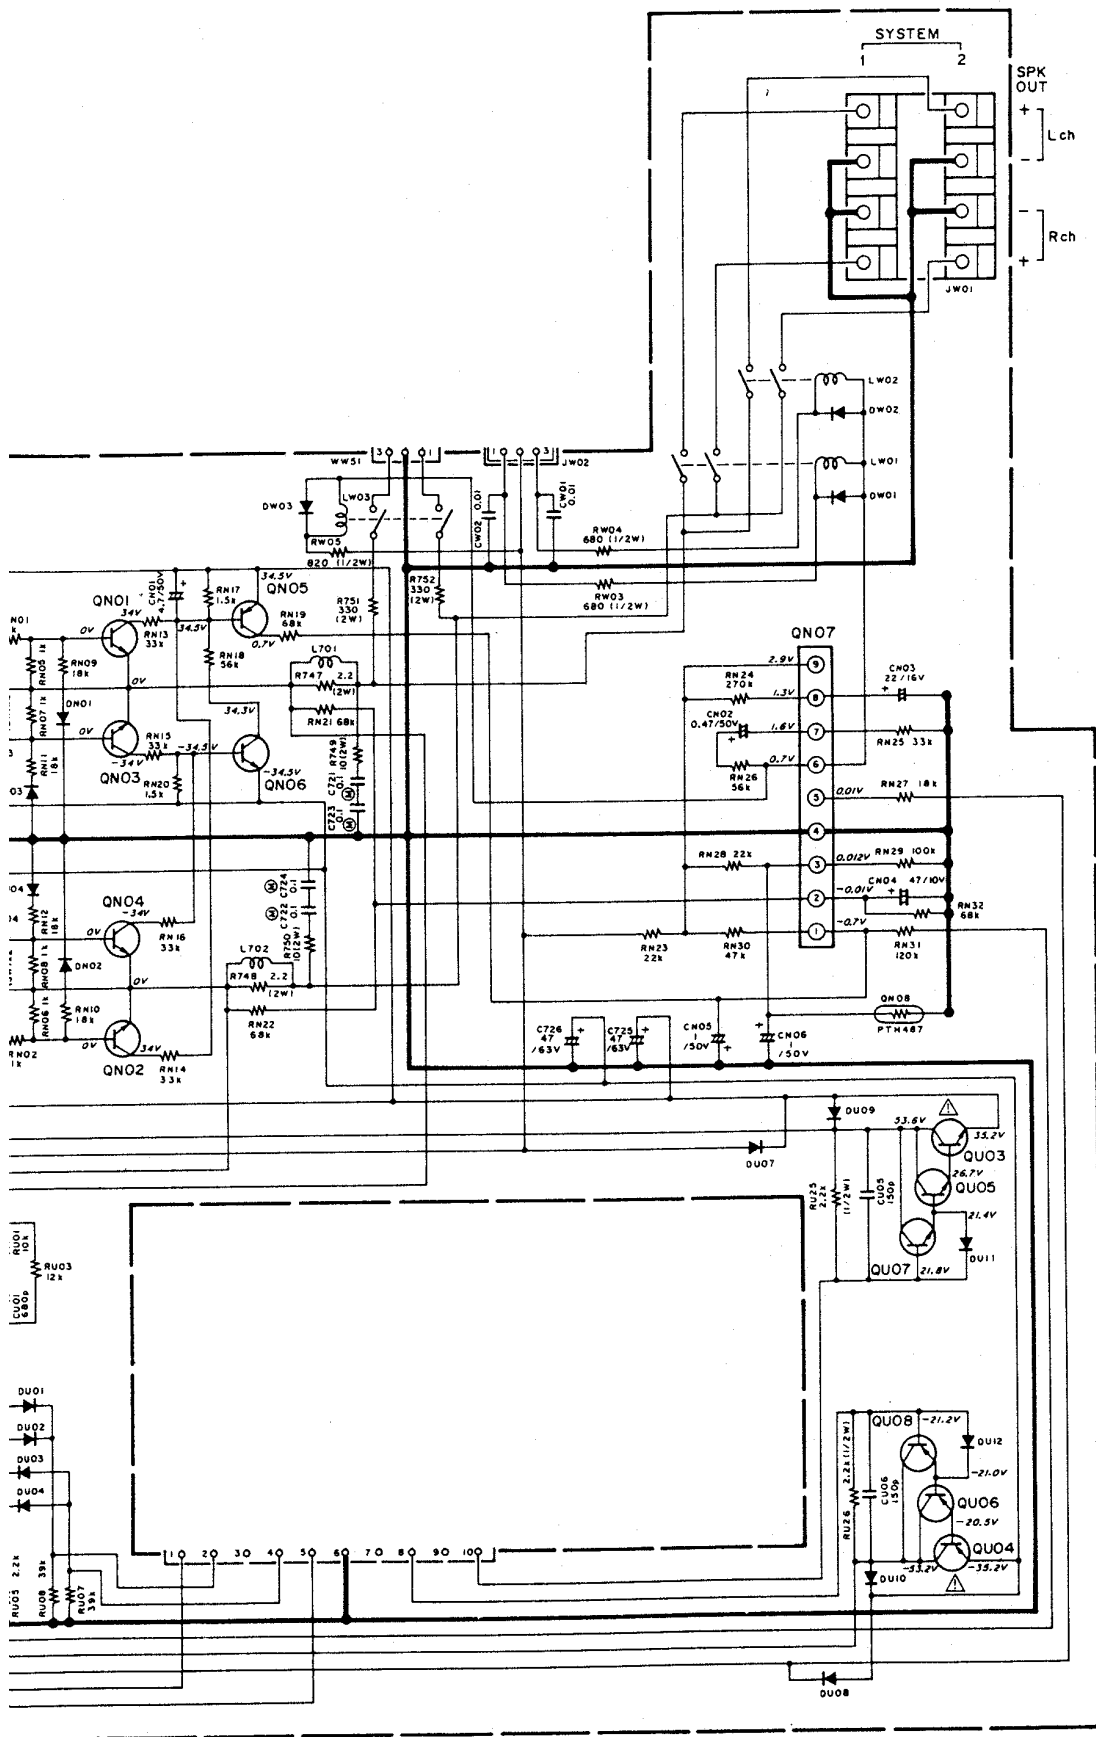
8.2 Main Amp/Power Supply (P701) Schematic Diagram and Component Locations

Diagram and Component Locations

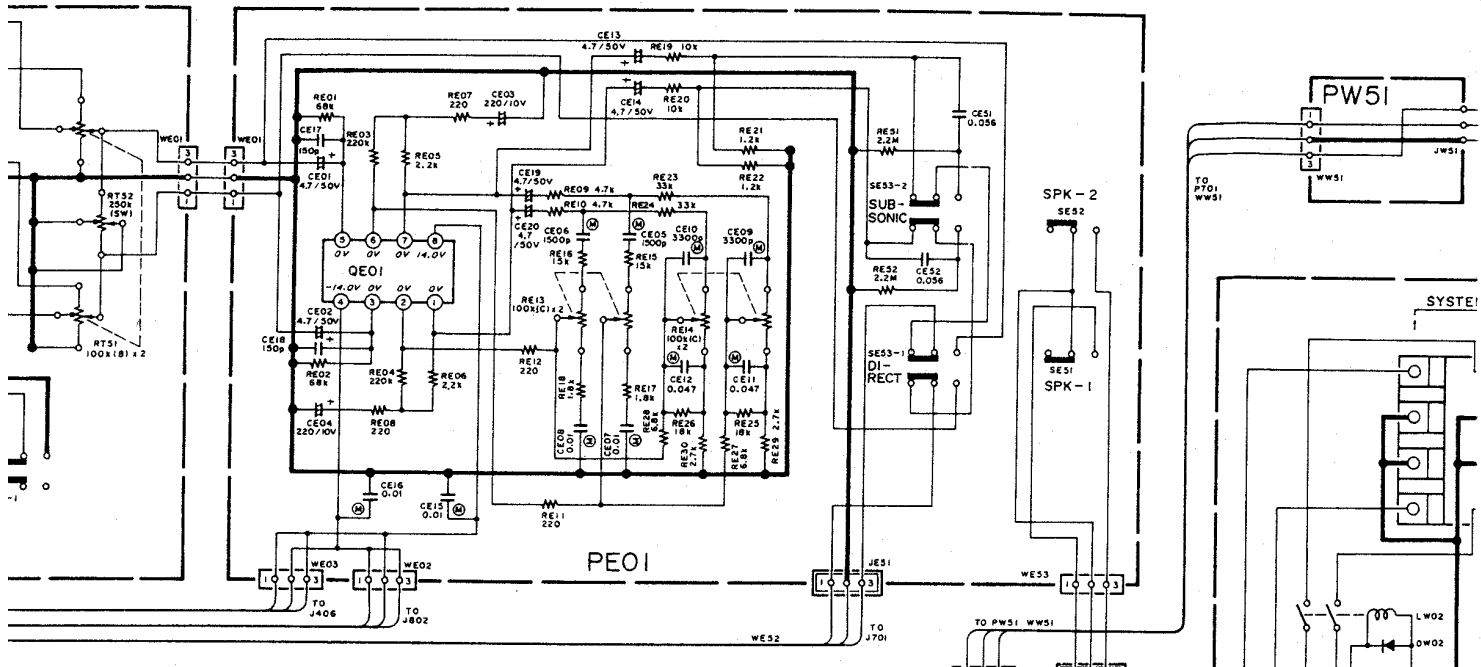
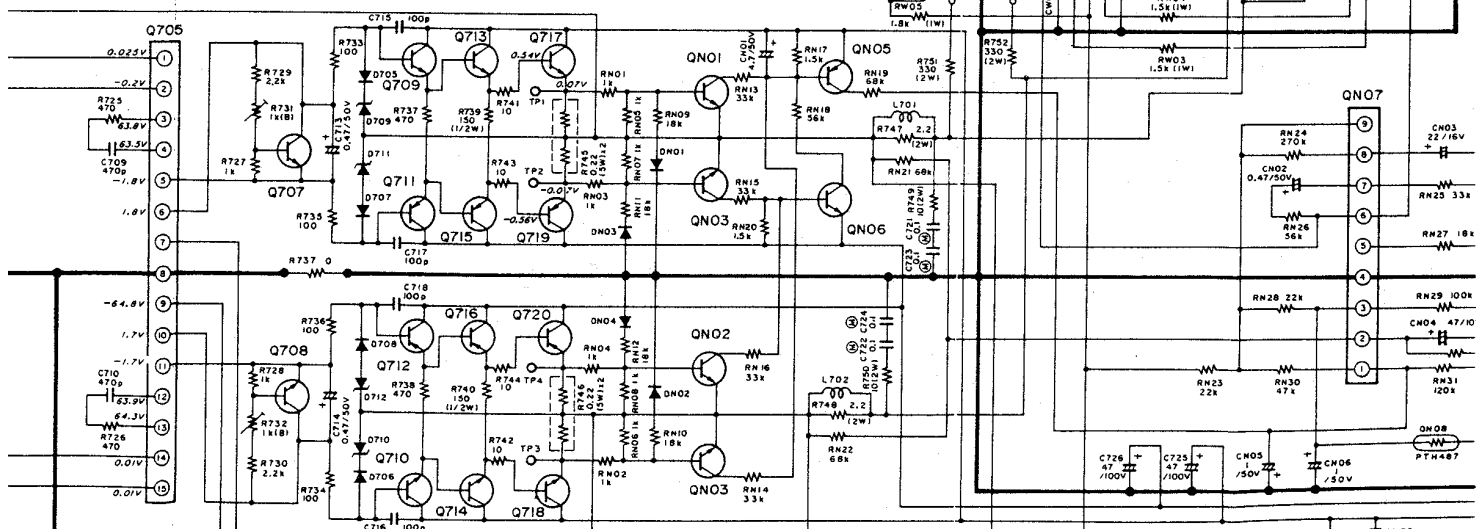
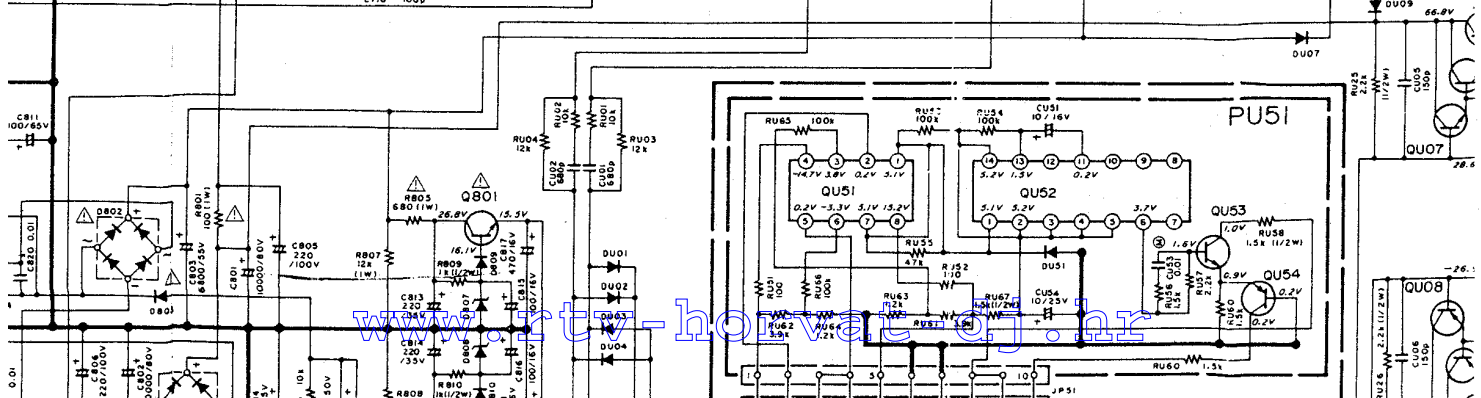
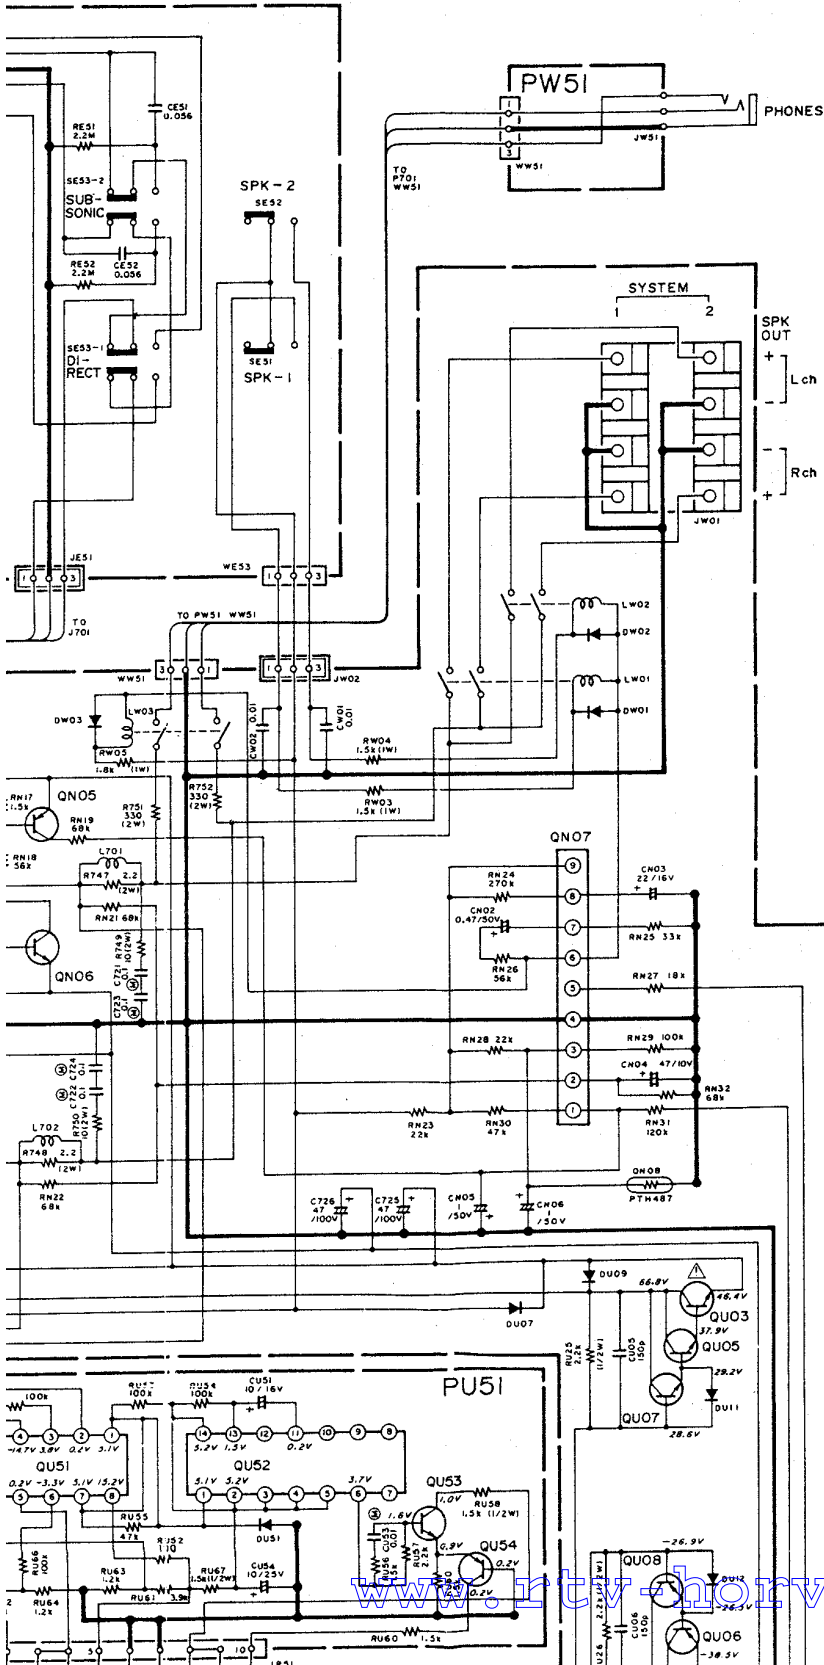
MODEL PM-64

Q801	Q802	QE01	QN03~QN05	QN07	QU03	QU04	QU05	QU06	QU51	QU52	QU51
HT412662B0	HT209412B0	HC10026090	QU08,QU54	HC10042050	HT412382B0	HT209222B0	HT323441D0	HT110111D0	HC10022090	HC712200A0	HD20002:
2SD1266	2SB941	NJM20410	HT109922B0	TA7317P	2SD1238	2SB922	25C2344(D)	2SA1011(D)	NJM29030	HA74LS122P	IS2472
(Q,P)	(Q,P)		(F,E)		(R,S)	(R,S)

209222B0
B922
(R,S) | QU05
HT32344(D0
25C2344(D) | QU06
HT11011(D0
2SA1011(D) | QU51
HC10022090
NJM2903D | QU52
HC712200A0
HA74LS122P | DU51
HD20002210
IS2472 | D705~D708
D803,DN01~DN04
DU01~DU04,DU11
DU12,DW01~DW03
HD20003210
IS2471 | D709~D712
HD30064060
RD6.2E |

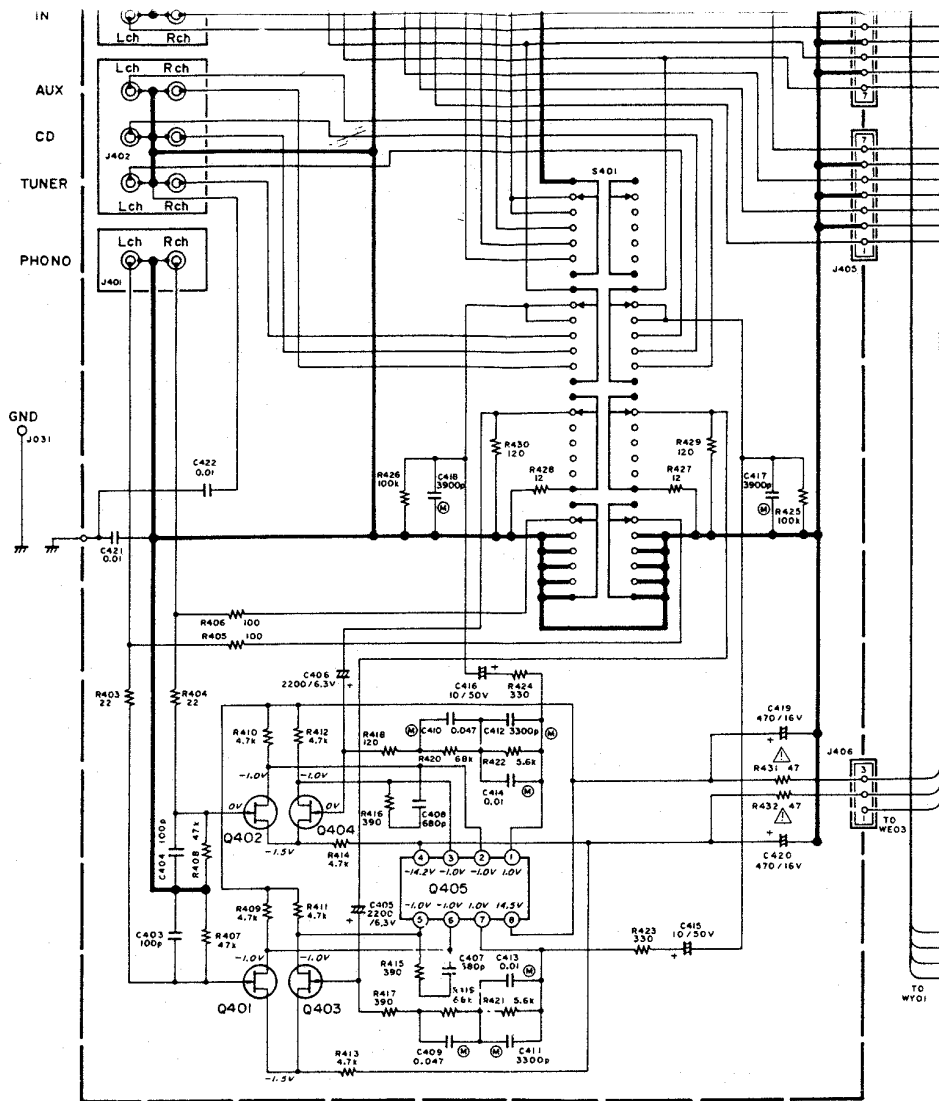
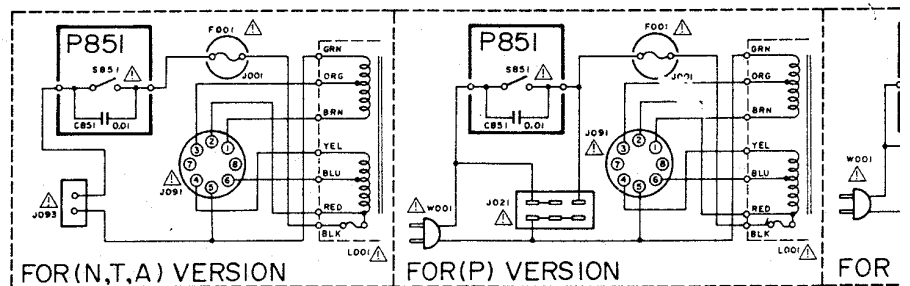
2SC1845 (F, E)
Q707, Q708
Q001, Q002, Q006, Q007, Q053

2SA992 (F, E)
Q003 ~ Q005, Q008, Q054

2SC2682 (P)
Q709, Q710

2SA1142 (P)
Q711, Q712

2SK369 (BL)
Q401 ~ Q404

2SC3298
(O, Y)
Q713, Q714

2SA1142 (P)
Q715

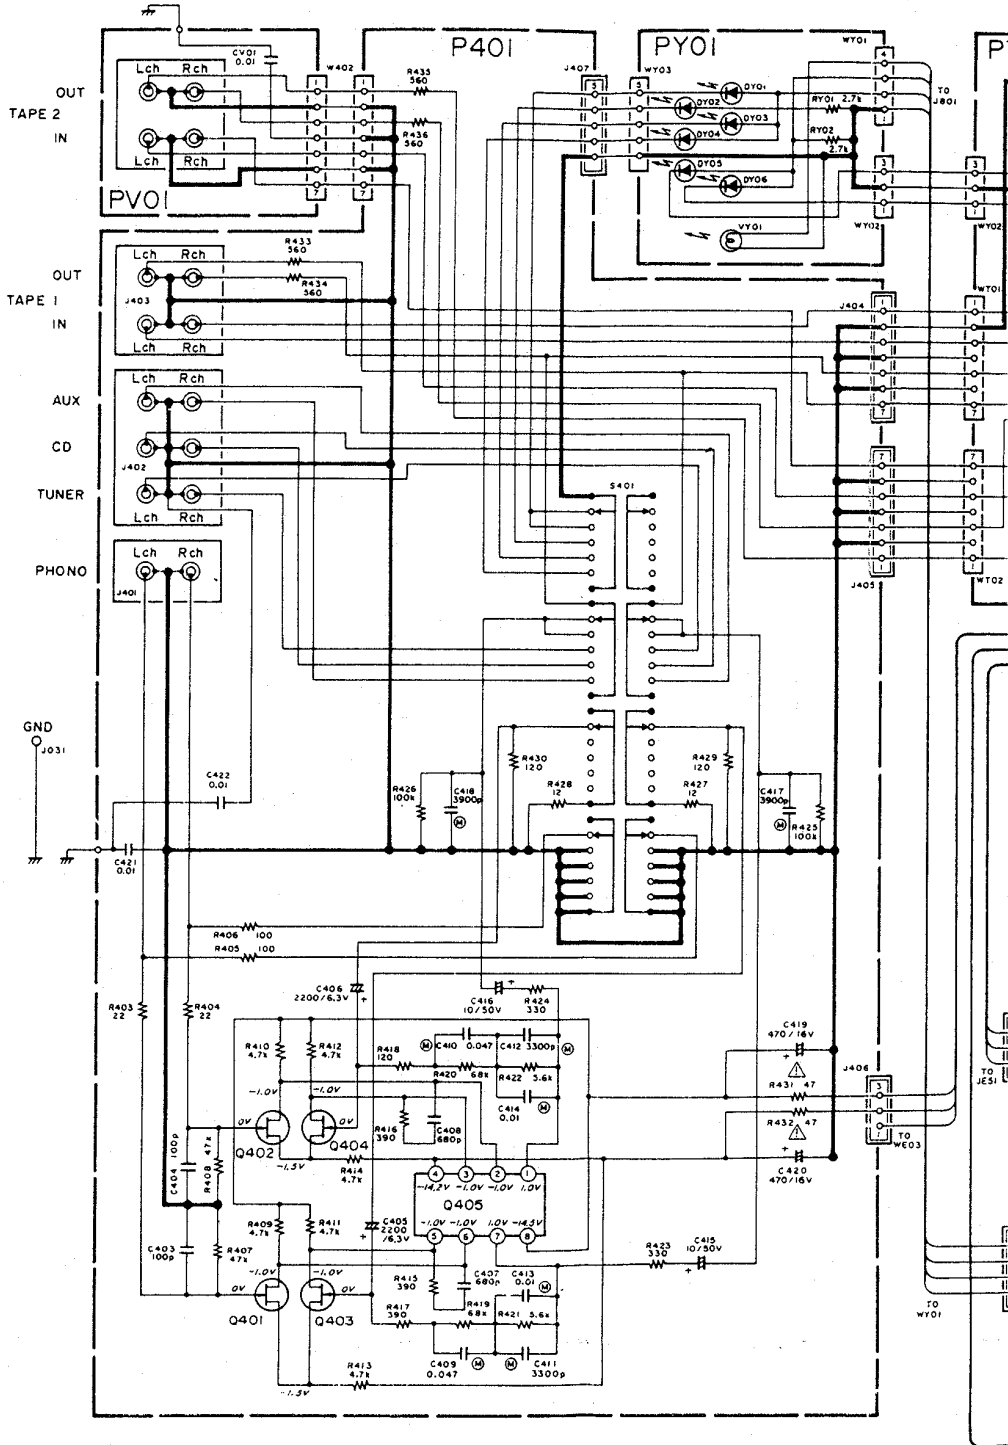
Q707, Q708
 QN01, QN02, QN06, QU07, QU53
 HT318452B0
 2SC1845(F,E)

Q705
 HC10145030
 STK3102 II

Q713, Q714
 HT332982D0
 2SC3298
 (O, Y)

Q715, Q716
 HT113062D0
 2SA1306
 (O, Y)

Q717, Q718
 HT327732B0
 2SC2773
 (O, Y)

Q719, Q720
 HT11692B0
 2SA1169
 (O, Y)

Q801
 HT412662B0
 2SD1266
 (Q, P)

Q802
 HT209412B0
 2SB941
 (Q, P)

QE01
 HC10026090
 NJM2041D

QN03 ~ QN05
 QU08, QU54
 HT109922B0
 2SA992
 (F, E)

QN07
 HC10042050
 TA7317P

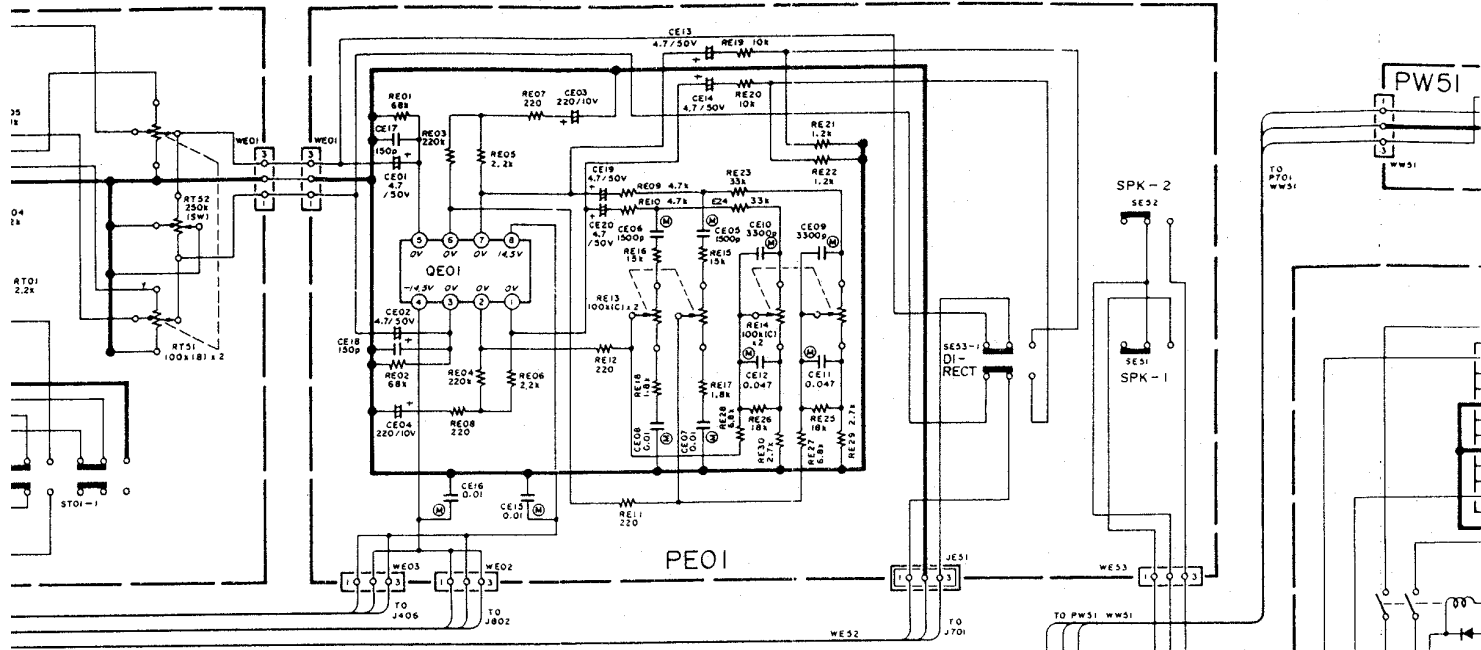
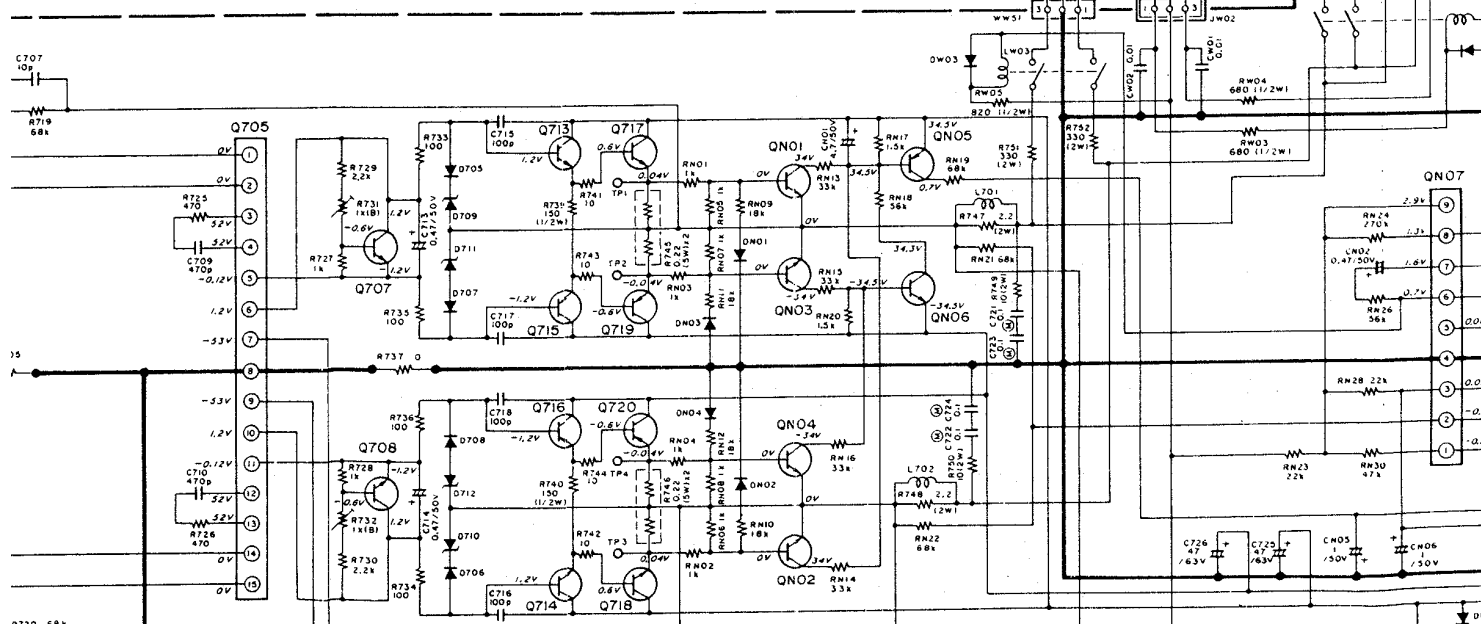
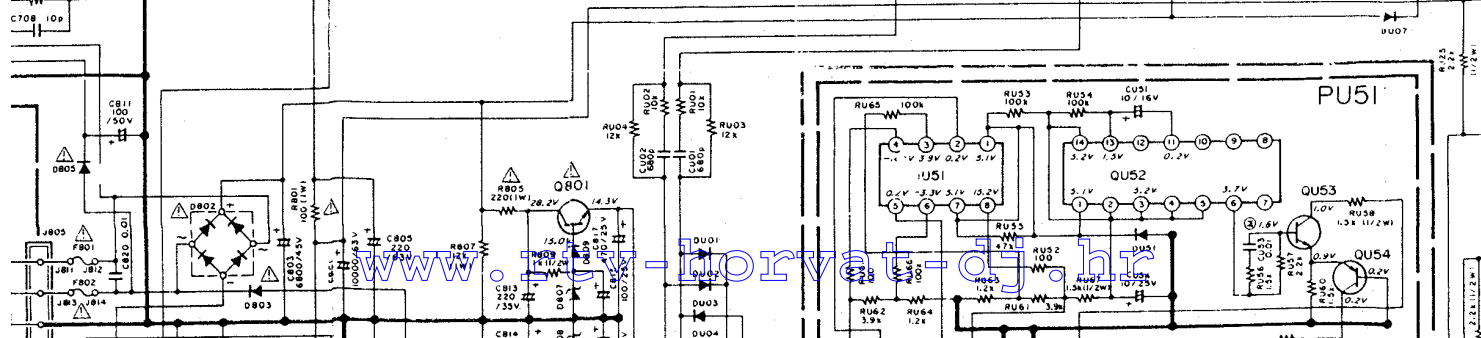
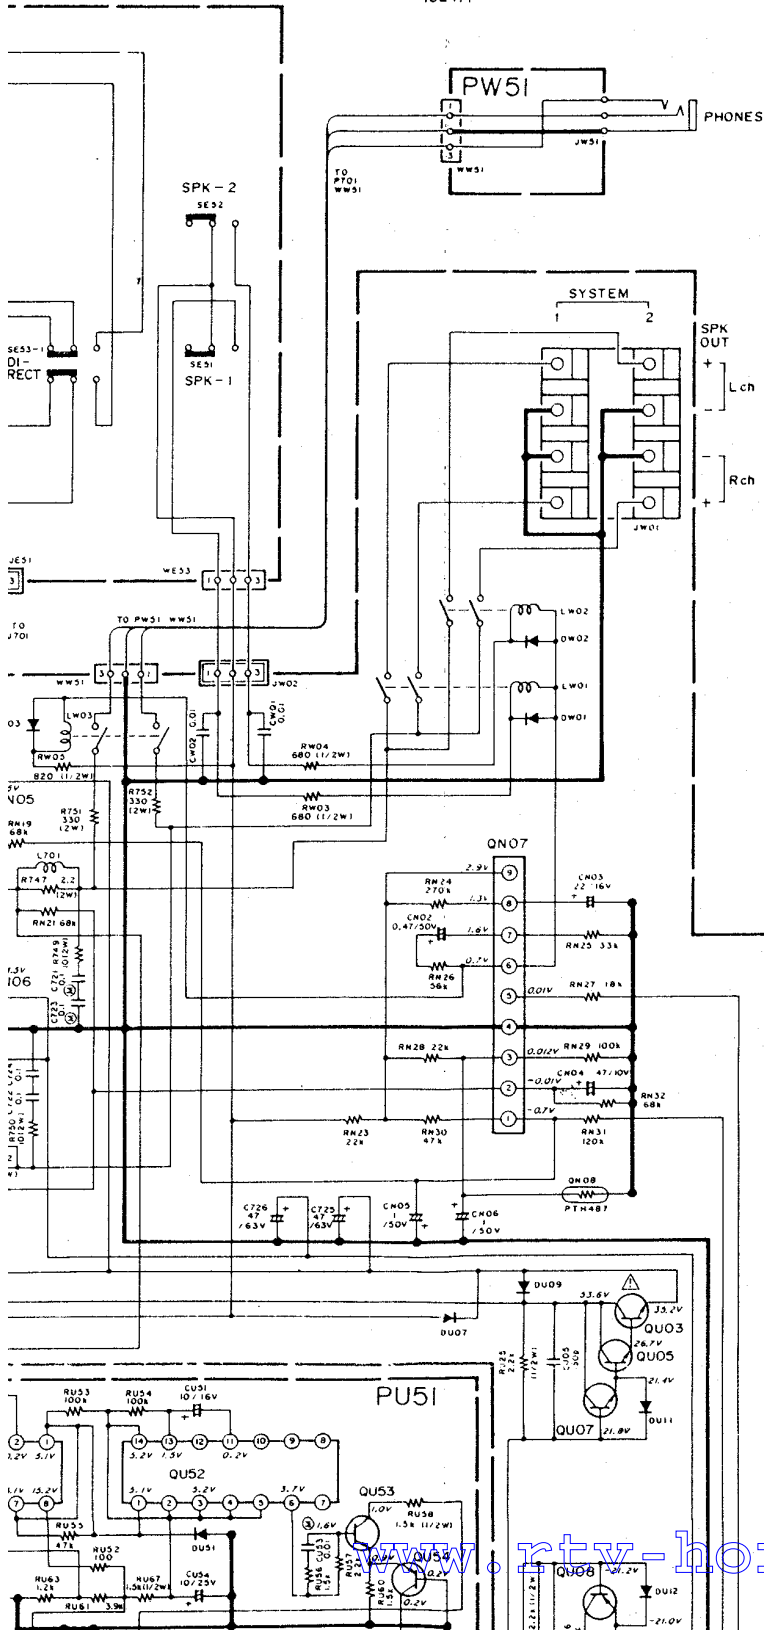
MODEL PM-54

1B02 IT209412B0 SB941 (Q,P)	QE01 HC10026090 NJM2041D	QN03 ~ QN05 QU08, QU54 HT109922B0 ZSA992 (F,E)	QN07 HC10042050 TA7317P	QU03 HT412382B0 ZSD1233 (R,S)	QU04 HT209922B0 ZS6992 (R,S)	QU05 HT323441D0 ZSC2344(D)	QU06 HT110111D0 ZSA1011(D)	QU51 HC10022090 NJM2903D	QU52 HC71220040 HA74LS122P	DU51 HD20002210 IS2472	0705 ~ 0708 D803, DNO1 ~ DNO DU01 ~ DU04, DU11 DU12, DWO1 ~ DWO HD20003210 IS2471
--------------------------------------	--------------------------------	--	-------------------------------	--	---------------------------------------	----------------------------------	----------------------------------	--------------------------------	----------------------------------	------------------------------	--

QU51 HC10022090 NJM2903D	QU52 HC712200A0 HA74LS122P	DU51 HD20002210 IS2472	D705 ~ D708 D803, DN01 ~ DN04 DU01 ~ DU04, DU11 DU12, DW01 ~ DW03 HD20003210 IS2471	D709 ~ D712 D805, DN01 ~ DN04 HD30064060 RD6-2E	D805 DU09, DU10 HD20022030 DSF10C	D801 HE2009290 S5VB20
--------------------------------	----------------------------------	------------------------------	--	--	--	-----------------------------
