8.2 Main Amp/Power Supply (P701) Schematic Diagram and Component Locations

PM-64

PM-54

12. SCHEMATIC DIAGRAM

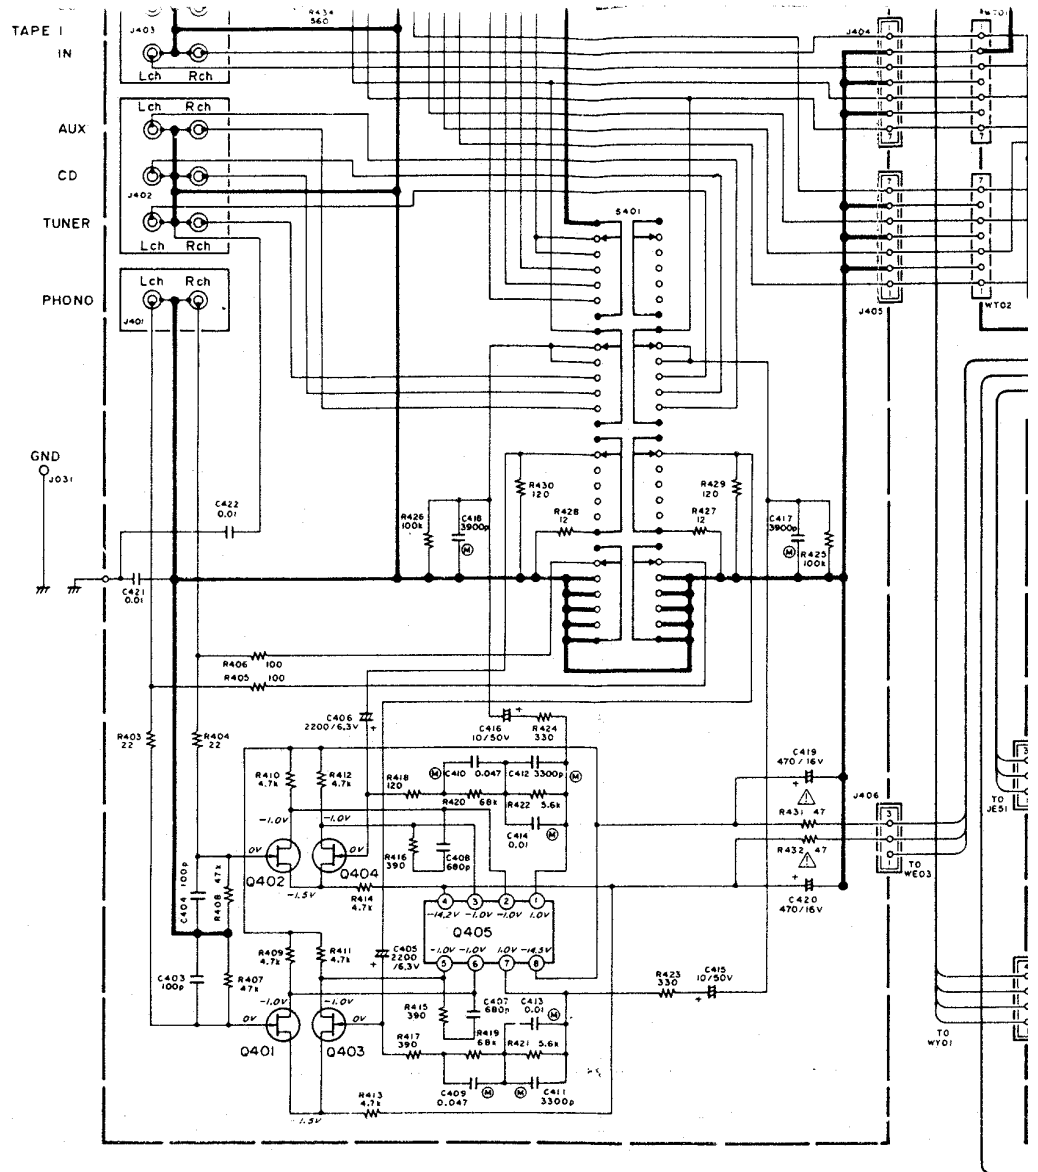
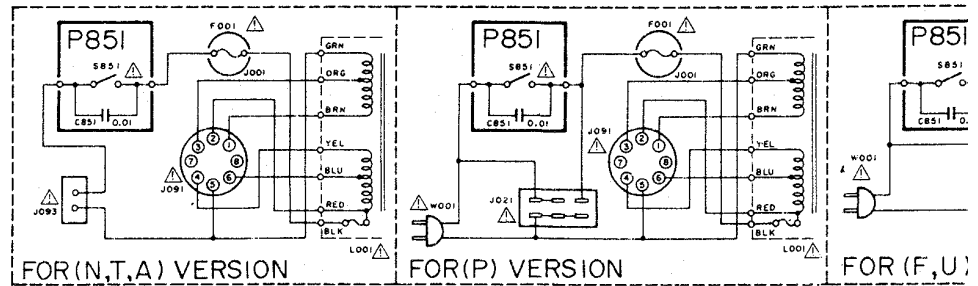
2SC1845 (F, E)
Q707, Q708
QN01, QN02, QN06, QU07, QU53
-

2SK369 (BL)
Q401~Q404
-

2SA992 (F, E)
QN03~QN05
QU08, QU54
-

2SC3298 (O, Y)
Q713, Q714
-

2SA1306 (O, Y)
Q715, Q716

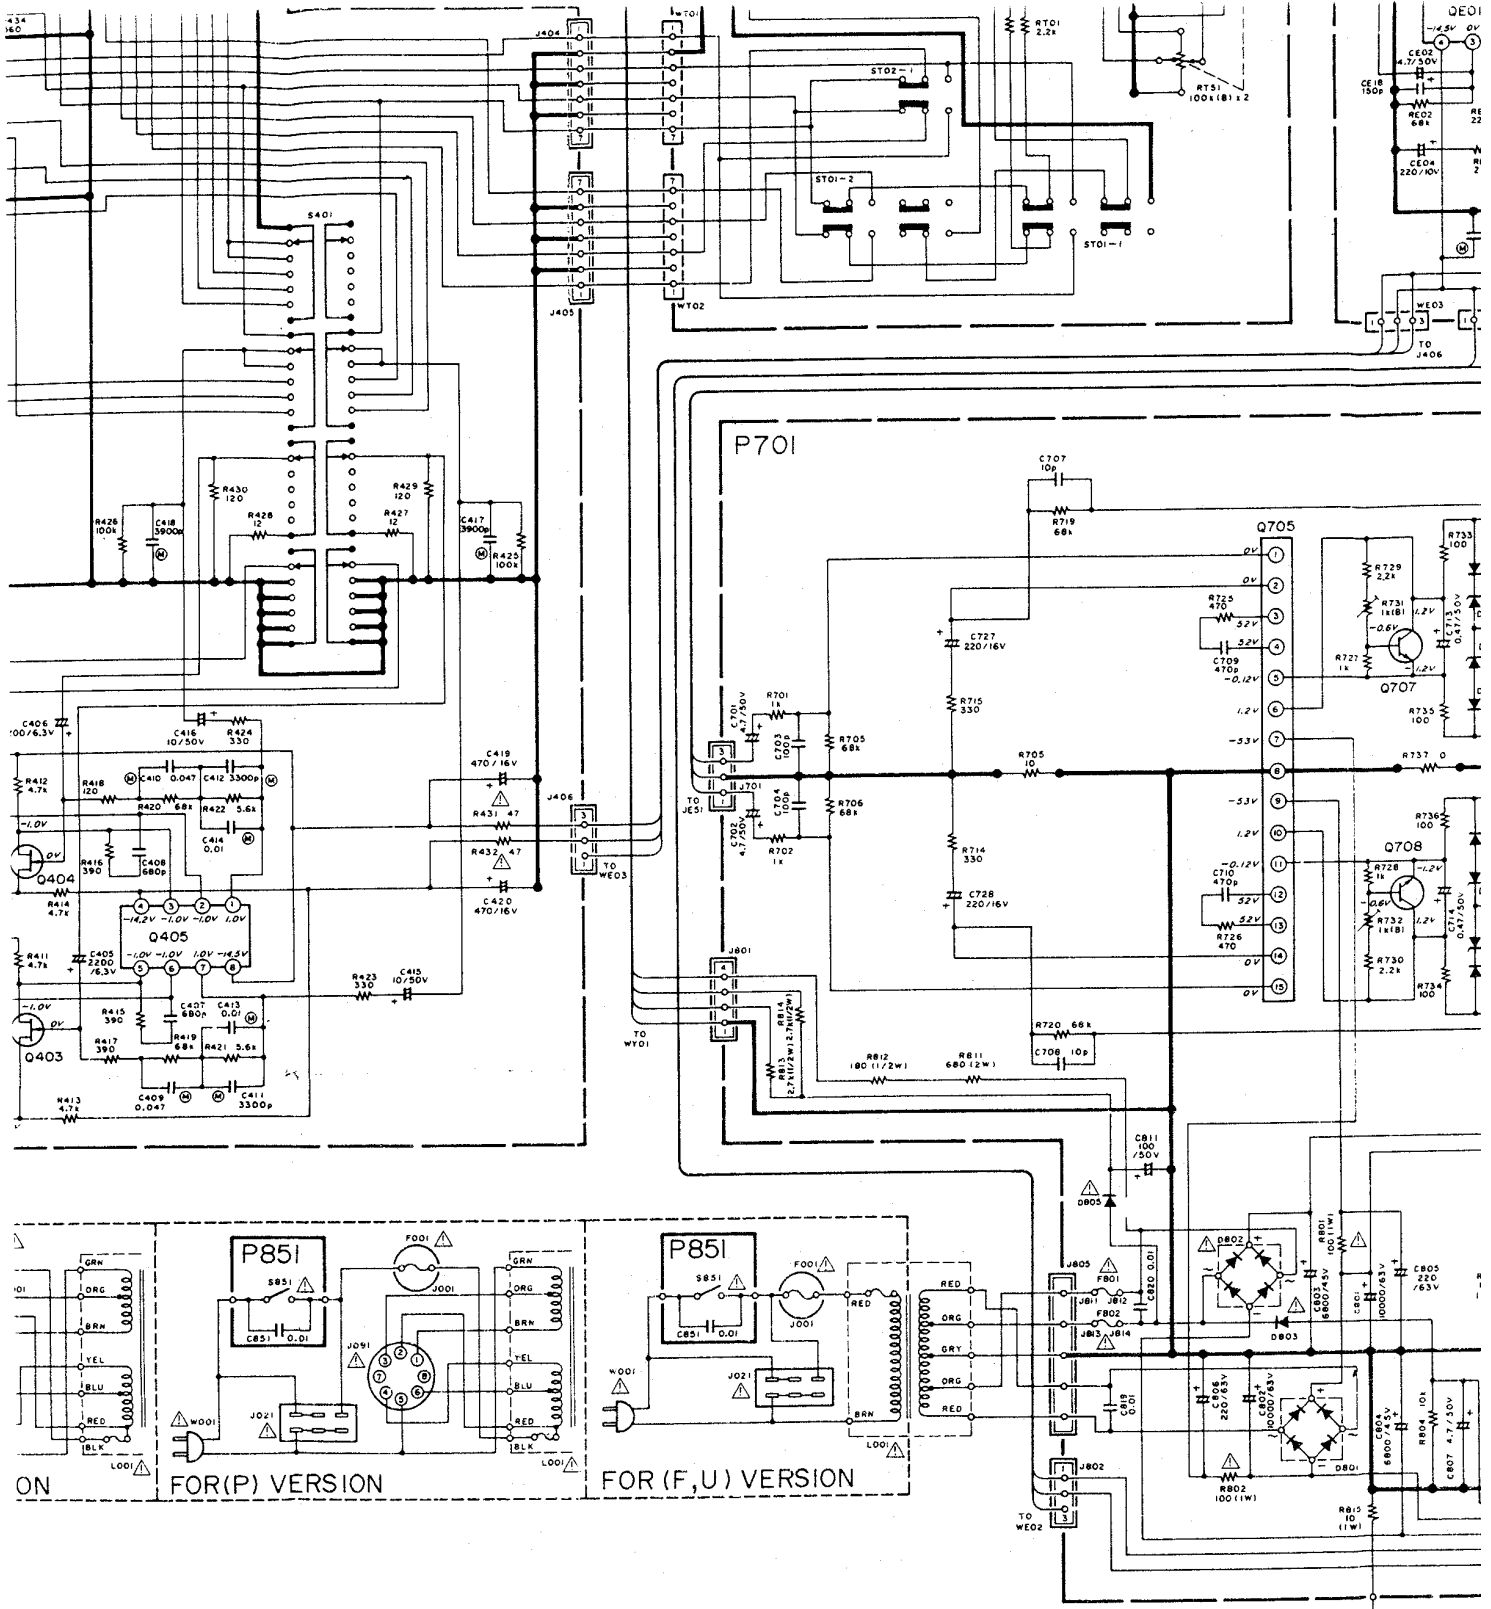
1845 (F,E)
7, Q708
11, QN02, QN06, QU07, QU53

2SK369 (BL)
Q401~Q404

2SC3298 (O,Y)
Q713, Q714

2SA1306 (O,Y)
Q715, Q716

2SD1238 (R,S)
QU03

2SB922 (R,S)
QU04

2SC2344 (D)
QU05

2SA1011 (D)
QU06

992 (F,E)
13~QN05
18, QU54
