Service Bulletin

No.: MZ09-022 **Date:** April 1, 2009

Model: SR4002, SR5002, SR4003, SR5003, SR6003

Subject: Improvement of GND screws contact.

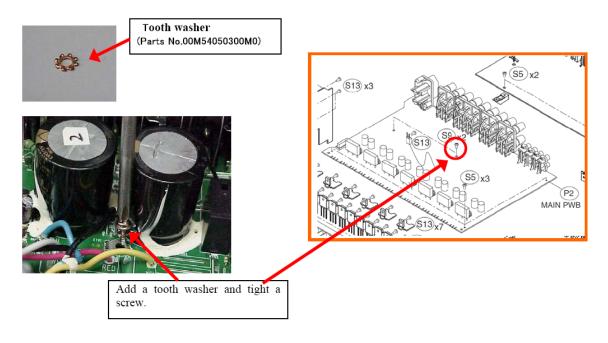
Symptom: The unit may intermittently go into protection (Fast blinking Stand by LED). No problems are found in the output circuitry and heat is not an issue. The ground point screw on a Main board can loosen during transportation, handling etc., and the contact to ground may become intermittent causing a protect situation.

Solution: Add a toothed washer between the ground point screw and PCB land located on a Main board (see diagram below) and then tighten the screw.
