marantz® SERVICE BULLETIN		Date: 28-Aug-2004	Model: SR5400, SR6400
		Page: 1 / 2	REF.NBR: MZ04-061
Level		Application:	
★ ★		MZ00xxxxxxxxxx	
		Int.ref:	
		Subject: 1. Noise from Surround L/R Speaker. 2. The Sound is MUTE by operation of HDD Recorder. 3. The output level changes.

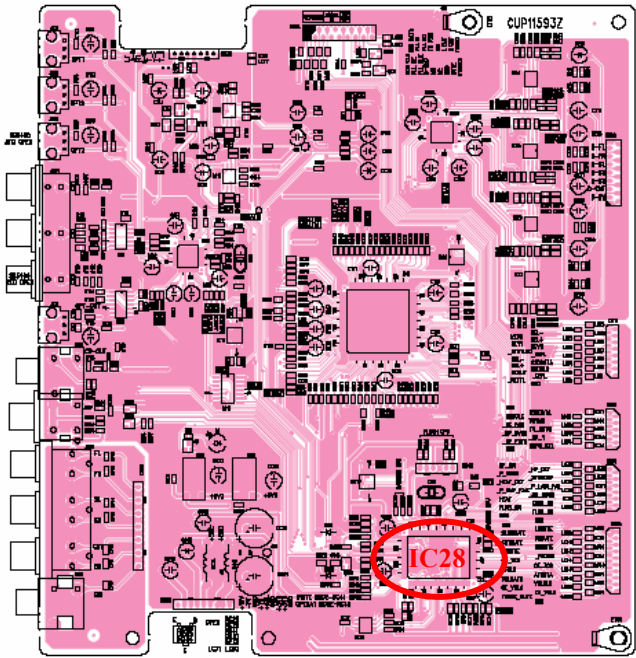
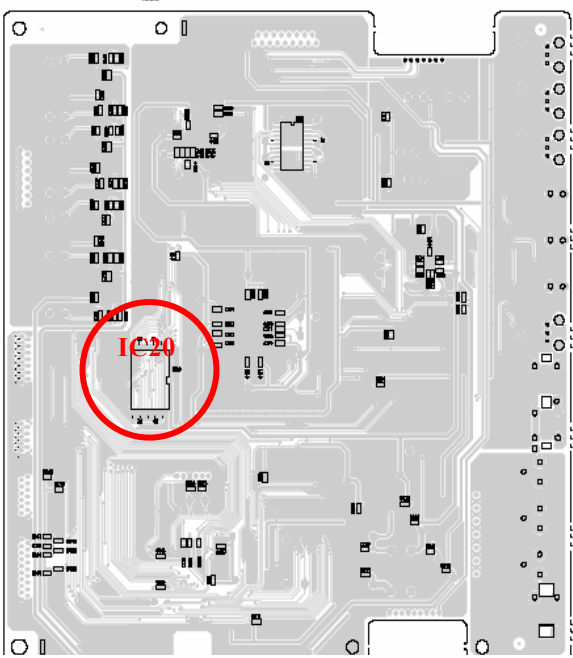
V 0 4 0 4 1 2 1

CD01 02060104	CD02 02010116	CD03 02060206	CD04 02040113
CD05 02030306	CD06 02030114	CD07 02030211	CD08 02020206
CD09 02050211	CD0A 0205030A	CD0B 0205040D	CD0C 02050510
CD0D 02050110	CD0E 02050603	CD0F 00000000	CD10 00000000
CD11 00000000	CD12 00000000	CD13 00000000	CD14 00000000

1. Replace the microprocessor **IC28** on the **DSP PCB**. Version to [**V040412 1**]
2. Replace the DSP **IC20** on the **DSP PCB**. DSP Code ID to [**CD02 02010116**]
Please see to the service manual page 60 about details of "10. SERVICE MODE".

| 1. POS. No. IC28 | Part no. 90M-HS27AWH2R | (HVIHD64F2398F20 programmed flash ROM) |
| 2. POS. No. IC20 | Part no. 90M-HS27AWX2R | (HVIMX29LV400TTC programmed flash ROM) |
