marantz® SERVICE BULLETIN		Date: 28-Dec-2004	Model: SR7400/SR7500/SR8500
		Page: 1 / 1	REF.NBR: MZ04-085
Level		Application:	
★ ★		See below	
		Subject: FL Display does not light up.	
		Int.ref:

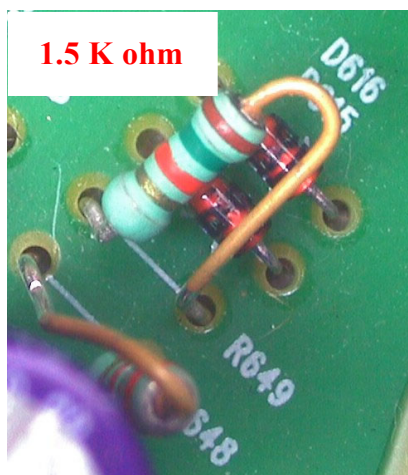
SR7400

1. In condition, AC input is about 10% overvoltage than Rated voltage and the sound is not outputted for a long time.
2. The DIODE (POS NO.D616) may short-circuit. R648 and R649 are broken by this short-circuit.

D616 Zener Diode part no. 90M-HD302190R

1. POS.NO **R649** RESISTOR (**1.5K OHM**) is changed to RESISTOR(**2.2K OHM**) on the POWER PCB

POS.NO. R649 nsp (RESISTOR 2.2K OHM 1WJ) Factory code number KRG1SANJ222RT

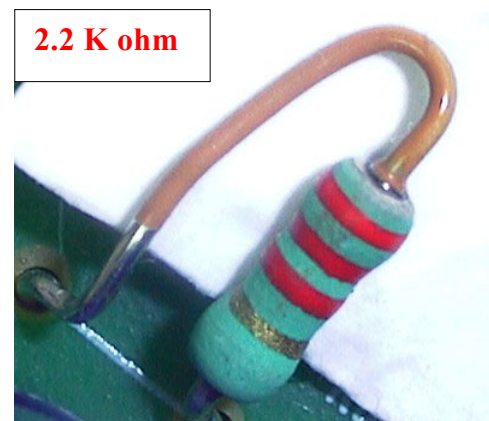
SR7500 / SR8500

D616 Zener Diode part no. 90M-HD302190R
