## PM8200,PS17, Date: 16-July-2002 Model: SR8200,SR9200 marantz<sup>®</sup> Page: 1/1 REF.NBR: MZ02-013 **SERVICE** BULLETIN Subject: Circulation: Application: In correct a RELAY part was used. x for information customer complaint in case of service mandatory See Below ...... Int.ref:

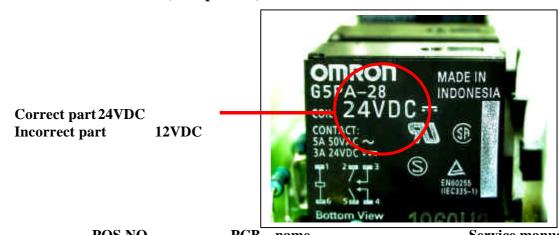
Incorrect parts mixed and were used.

Correct part no 9965 000 05895 (PCS part no) LY20240490 (MJI part no)

Please exchange for the correct the part.

POS.NO.	PCD name	Service manual
PM8200	L701	P101-MAIN CIRCUIT BOAD	page 9 and page 10
PS17	LB03/ LB04	PB04-BACK UP SUPPLY CIRCUIT BOARD	page32
SR8200	LP91	P124-SPK OUTS FRONT SURRBACK	page71
		HEAD CIRCUIT BOARD	
SR9200	LP91	P124-SPK OUTS FRONT SURRBACK	page71
		HEAD CIRCUIT BOARD
