## Technical Tip

**Model:** C-707CHX, DXC-380/390, CDC-3.4

**Subject:** Defective lot of CD laser pickups

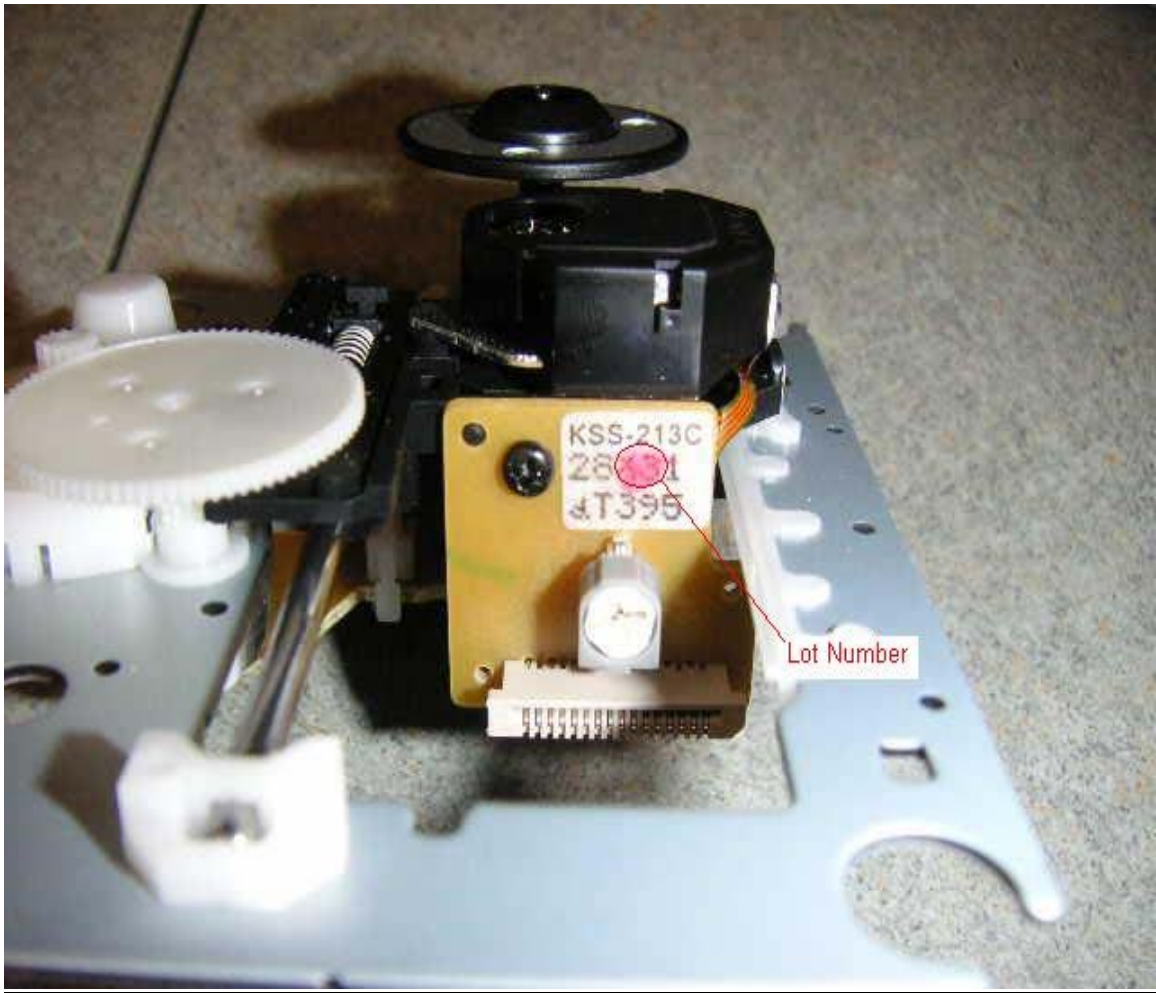
**Symptom:** The CD laser pickups marked with the lot number "X3" (see attached picture for details) have been reported by the manufacturer to be defective.

Lot number location on laser pickup.

**Solution:** Replace the CD mechanism with a new part. The CD mechanism should be replaced regardless of the customer complaint. Acceptable lot numbers are as follows: "93", "Y3", "Z3". Verify the lot number of the new pickup before installing the replacement CD Mechanism.
