**SERVICE BULLETIN**  
**NO:06011-R3**

MODELS : TX-SR674 / TX-SR804 / DTR7.7

SUBJECT : Picture Interruption in output of 1080P signal via HDMI on Playstation 3

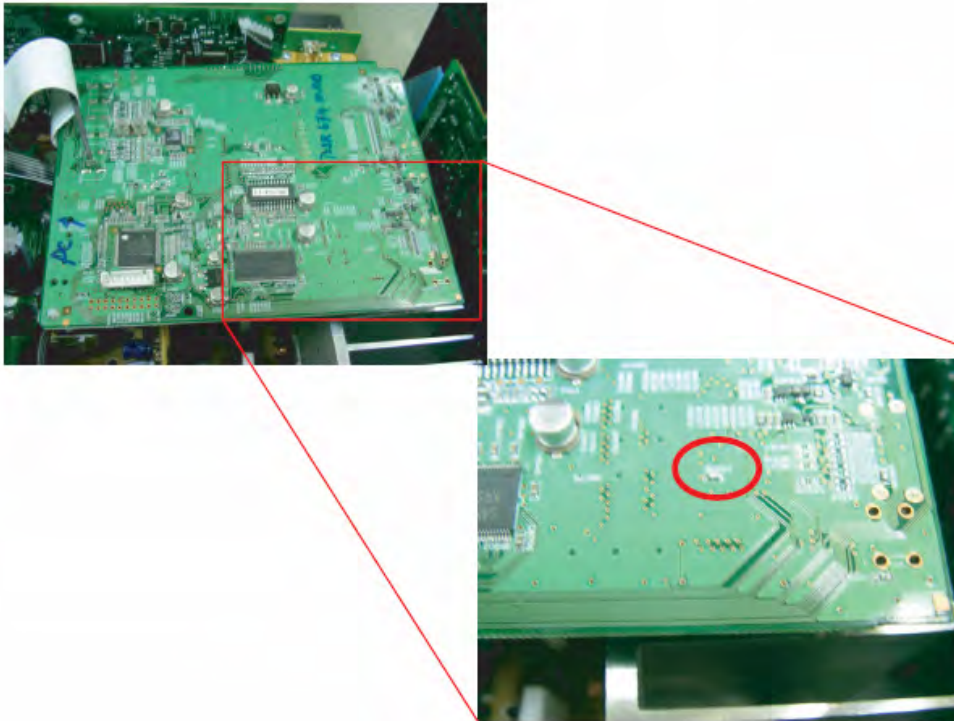
Video output is often interrupted when 1080P signal outputs via HDMI because of authentication error.

Monitor detects problem by mistake because of unstable pixel clock for HDMI output IC.

C8428 Remove this capacitor.

- 1) Remove Capacitor C8428 on HDMI Board NAVD-8824.
- 2) Change Resistor at R8524 from 33 ohm to 0ohm on HDMI Board NAVD-8824.

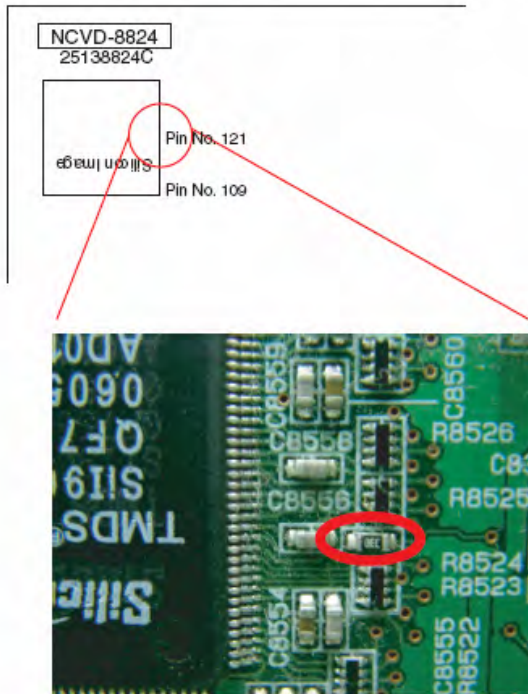
R8524 Change Resistance Value from 33ohm to 10ohm.

The resistance value of R8524 was changed to 22ohm first and then to 10ohm again. and finally to 0ohm . 0ohm is the best and 10ohm is better, but 10ohm and 22ohm are also effective. Therefore, when 22 or 10 ohm Resistor is mounted at R8524, it is not necessary to replace it by 0ohm Resistor as long as the unit has no problem.
