SERVICE BULLETIN NO: 070710-R1

**Models:** TX-SR605/DTR5.8

Subject: Static (pop) noise in DSP mode

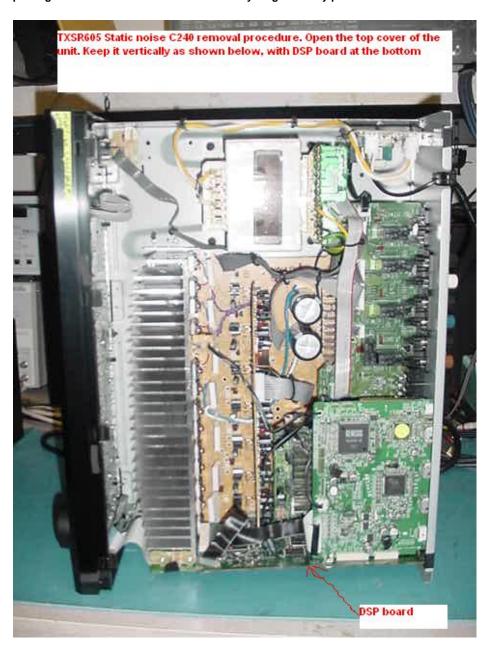
**Symptom**: During playback in any listening modes except Analog Direct, Multi-ch, and 2ch Pure Audio, Static (Pop) noise randomly comes out from all channel speakers, when the internal temperature is high. This noise stops when the unit is cooled (internal temperature is low)

**Cause**: When the internal temperature becomes high: depending on the variation of IC quality, SDRAM clock cannot catch up with the data reading speed.

When the above problem is reported, remove C240 from DSP Board NADG-9189. Place the unit as shown in Fig 1. below and then remove C240 as shown in Fig 2.
