# QUAD ESL-63

## service data

## description

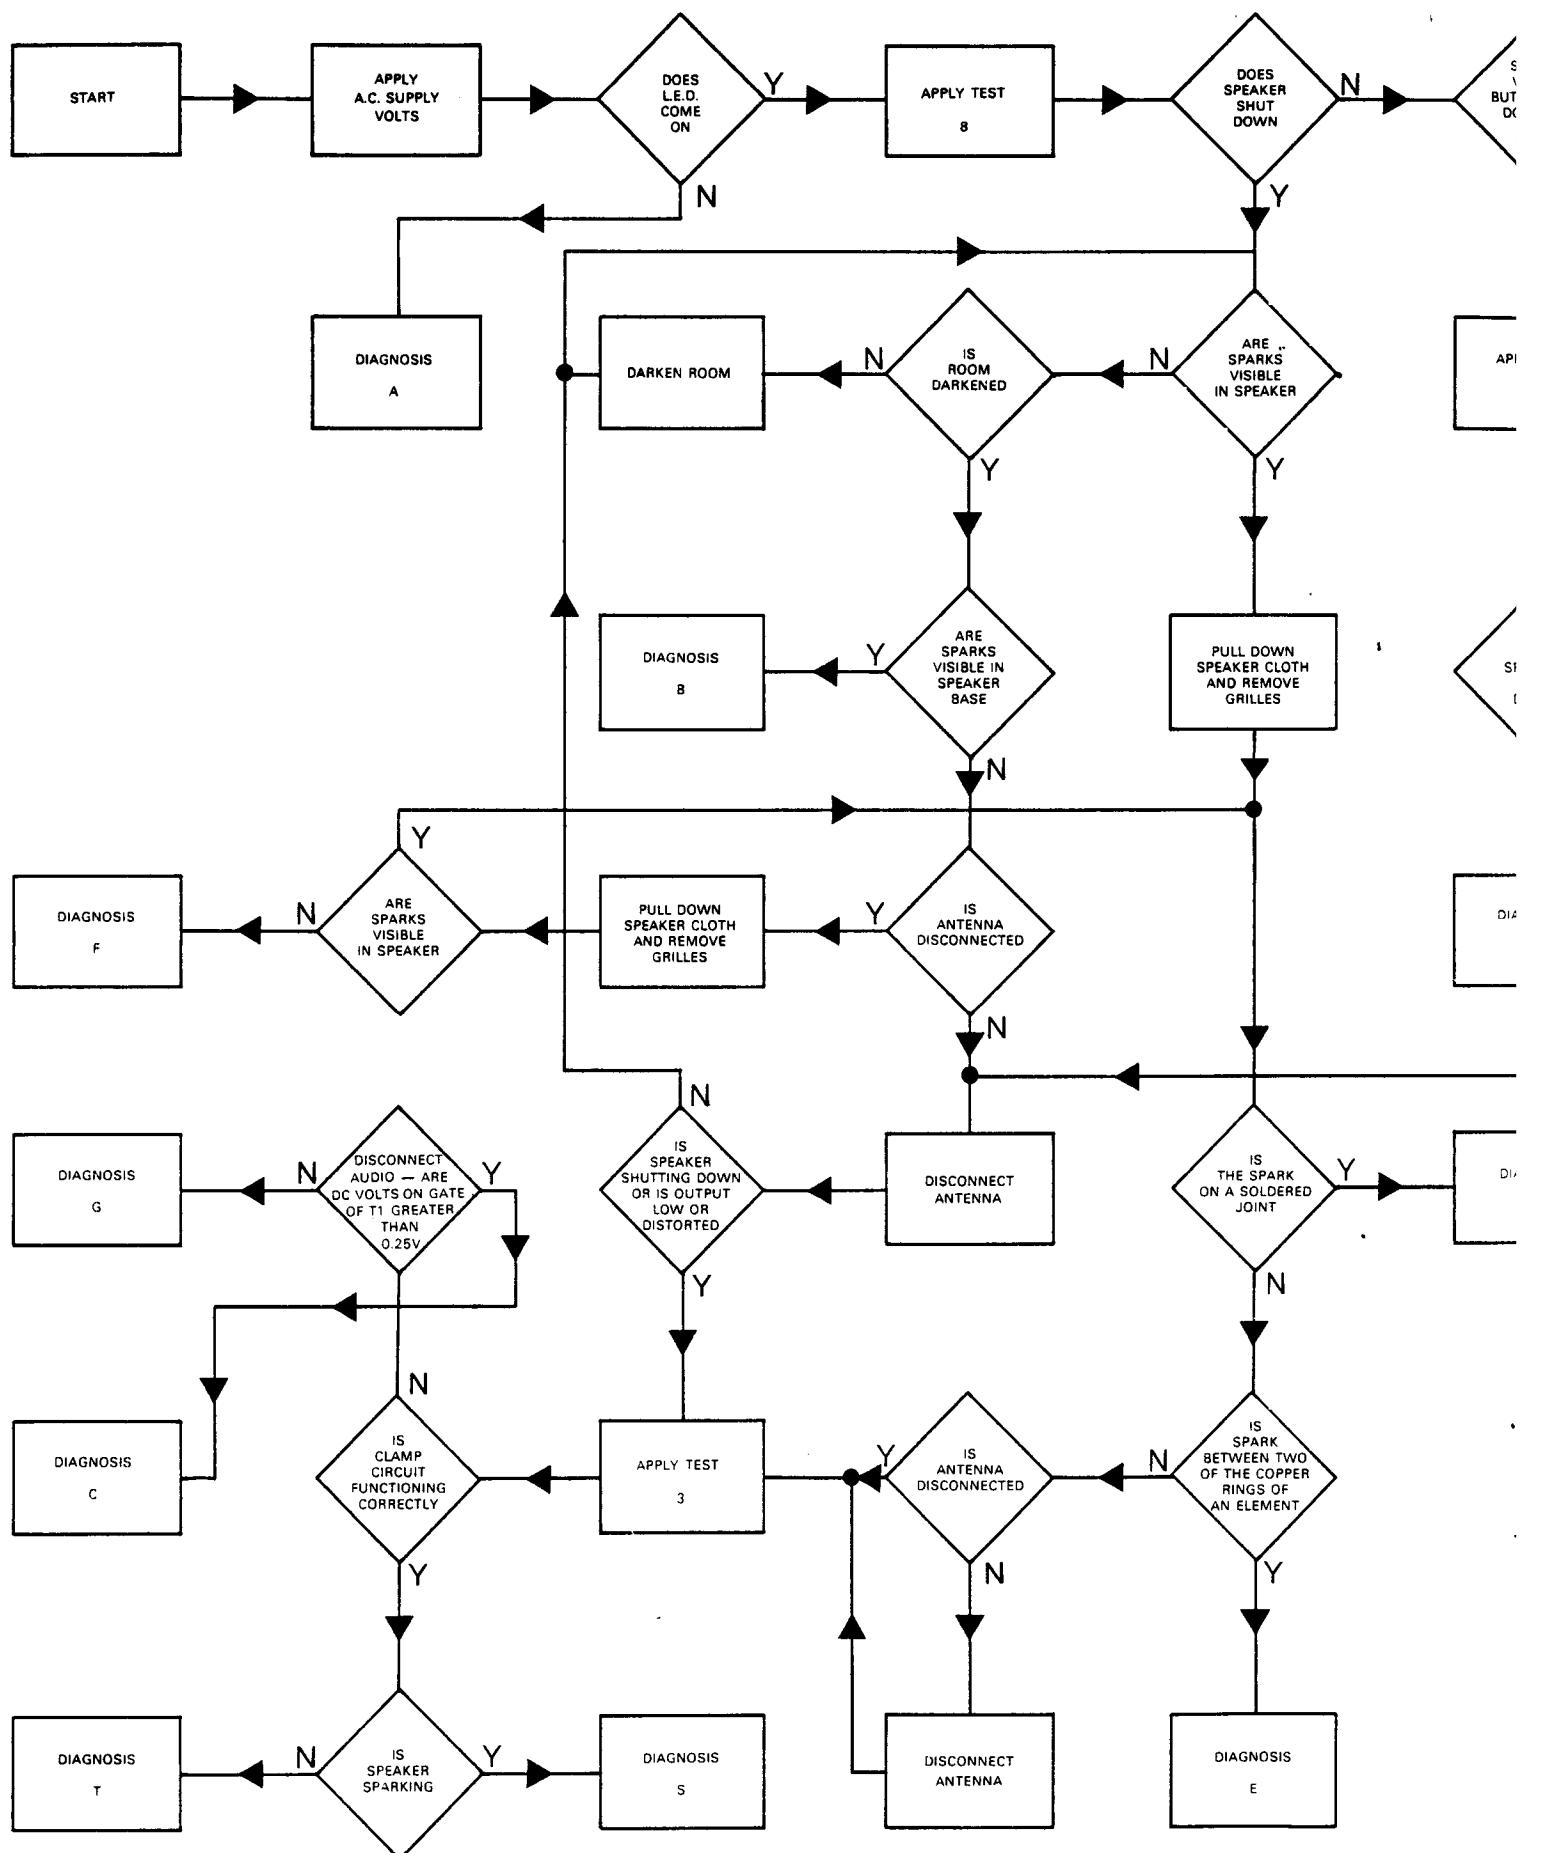
Fig. 1

Fault Finding on a 63 may most easily be carried out by following the flow diagram on (Fig. 1), however it is important that the following notes be read prior to proceeding with any work.

The flow diagram (Fig. 1) refers to several tests which must be carried out in order to isolate faults. The test equipment layout shown in Fig. 2 is used as a basis for all tests, unless otherwise stated.

Exit from the diagram will be at one of the diagnoses each of which is clearly defined below.

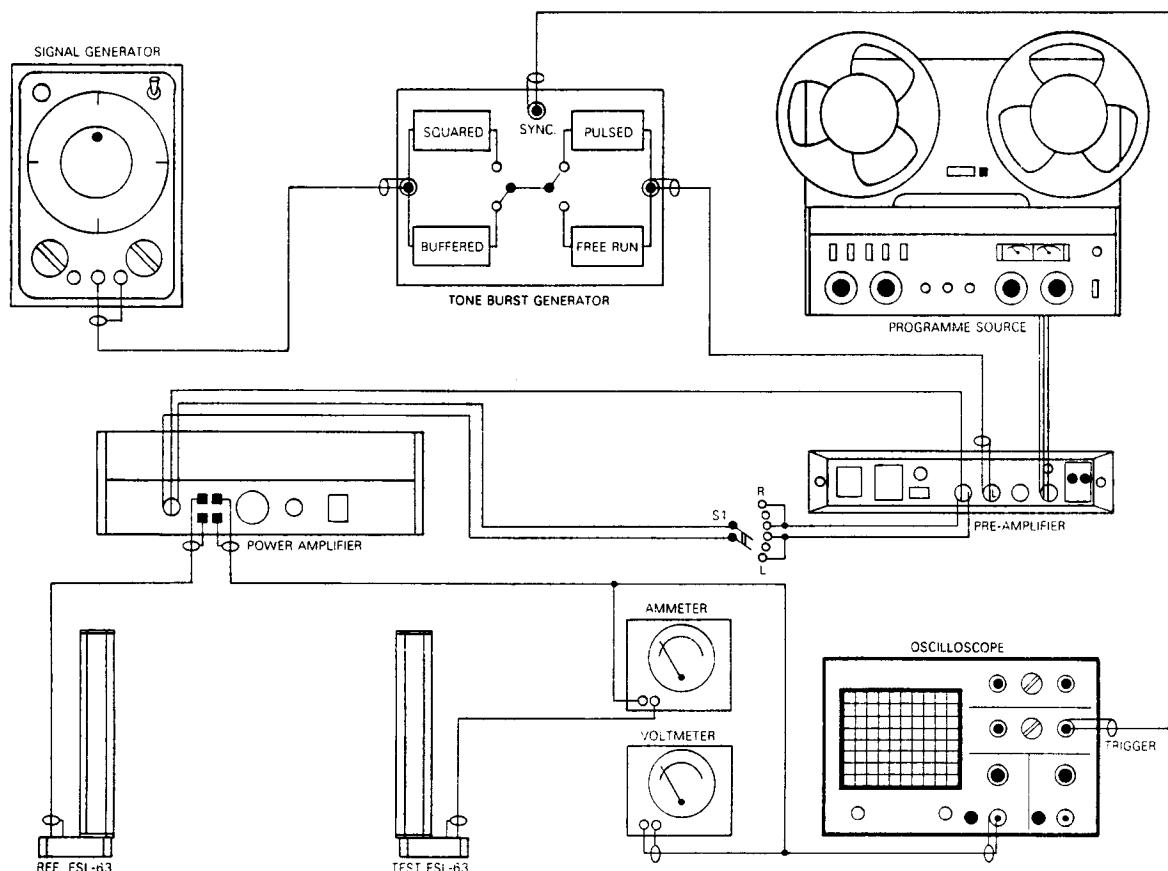
Fig. 2

Complete testing of an ESL-63 may most easily be carried out by using the test equipment listed below and inter-connecting these units as shown in Fig. 2.

*Suggested Test Instrument Layout for Complete Testing of ESL-63*

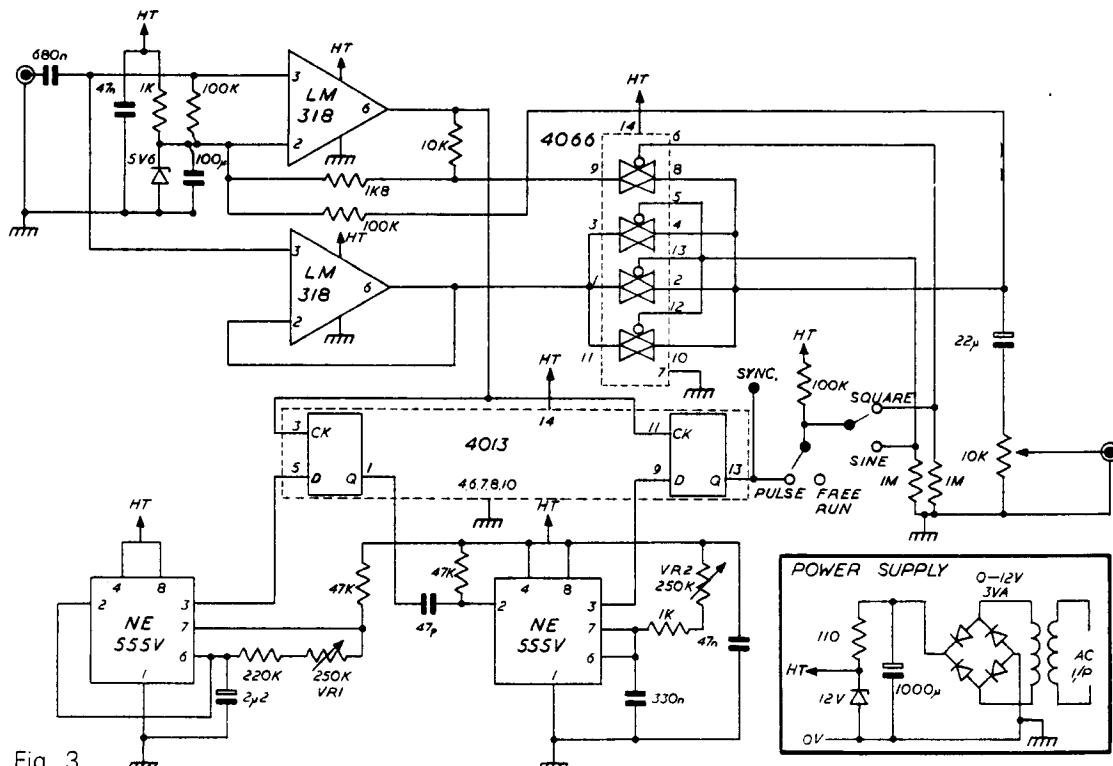
Fig. 3 shows a simple TBG circuit where VR1 controls the pulse repetition rate and VR2 controls the pulse duration. It is important to ensure that the duty cycle does not exceed approximately 10%.

When applying Steady State input signals to the loudspeaker these should not exceed 10V rms. The tone burst generator is used to switch the output from the signal generator such that short bursts of signal are applied to the loudspeaker, which may then be subjected to overload for lengthy periods of time without damaging the clamp circuit. These extreme conditions will enable checking of the clamping level and will encourage any sparking faults.

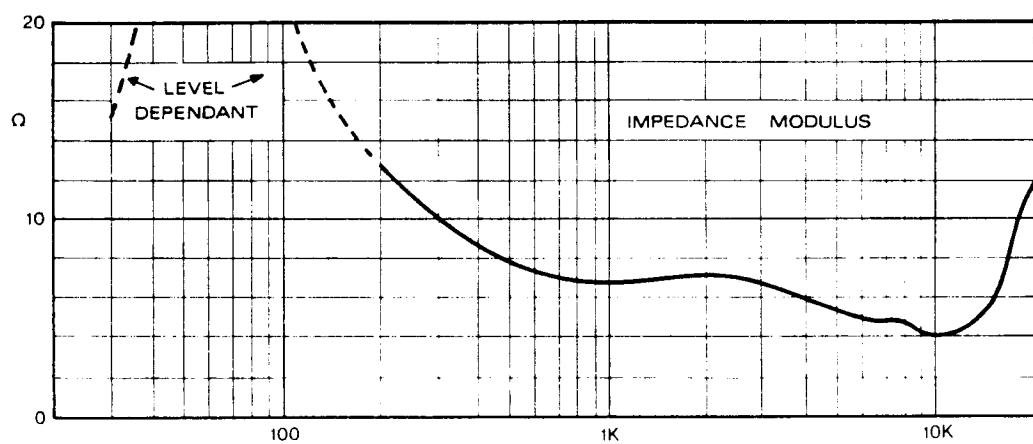
Increase the volume on the pre-amplifier to a comfortable listening level. By taking voltage and current readings at several frequencies the impedance may be calculated and compared to the impedance modulus in Fig. 4. Large deviations from this curve indicate a fault in the audio circuitry.

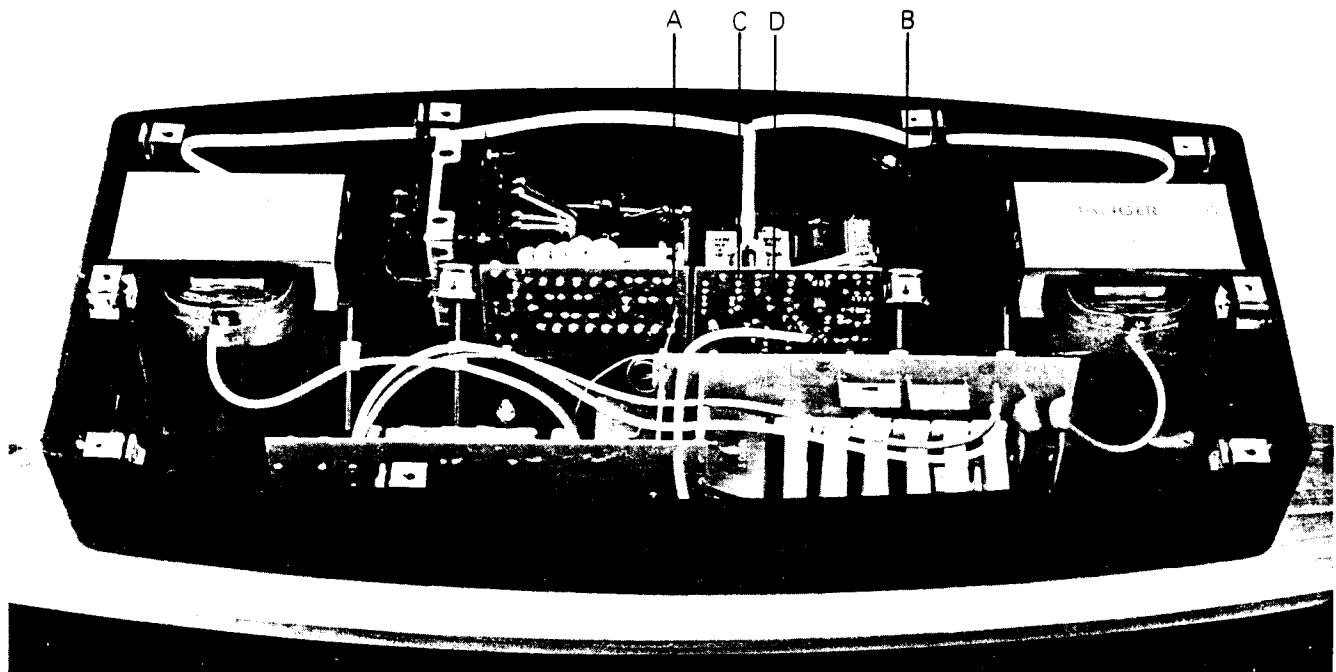
(b) AC supply volts should now be connected. Measure the volts across the points labelled A and B in Fig. 5 which should be between 5 and 5.3 kV.

Contact with the EHT path should be avoided both when the loudspeaker is connected to or recently disconnected from the AC supply volts. If the nature of the work being undertaken necessitates contact, the EHT should first be discharged by short circuiting point A (Fig. 5) to earth, with AC supply volts disconnected.

(b) To check that the clamp circuit is functioning correctly, points C and D Fig. 5 should be connected to the input of the oscilloscope.

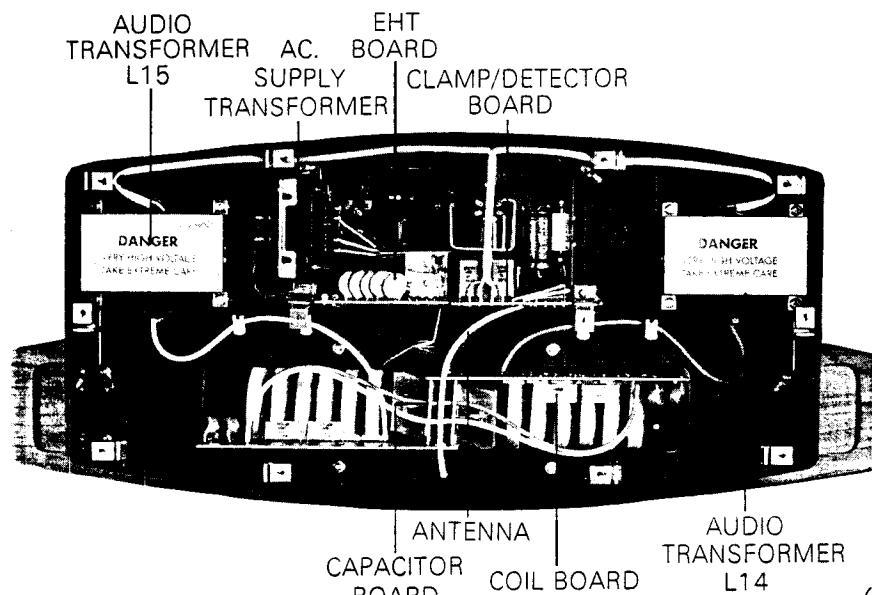
Fig. 6

(a) Removing the base plate (12 screws) gives access to the input protection circuits, EHT power supply, audio transformers and the nuts securing the loudspeaker and delay lines to the base.

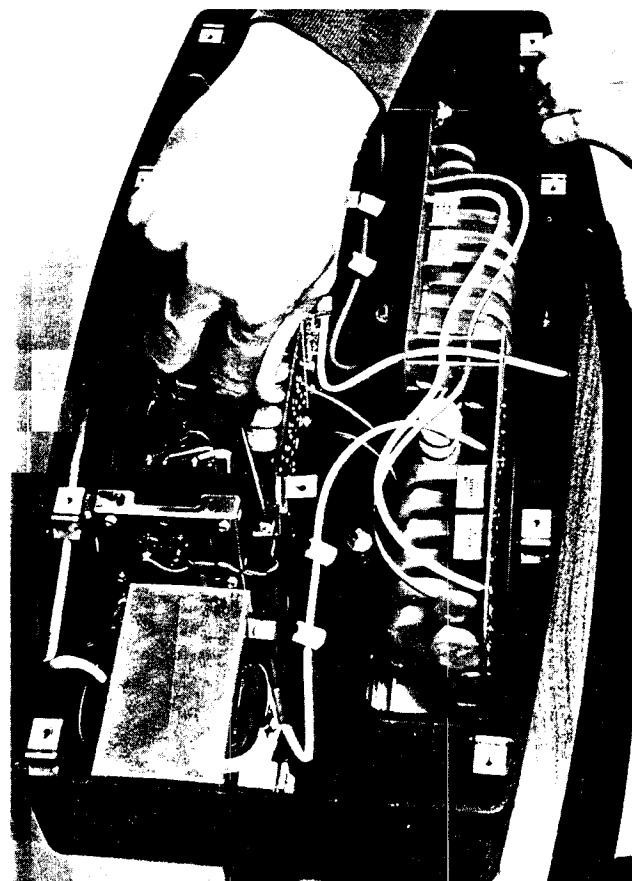
Fig. 7

(b) The sub chassis holding the protection circuits, EHT power supply, input and AC connectors and fuse can be removed by undoing the four screws. Replacement of the protection circuit and EHT power supply is then quite straightforward.

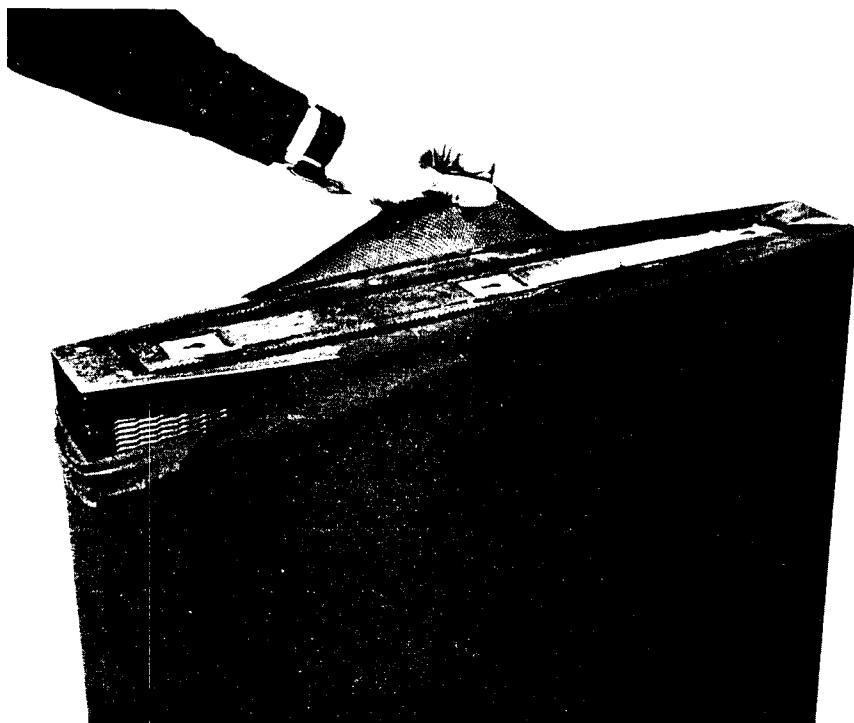
Fig. 8

(a) Remove the wooden top from the loudspeaker by sliding it to the right (viewed from the front). Detach the grille cloth from the velcro hooks as shown in Fig. 8, and pull the cloth down taking care not to ladder it.

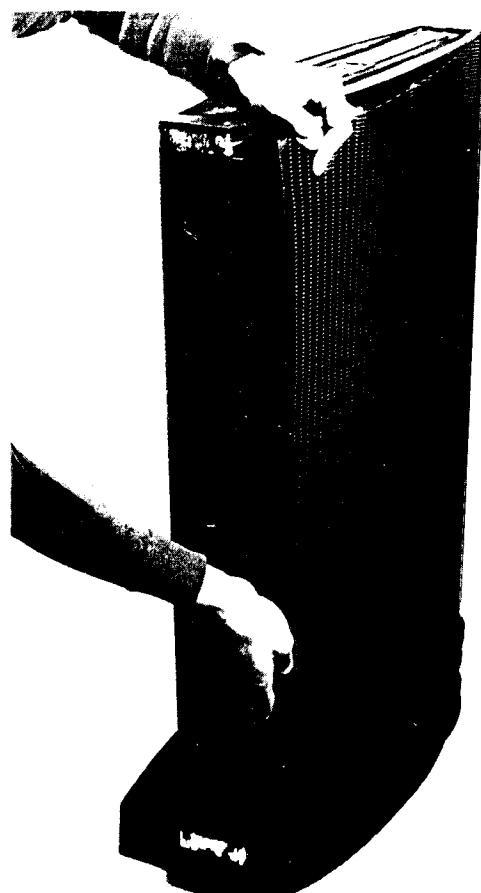
Fig. 9

(b) The grilles are taped top and bottom to prevent rattles and once the tape has been removed it is possible to prise the front and back grilles from their retaining slots in the side extrusion. Care should be taken when handling the grilles as it is relatively easy to distort the edges beyond repair.

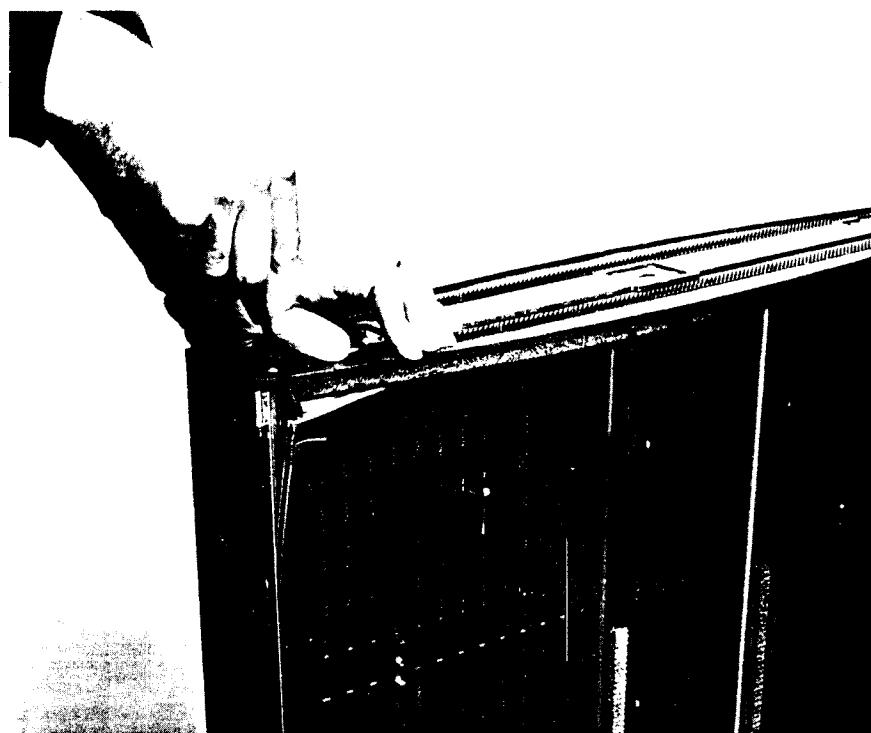
Fig. 10

(c) The dust cover is fitted to a clip-on frame and is removed by inserting a screwdriver at either of the top corners and gently lifting a corner free.

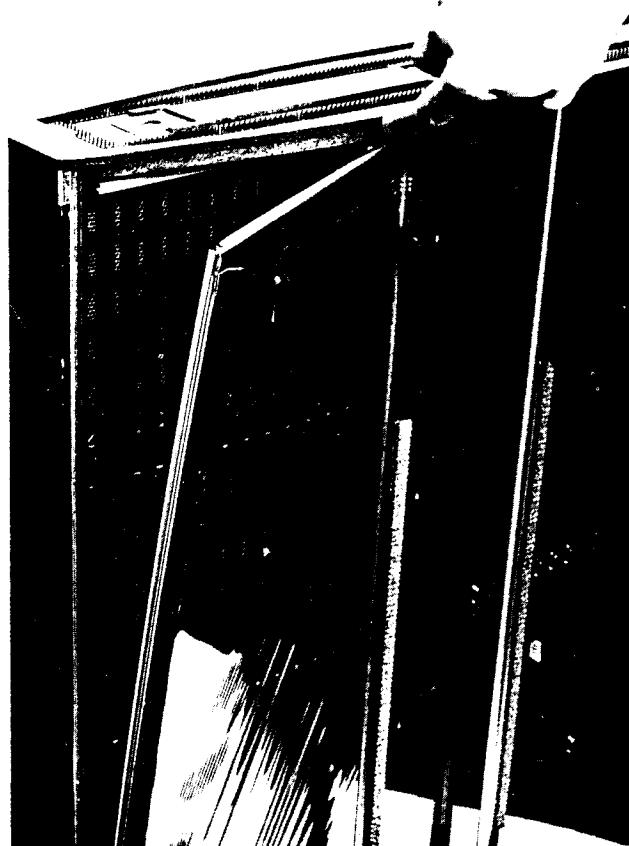
Fig. 11

The screwdriver is then slid down between dust cover and side frame. This should be repeated in each of the other three corners after which the dust cover can then be withdrawn.

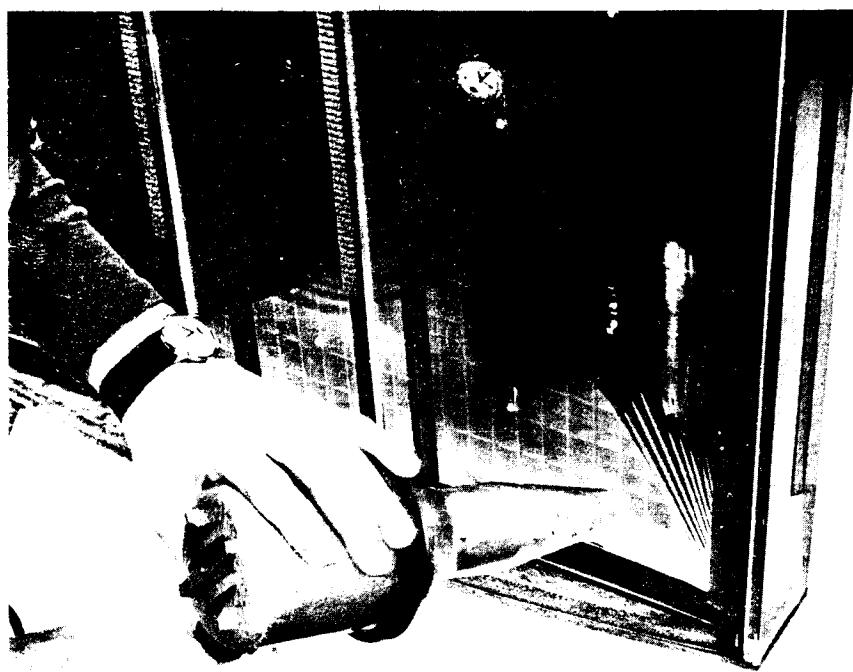
Fig. 12

(e) With the faulty element replaced the loudspeaker can then be re-assembled in reverse order. Once the dust covers are in place they must be retensioned with a hot air blower to remove all wrinkles. A domestic hair dryer may not be hot enough but restricting the air flow by hand will raise the temperature sufficiently. The blower should be kept moving all the time in order to prevent burning a hole in the material.

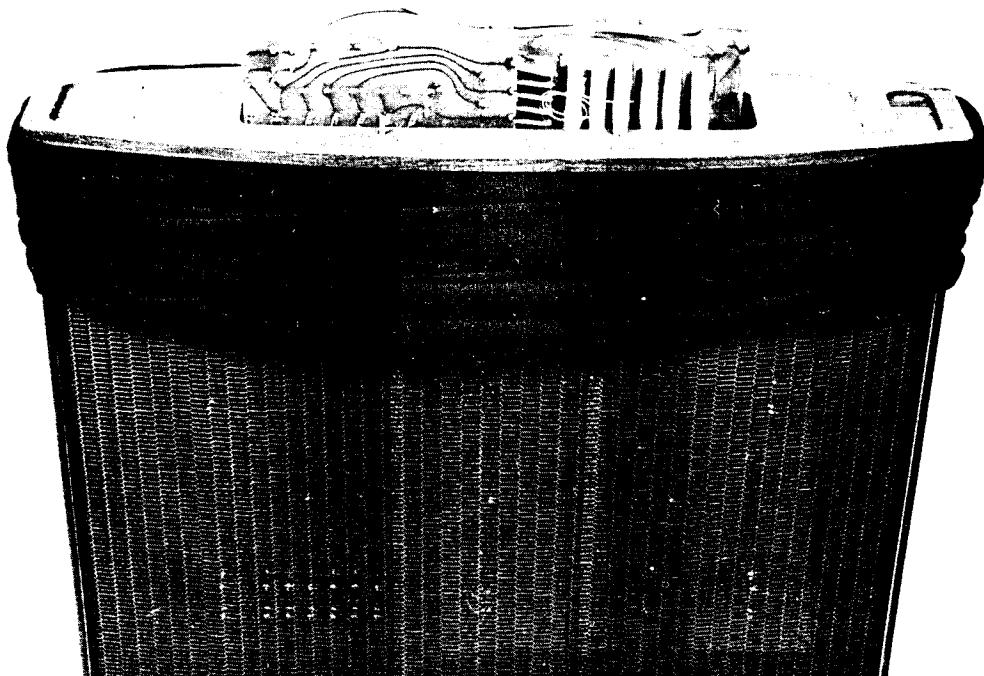
Fig. 13

- (b) Lift off the wooden base. Disengage the existing cloth from the velcro fixings at the bottom of the loudspeaker assembly and remove. Slip the new cloth over the inverted loudspeaker leaving about 2" projecting above it, with creases down the middle of the sides. Align the pattern with the corners, always taking great care not to ladder the material. Fix the cloth to the velcro fixings starting at the centre of each side and working out to the ends. Fold to form mitre pleats at the corners and attach to the velcro at the ends. Recheck the alignment of the pattern and adjust if necessary.

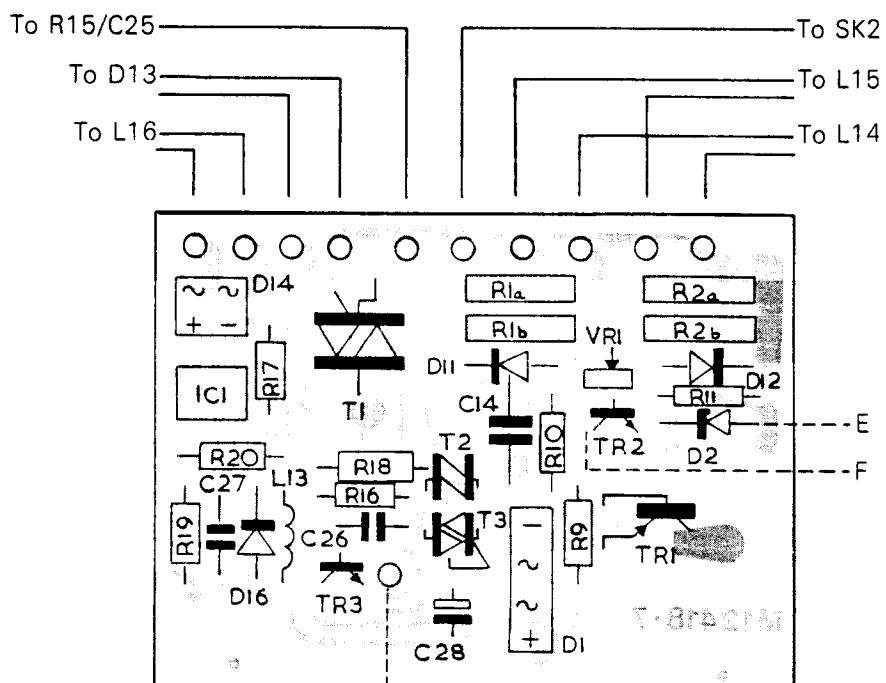
Fig. 14 TO ANTENNA

M12418 - ISS 7

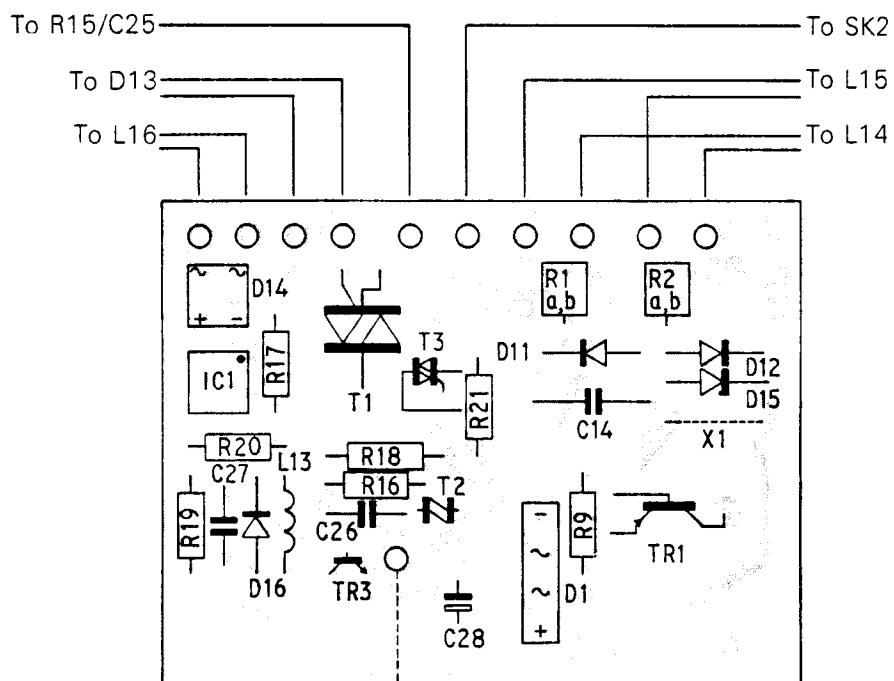
Fig. 15 TO ANTENNA

M12418 - ISS 9, 10

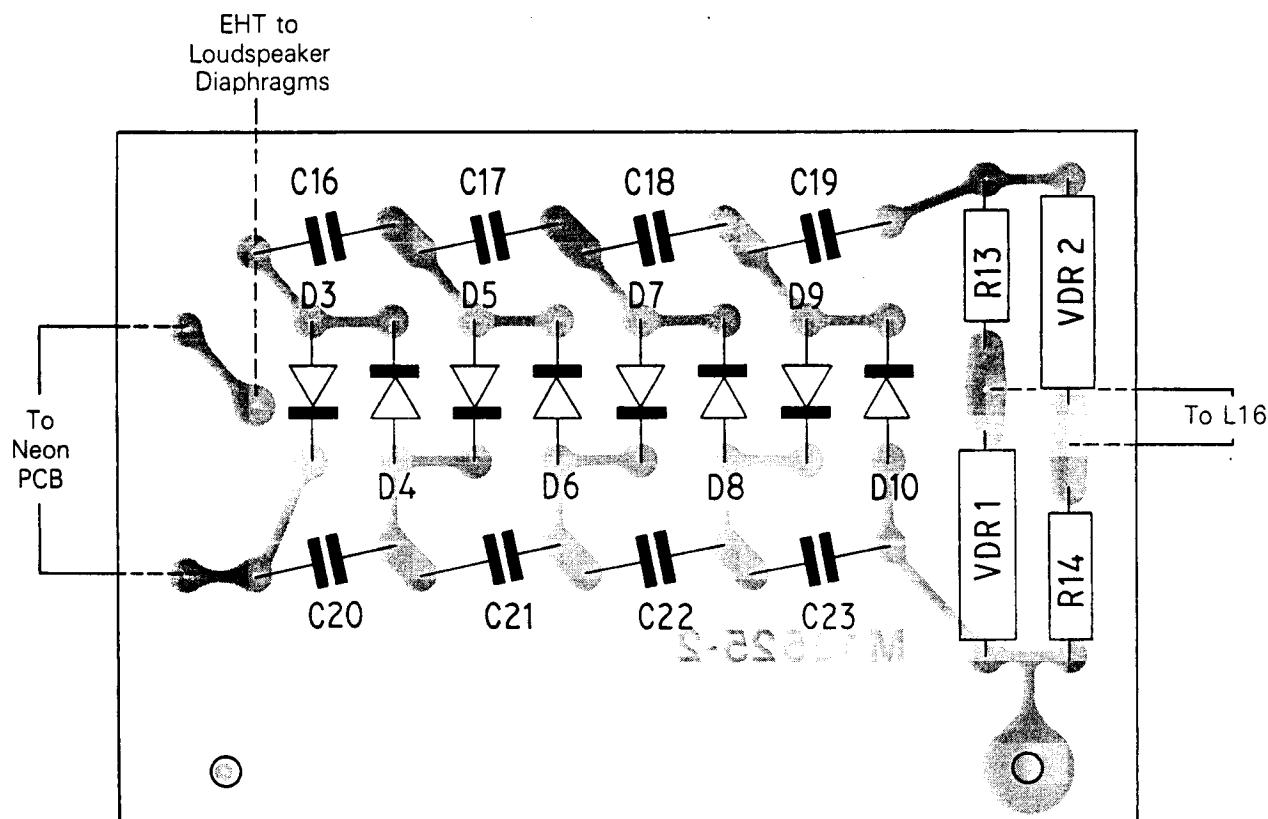
Fig. 16

M12525 – ISS 2

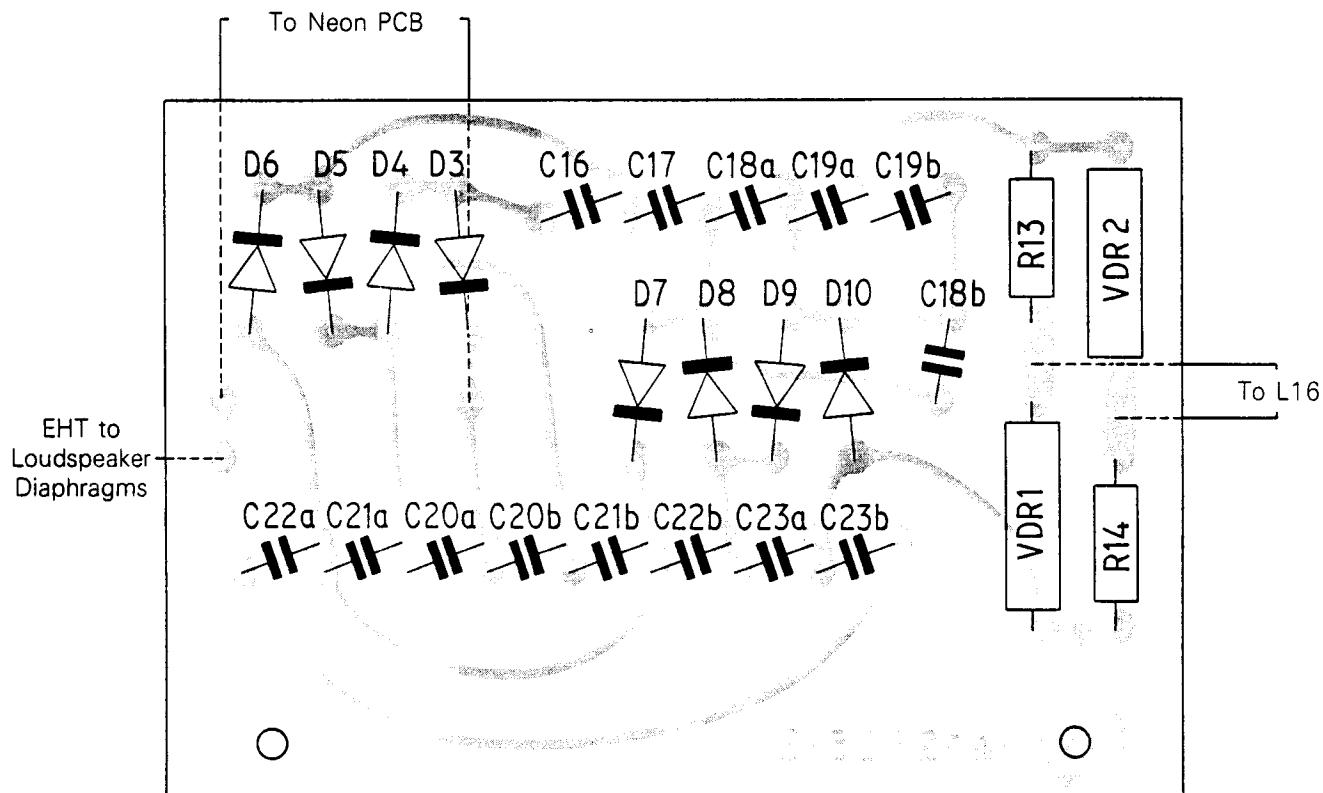
Fig. 17

M12525 – ISS 3

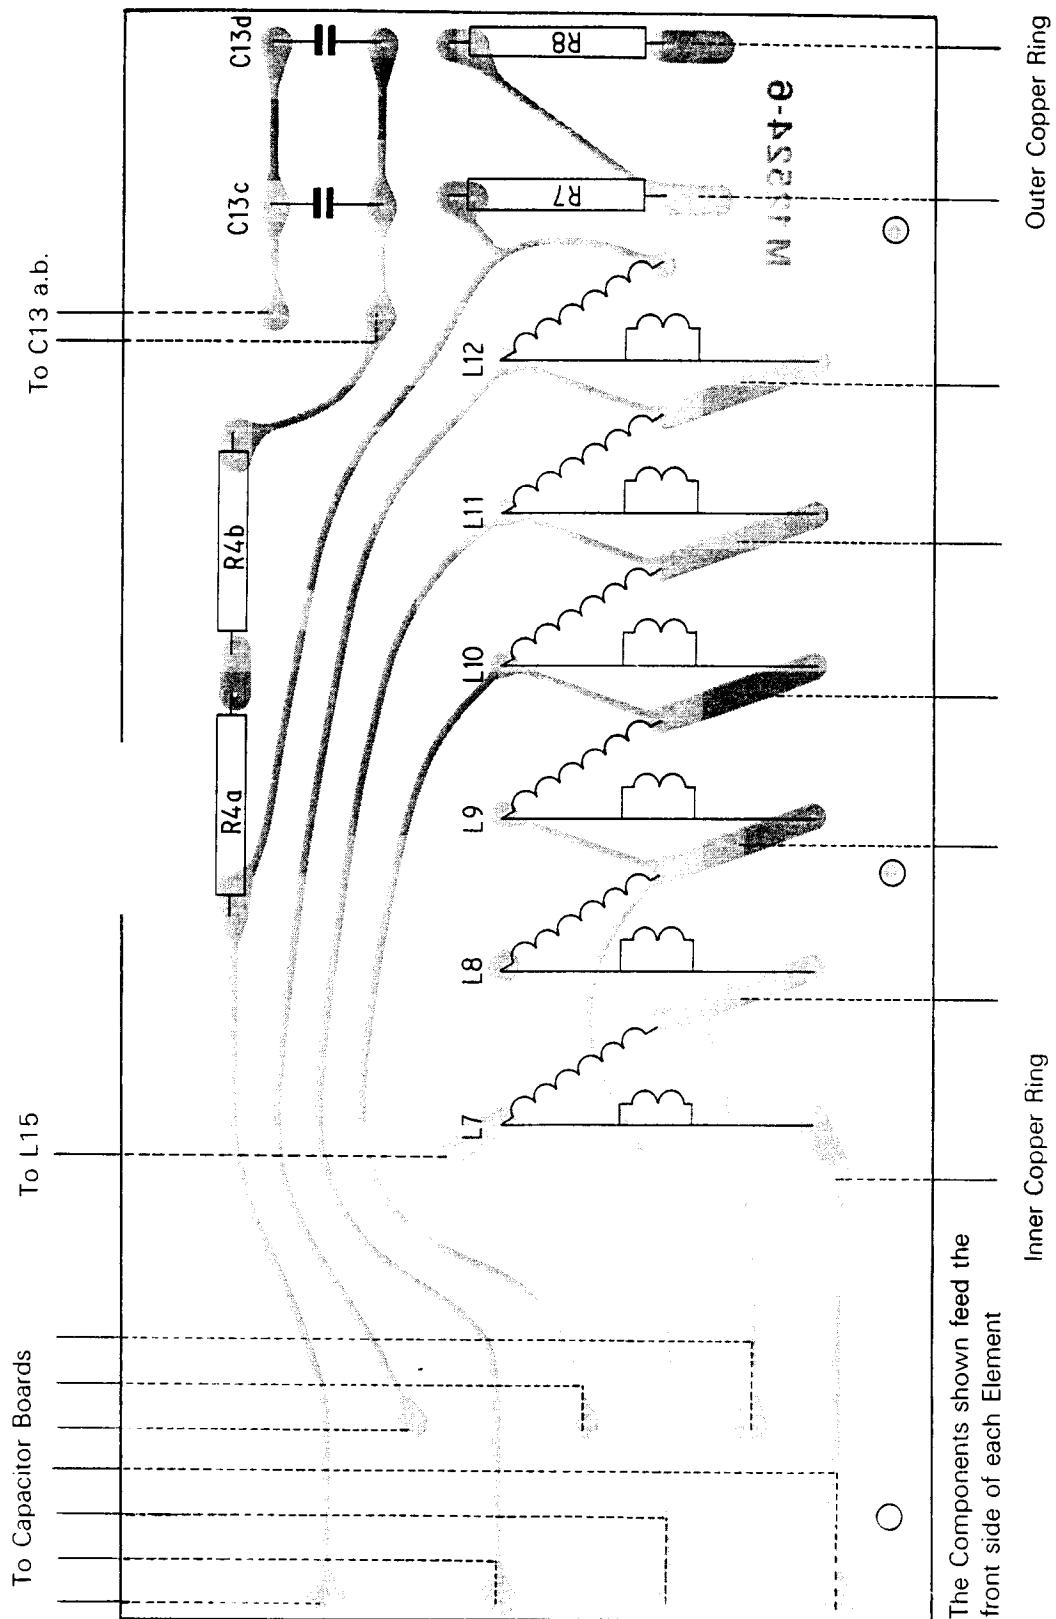
Fig. 18

M12524 - ISS 6

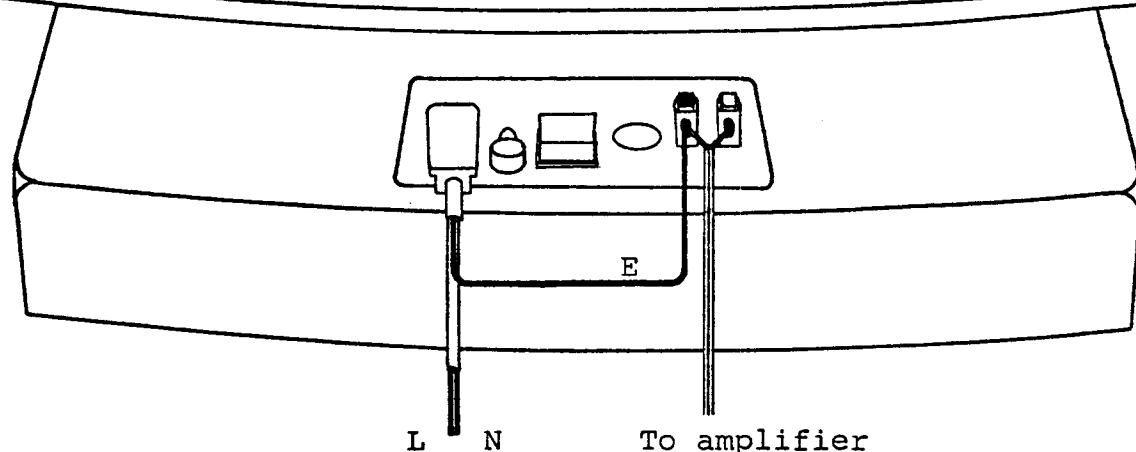
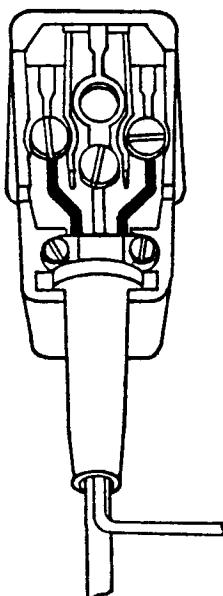
In some circumstances the ESL-63 protection circuit can be triggered by the operation of central heating thermostats, light switches etc., resulting in a few seconds of reduced and distorted output.

In such cases, the earthing arrangement shown in the sketch below should be used.
