TEAC TECHNICAL INFORMATION

TASCAM MMC-38, Change of the Software

TASCAM DA-38/88/98, Impedance Roller Height Adjustment

TASCAM DA-38/88/98, Changes on Mechanism (S-Err 08/31)

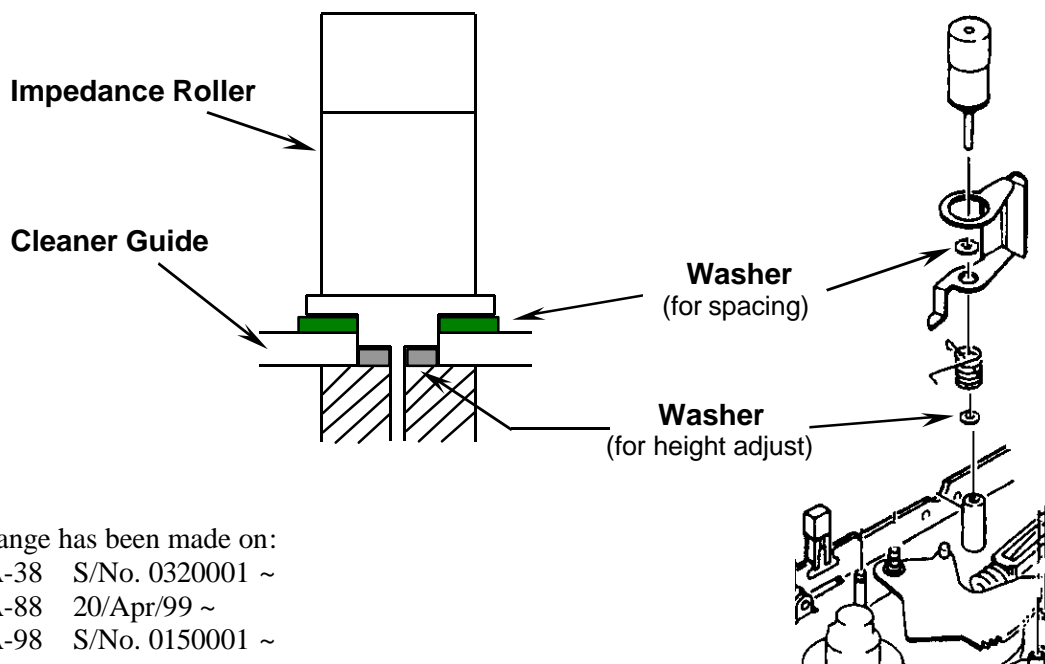
A washer (Procedure 4-6-1, DA-38/98 service manual) has been used to adjust the height of impedance roller. If thicker one is used, there is a possibility that a lever of cleaner guide and a pin of sector gear do not engage causing incomplete tape loading.

To fix the height of cleaner guide uniformly, three pairs of washer have been newly used.

Pair 1	Pair 2	Pair 3
Washer (for spacing)	M0090660 (3.85×6×t0.2)	M0090670 (3.85×6×t0.25)	M0090680 (3.85×6×t0.3)
Washer (for height adjust)	M0090610 (1.63×3×t0.13)	M0090620 (1.63×3×t0.2)	M0090630 (1.63×3×t0.25)

Notice: Do not mix different pairs.

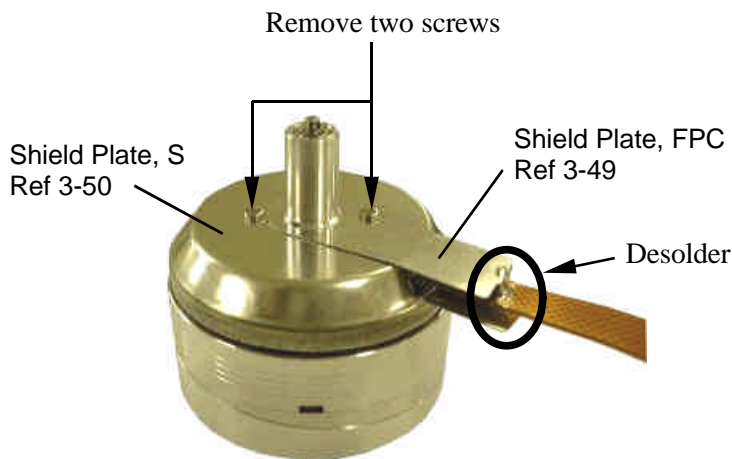
Rotate the REC Trans Assy so that two screws can be found through the holes. Remove those two screws.

Cause: Recording Rotary Transformer gets stuck. Gluing was not proper on some Rec Rotary Trans.

Solution: Replace the rotary transformer with Rec Trans Assy (SV), P/No. V000863-00A.

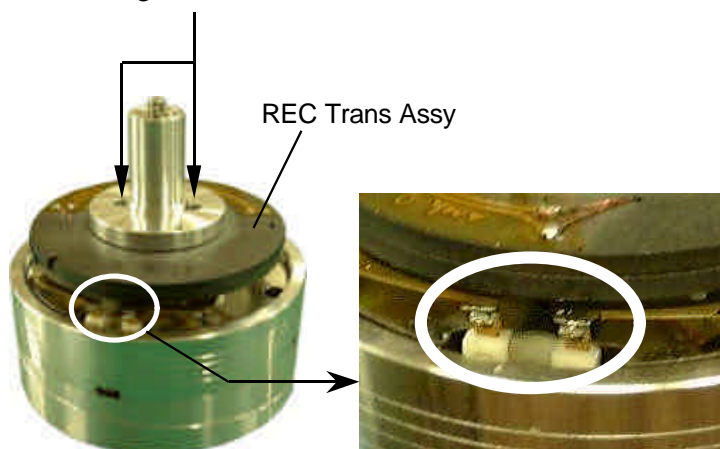
Desolder the head terminals.
 (There are same terminals at the opposite side.)

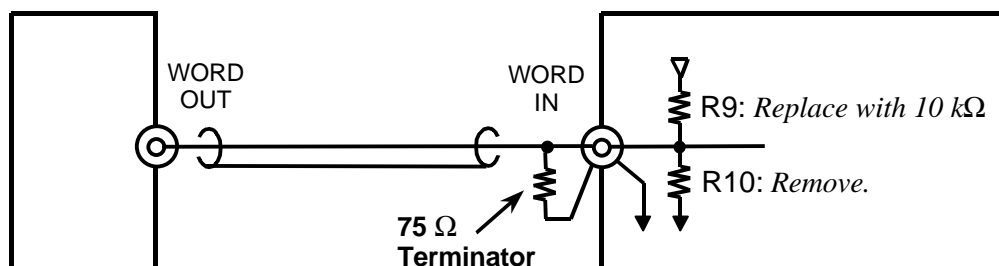
**Emitter Follower
Output Machine****DA-88 SYS PCB Assy**

- 1) Replace R9 on the SYS PCB Assy with 10 k Ω , 1/4 W, **P/No. 52400306-20**
- 2) Remove R10.
- 3) Connect an outside 75 Ω termination via a BNC T-piece.

- 3 If WORD is set for the clock source and 75 Ω terminator is connected, clock master machine should be turned ON. In other cases, remove both the outside terminator and the connection.
- 4 This countermeasure is effective for machines that use Emitter Follower type drivers for the word output. For machines not using Emitter Follower types (such as PCM-3324, PCM-7010), this countermeasure is not applicable.
- 5 If the DA-88(that this countermeasure has already been done on) is connected at the end of the word sync chain, connect a 75 Ω terminator using a BNC T-piece.

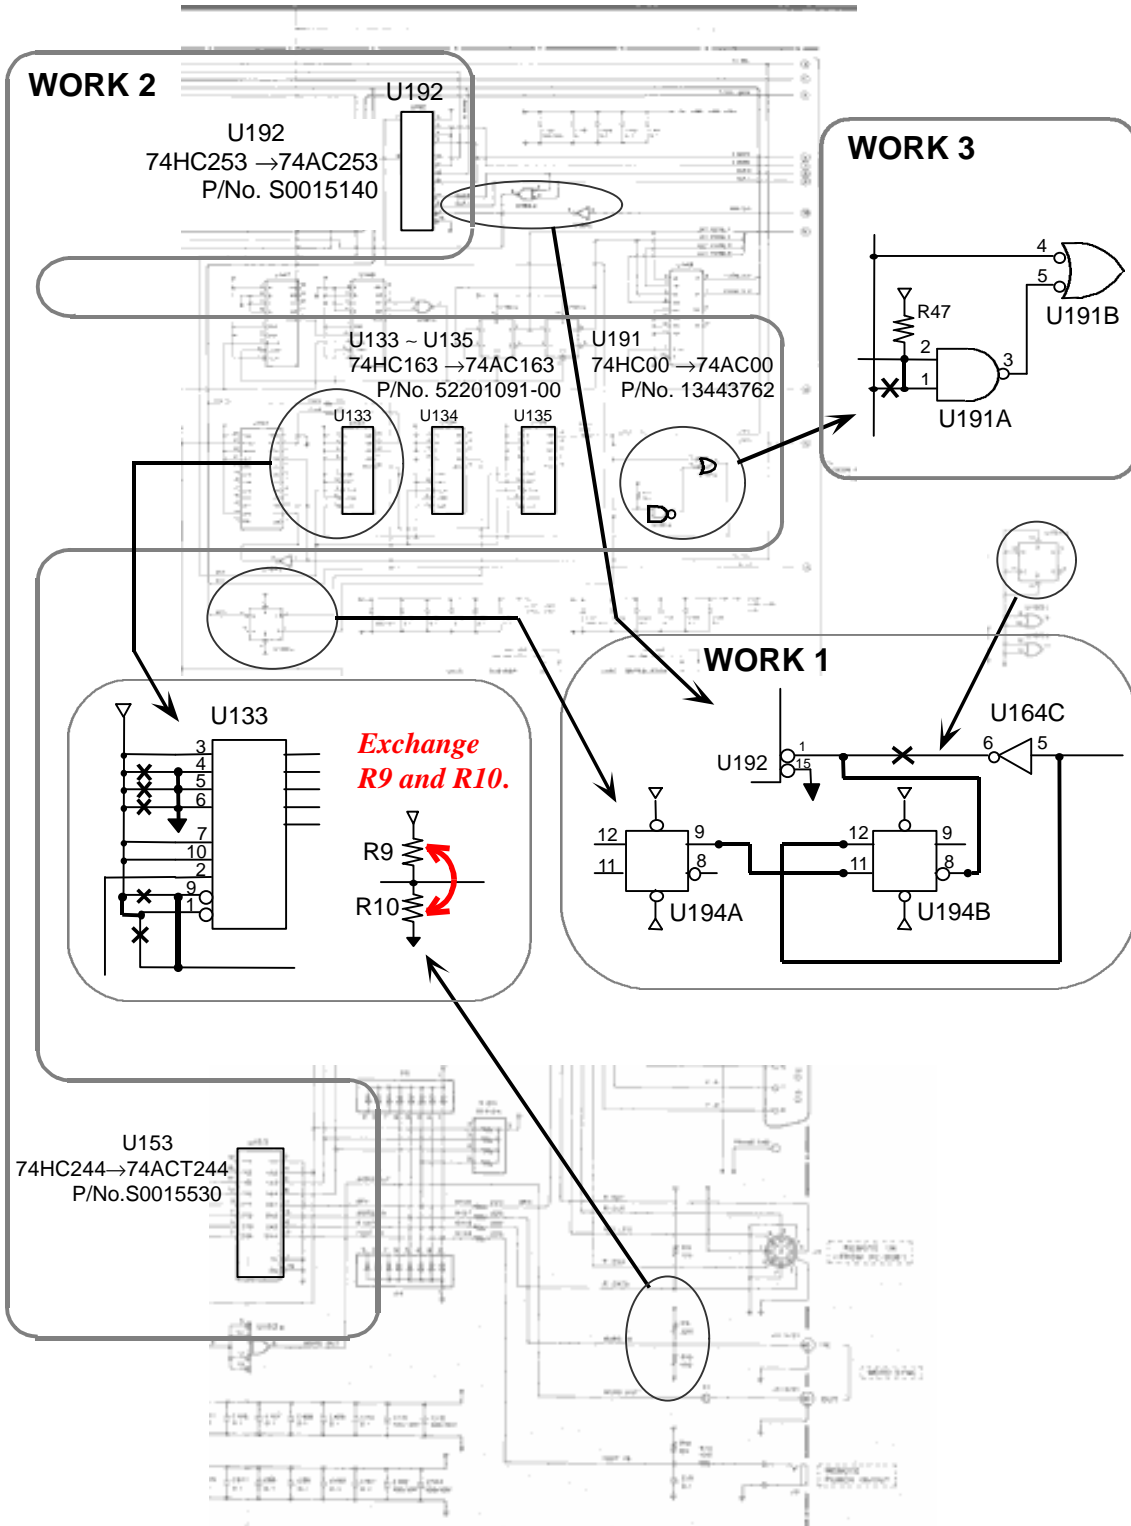
SYS PCB Assy (Soldering Side)

Overview of WORK 1, 2 and 3

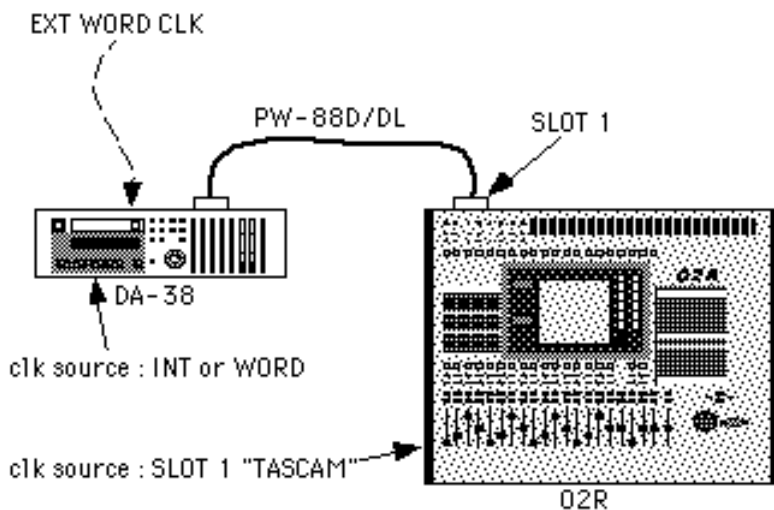
DA-38 should be used as a source of master clock. Clock source of O2R is set to a slot where the CD8-TD, an optional YAMAHA I/O card (TASCAM) is inserted.

If system set up is made with other methods, data transmission from O2R to DA-38 may not be done properly although DA-38 to O2R is OK.

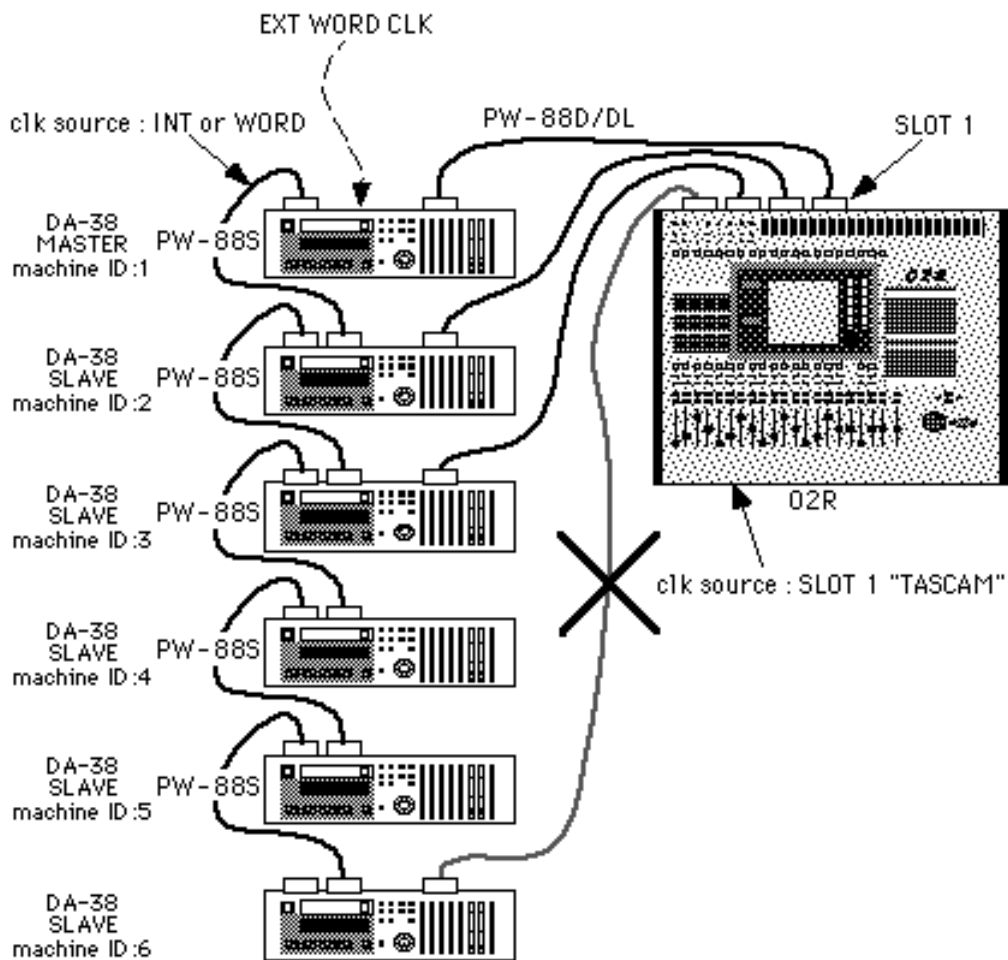
O2R accepts upto 4 units of DA-38. Clock source of O2R should be set to a slot where the master machine among multiple DA-38s being connected.

In the case of below, master DA-38 is connected to SLOT 1, then, clock source of O2R should be set to SLOT 1 "TASCAM". In multiple DA-38s connected to O2R, sync cable (PW-88S) should be connected in regular sequence. In case any discontinuity of regular order of sync cable is made, data transmission from O2R to DA-38 may not be done properly although DA-38 to O2R is OK.

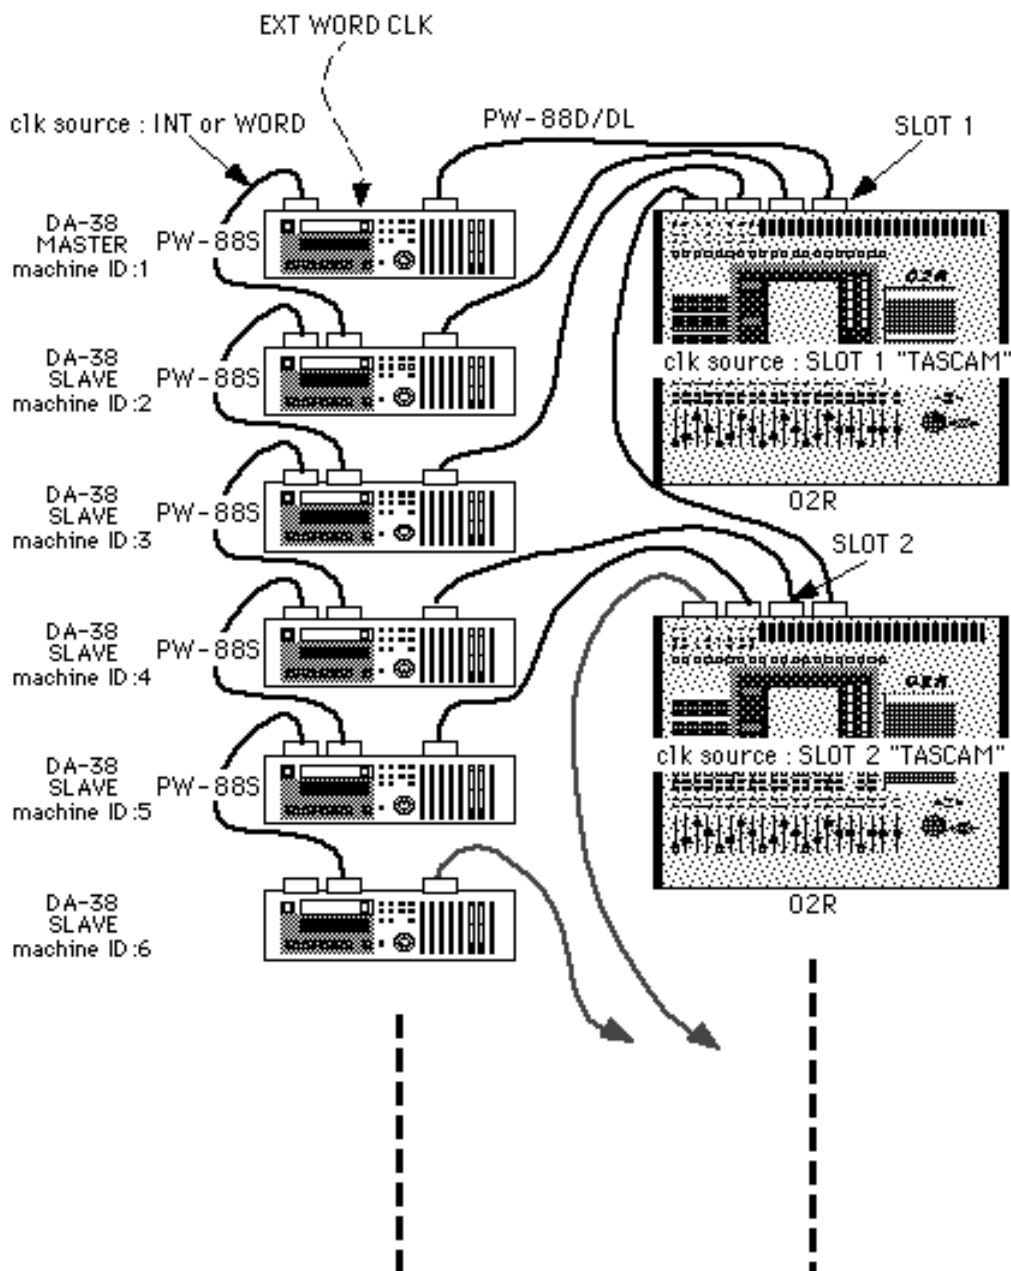
O2R can be daisy chained upto 4 units with the Digital Cascade card inserted to a slot. Then totally 10 units of DA-38 (3 units of DA-38 on master O2R, 2 on slave 1 O2R, 2 on slave 2 O2R, 3 on slave 3 O2R) can be connected to multiple O2Rs.

In the case of below, clock source of 1st O2R should be set to SLOT 1 "TASCAM" and clock source of 2nd O2R should be set to SLOT 2 "TASCAM". Sync cable (PW-88S) should be connected in regular sequence. In case any discontinuity of regular order of sync cable is made, data transmission from O2R to DA-38 may not be done properly although DA-38 to O2R is OK.

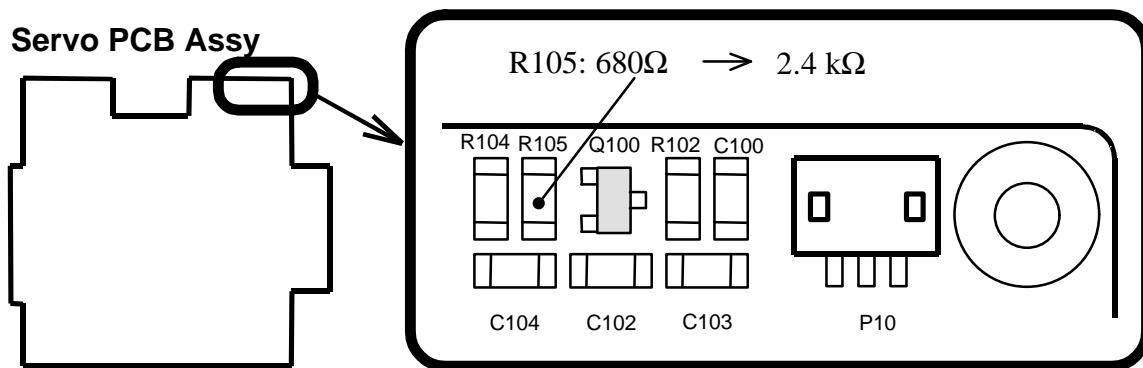
Circuit Diagram

Cause: The ATF signal is recorded with too much level for certain tape formulations..

Solution: Reduce the ATF signal input stage by replacing R105 (680Ω) on the Servo PCB Assy with 2.4 kΩ, **P/No. 11152242**.

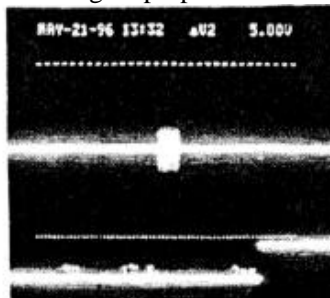
U2-43 (PRE AMP OUT)
ATF signal proper level

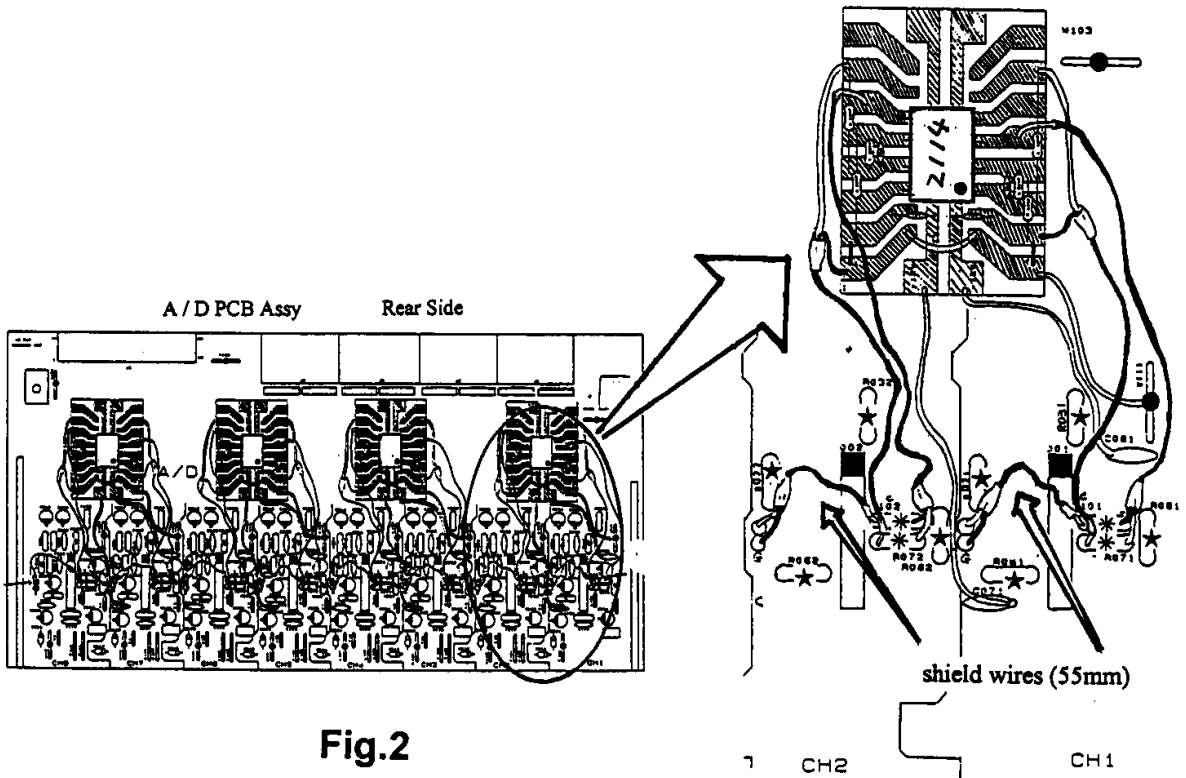
Fig.3

- ④ Replace * marked eight resistors with the supplied resistors per each Buffer Amp PCB as shown in Fig.3:

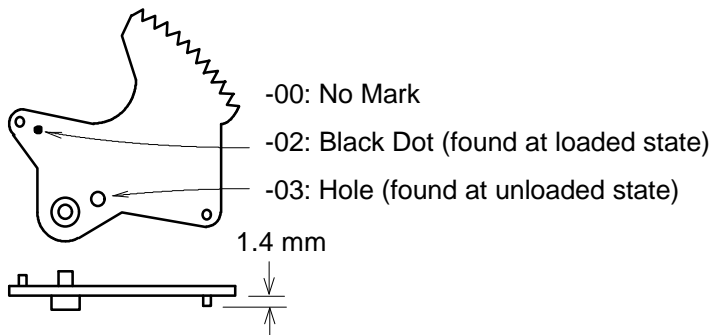
Sector Gear Assy
17968210-00/02/03

Cause: Fracture at inmost groove of the Logic Cam L (Ref 5-25).

Solution: Replace a damaged Logic Cam L. At the same time, replace the Sector Gear Assy (Ref 5-23) with the latest **P/No. 17968210-03**.

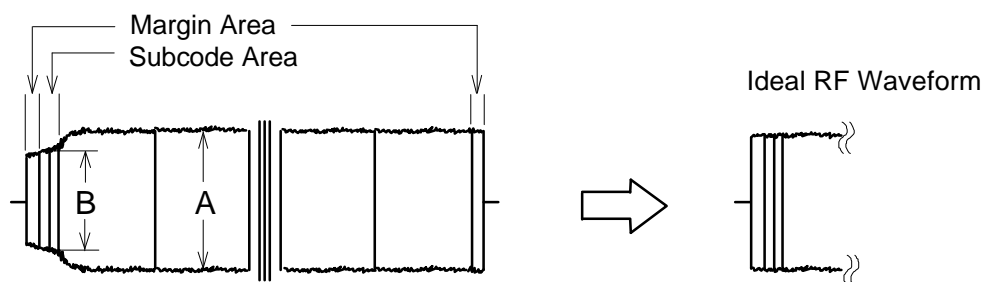
When the Drum Head is replaced with brand-new 56001657-21 or -22, there is a possibility that left side of the RF waveform becomes rounded/dull as shown below. Adjustment of supply guide cannot remove that dullness.

Specification: $B/A \geq 80\%$

Value of B should be measured at Subcode Area, not at Margin Area.

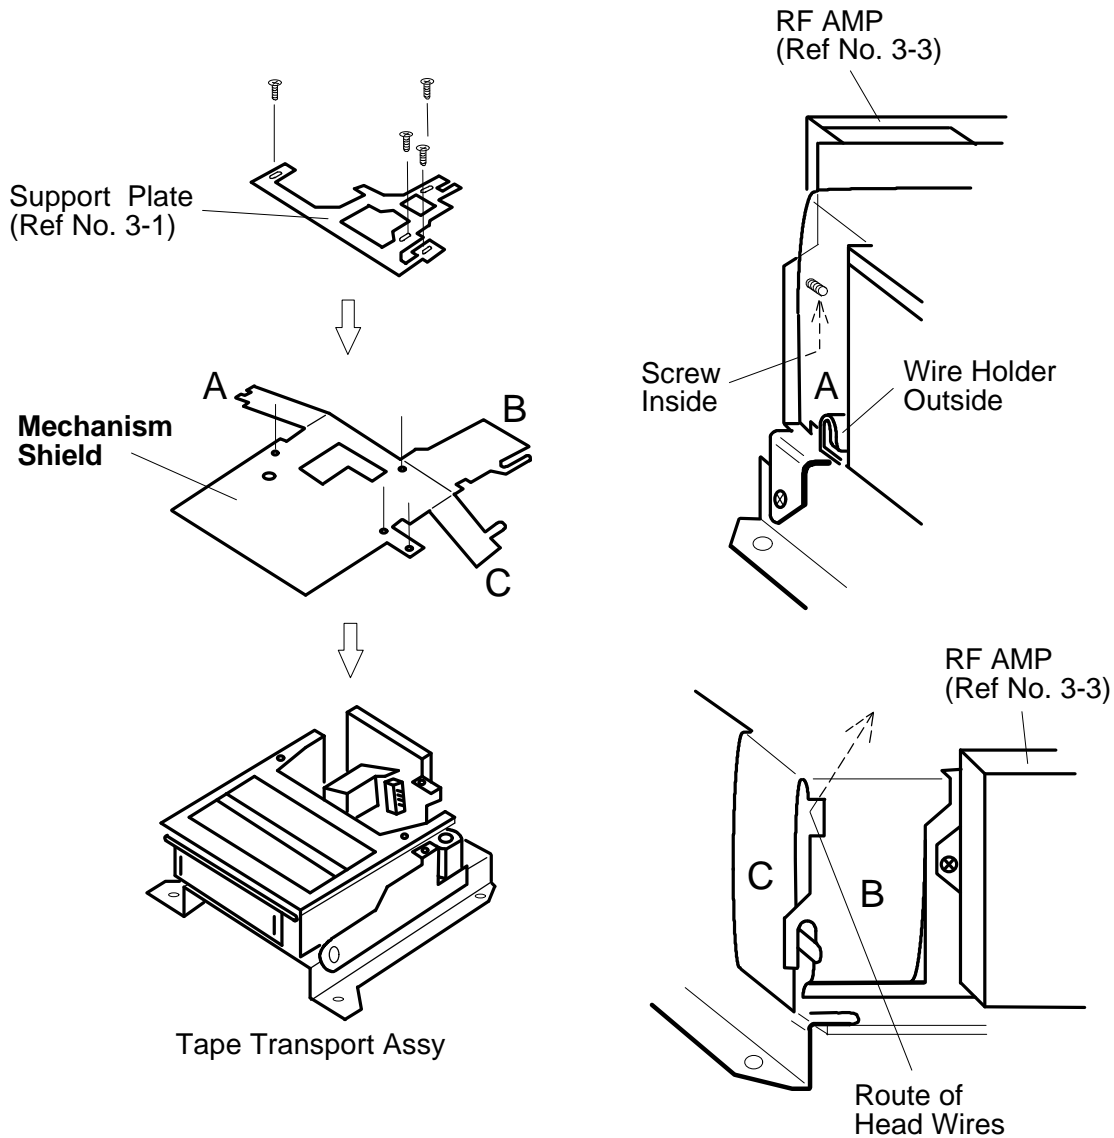
Products S/No. 300001 and up have this shield.

No further component to fit is needed. Once remove Support Plate (Ref No. 3-3) and refer to below for assembling.

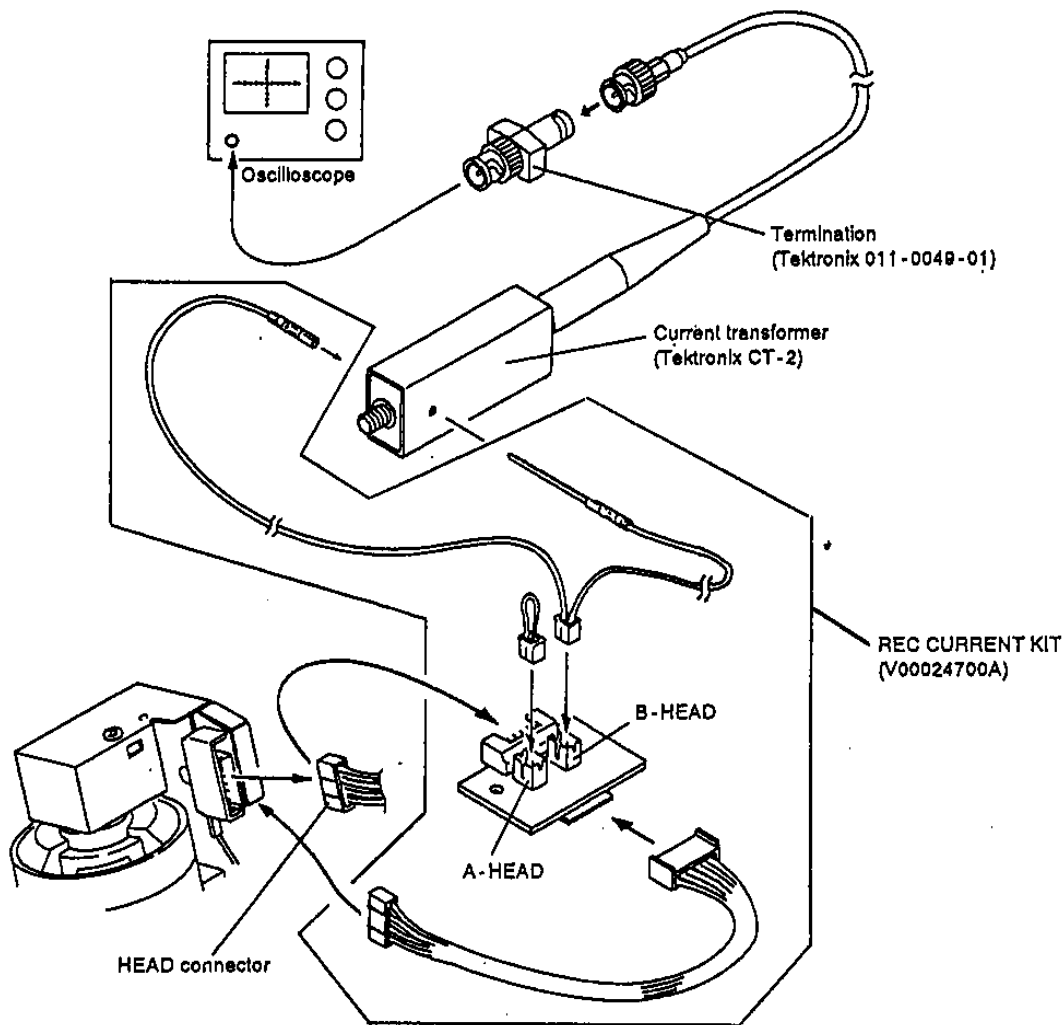
Connect all items as shown below and refer to 3-7-1 Adjusting Recording Current on the original and supplement service manual.

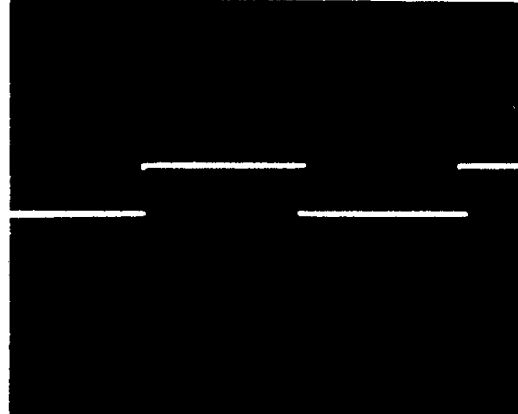
Stable State:

Square wave sways
slow horizontal (1610Hz approx.)
TP RFG SHTL FWD x 1)

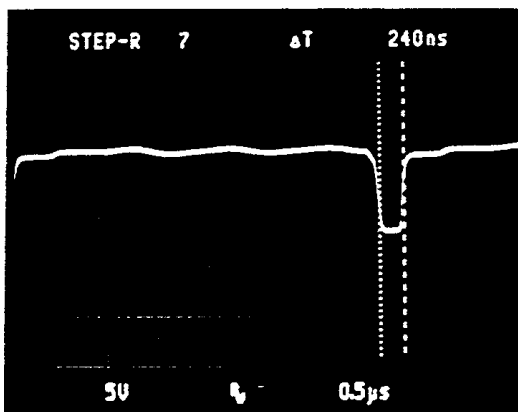
In case wave form shown is observed, note the time span of low level.

Wave form of Pin 1 U8
R613 replaced with 22 kohm

[Powered on with no tape loaded]

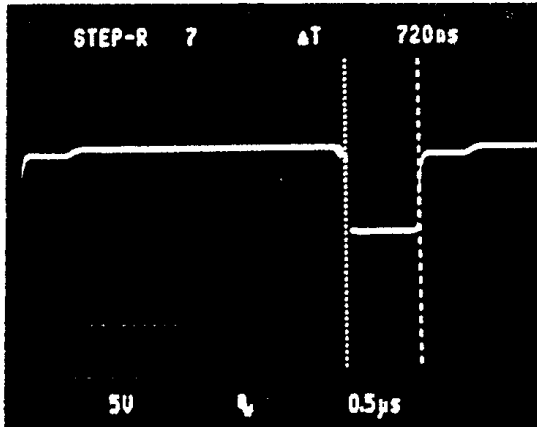
Wave form of Pin 1 U8
R613 replaced with 22 kohm

[SHTL FWD x 1 seed at Beginning Of Tape]

2-4 Shuttle tape on FWD x 1 speed and observe the voltage of Pin 1 U8. Then see the time span of low level. If that span is more than two times the span of low level measured on 2-2 step, it assures that adverse effect resulted is within a safe operation. Proceed to 2-5 step.

If not, replace U8, replace existing R613 with 18 kohm resistor and proceed to 1-1 through 1-6 steps.

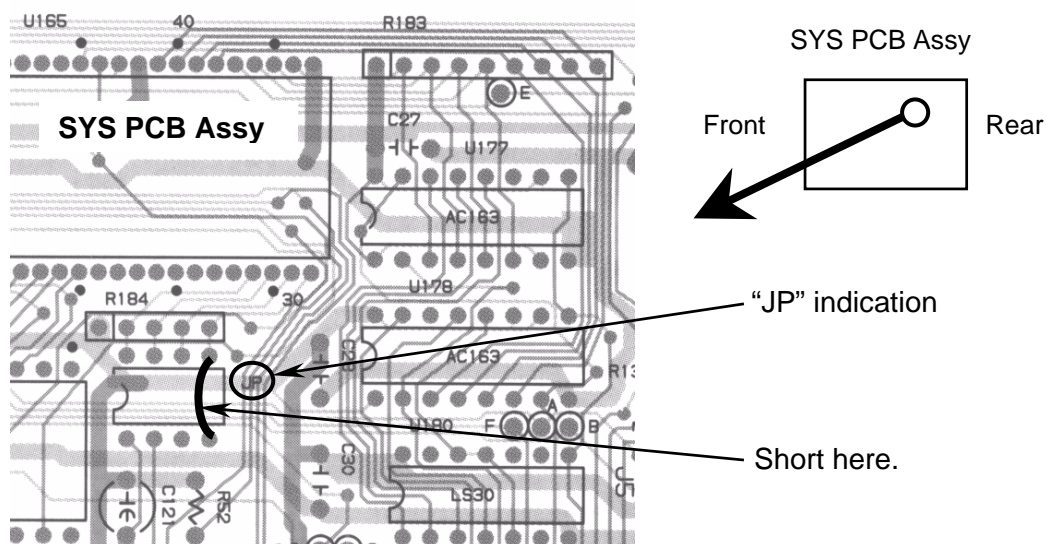
1. Turn the power on with "JP" shorted temporarily.
2. [rEAdy] appears.
3. Press STOP.
4. [CLEAR] appears then all data is cleared.
5. Turn the power off.

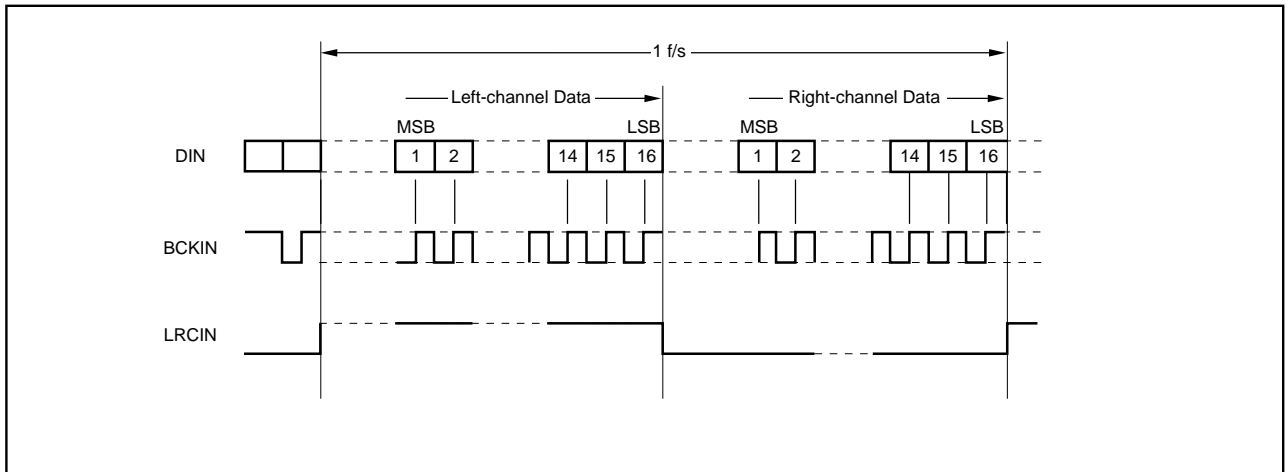
FIGURE 1. Normal Format, 16-Bit (LRCIN H: Lch).

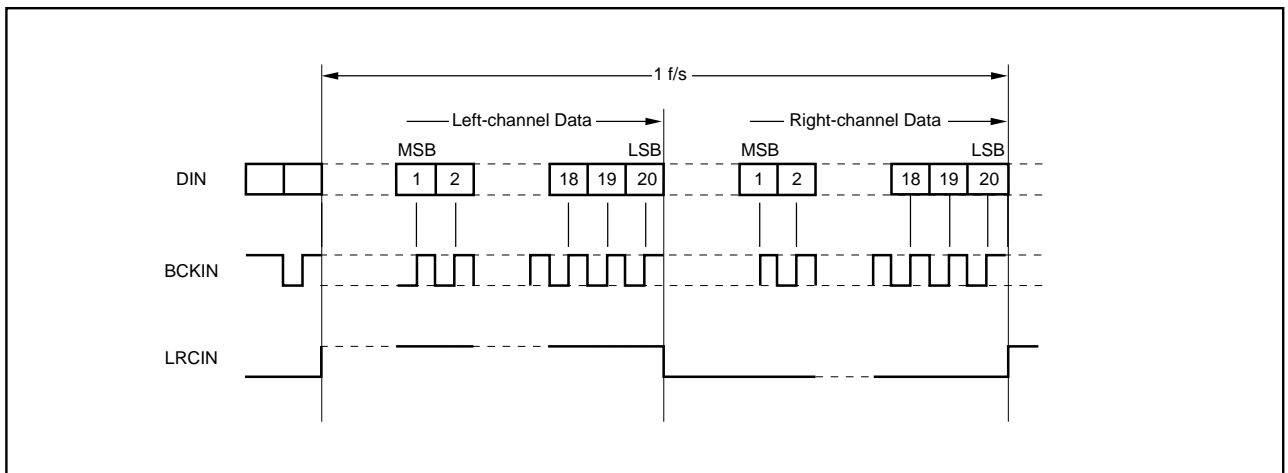
FIGURE 2. Normal Format, 20-Bit (LRCIN H: Lch).

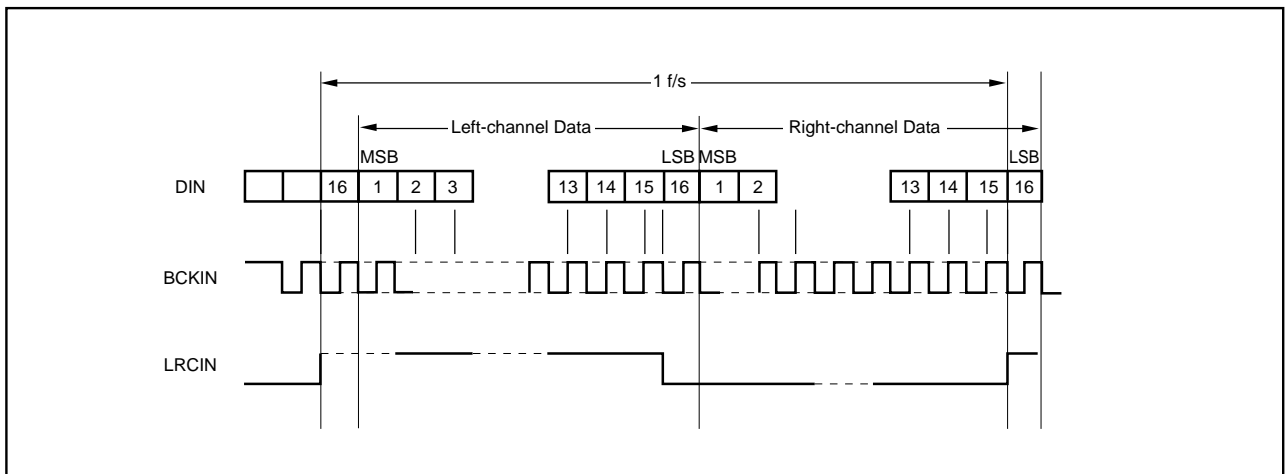
FIGURE 3. IIS Format, (16-Bit, 32 BCKIN Clock Cycles Per f_s Interval).

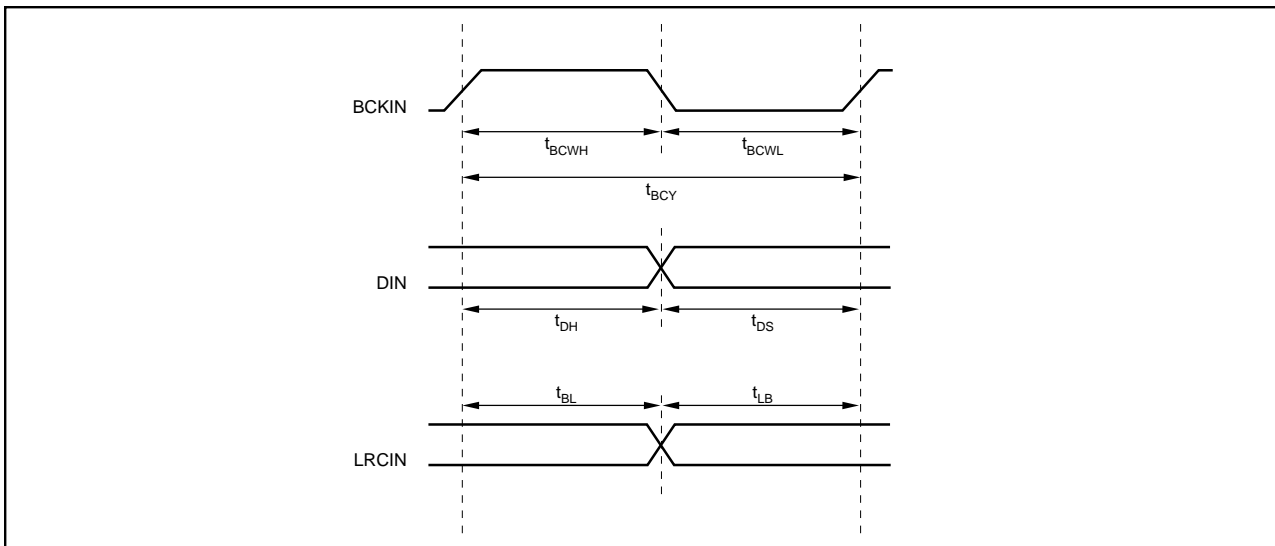
FIGURE 4. Data Input Timing.

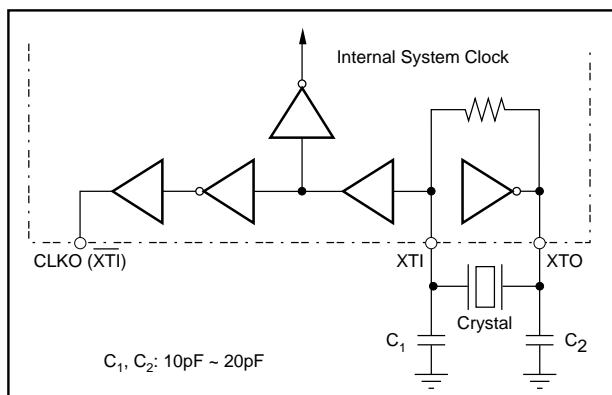
Figure 7 is a diagram showing the internal clock in conjunction with an external crystal oscillator.

FIGURE 7. External Crystal Oscillator.

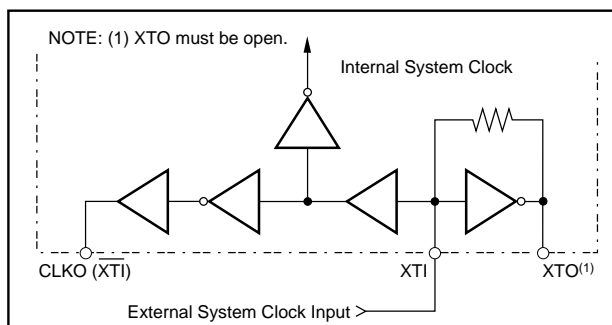
Figure 8 is a diagram showing the internal clock with an external clock source, instead of an oscillator. An external system clock (input to XTI) must meet the following conditions:

HIGH LEVEL	$V_{IH} > 0.64V_{DD}$	$T_H > 10ns$
LOW LEVEL	$V_{IL} > 0.28V_{DD}$	$T_L > 10ns$

FIGURE 8. External System Clock.

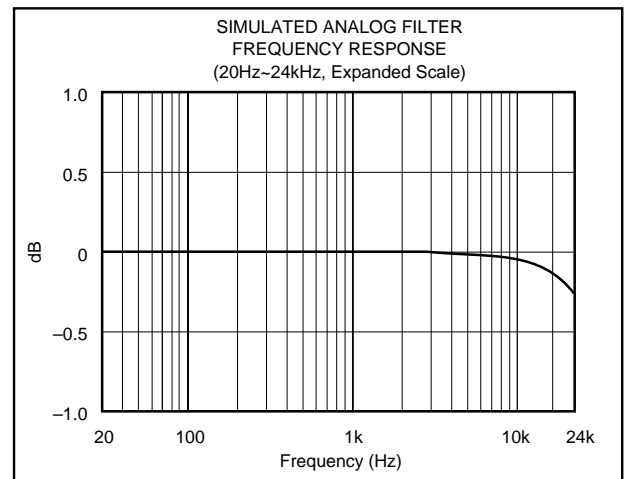
FIGURE 15. Low Pass Filter Frequency Response.

The performance of the internal low pass filter from DC to 24kHz is shown in Figure 15. The higher frequency rolloff of the filter is shown in Figure 16. If the user's application has the PCM1710 driving a wideband amplifier, it is recommended to use an external low pass filter. A simple 3rd-order filter is shown in Figure 17. For some applications, a passive RC filter or 2nd-order filter may be adequate.

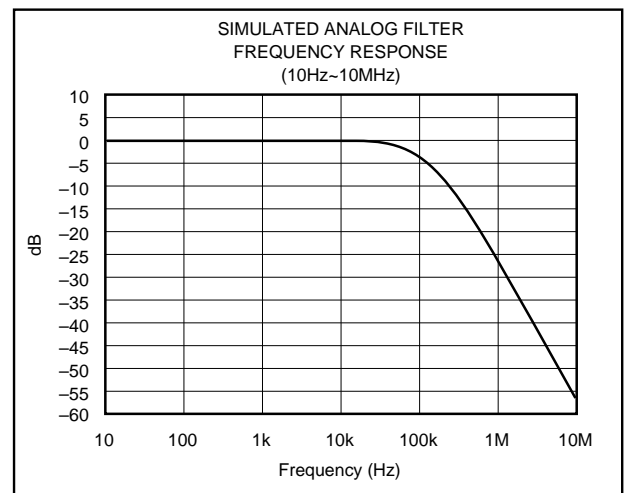
FIGURE 16. Low Pass Filter Frequency Response.

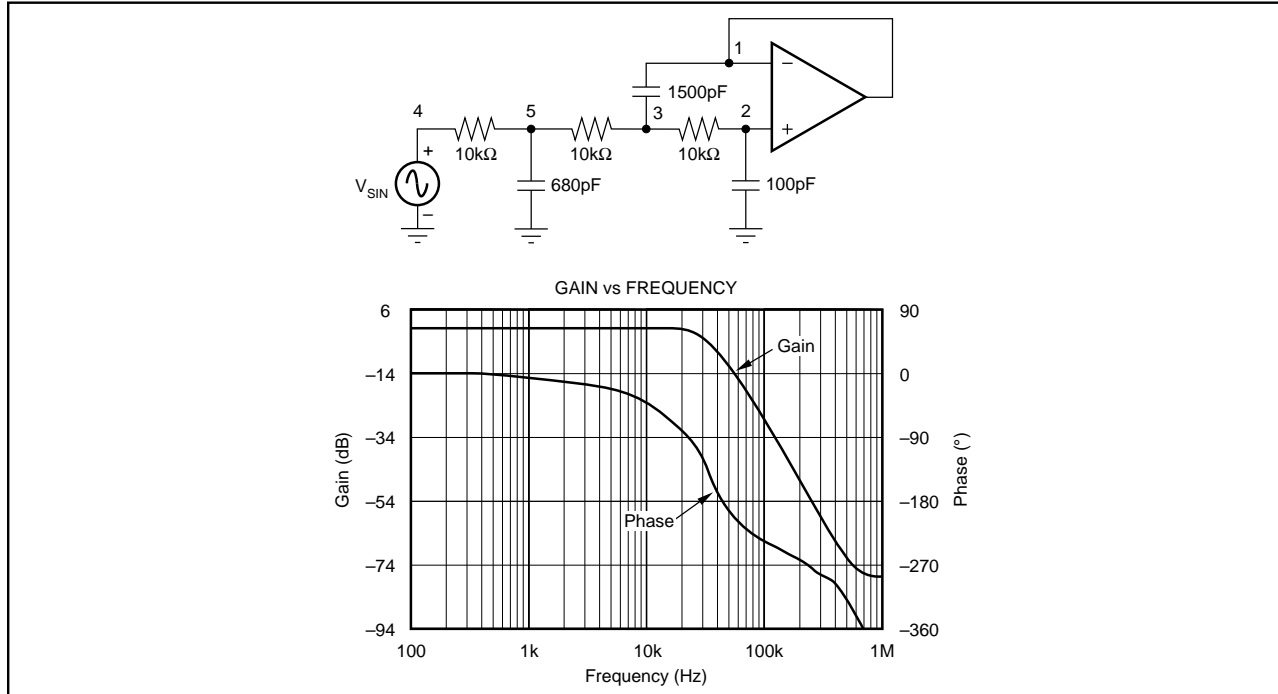
FIGURE 17. 3rd-Order LPF.

For testing purposes all dynamic tests are done on the PCM1710 using a 20kHz low pass filter. This filter limits the measured bandwidth for THD+N, etc. to 20kHz. Failure to use such a filter will result in higher THD+N and lower SNR and Dynamic Range readings than are found in the specifications. The low pass filter removes out of band noise. Although it is not audible, it may affect dynamic specification numbers.

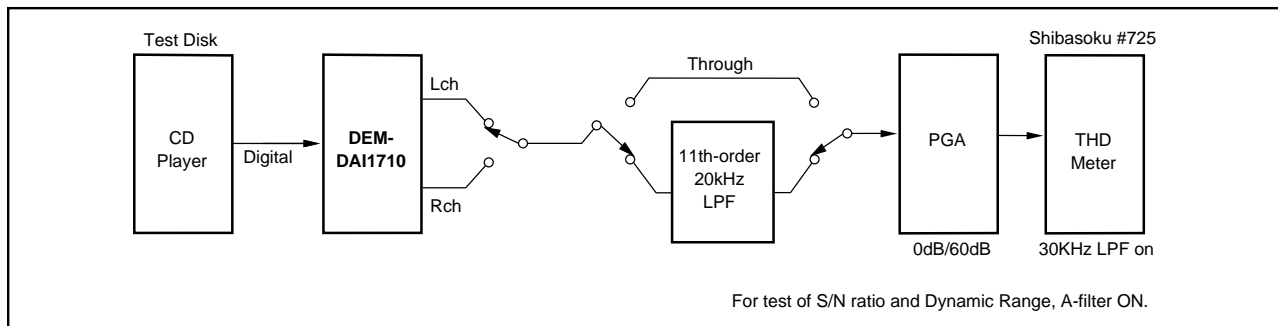
FIGURE 18. Test Block Diagram.

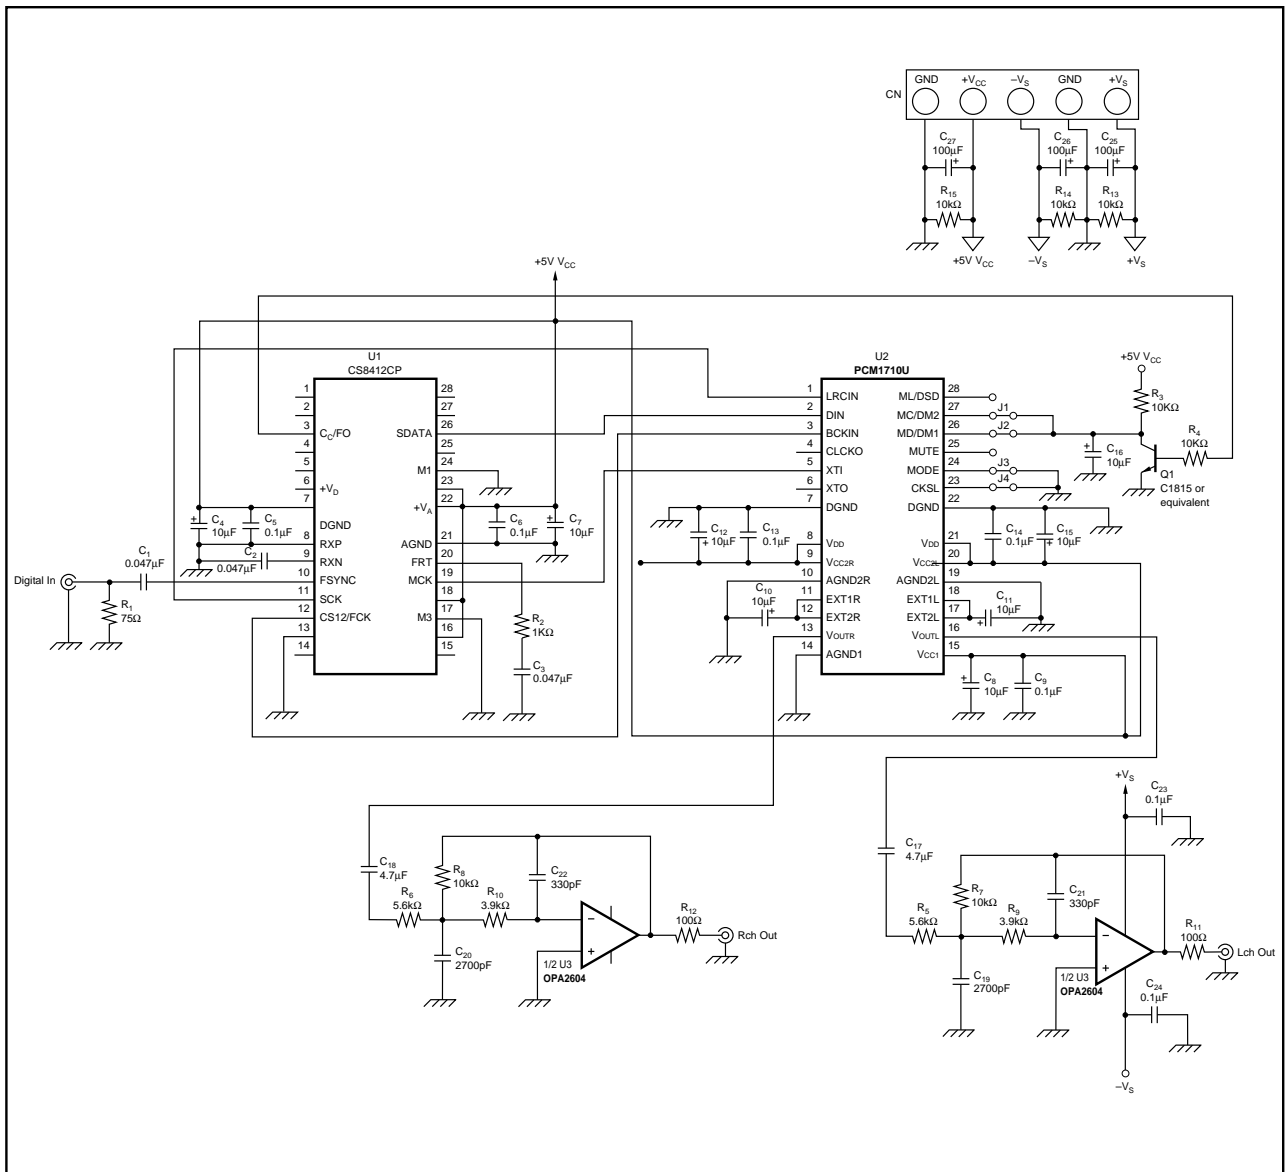
FIGURE 19. DEM-DAI1710 Schematic Circuit Diagram.

All of the functions of PCM1710 can be evaluated by using the DEM-DAI1710 jumper selections. DEM-DAI1710 requires $+5\text{V}$ and $\pm 5\text{V}$ to $\pm 15\text{V}$ power supplies. The schematic diagram for DEM-DAI1710 is shown in Figure 19. For more detailed information on the evaluation fixtures, contact your local Burr-Brown representative.
