PIONEER
The Art of Entertainment

No.. SK49006
Date: JAN,25, 1995

SERVICE KNOWHOW

THE CIRCUIT OPERATION OF THE POWER AMP MODULE

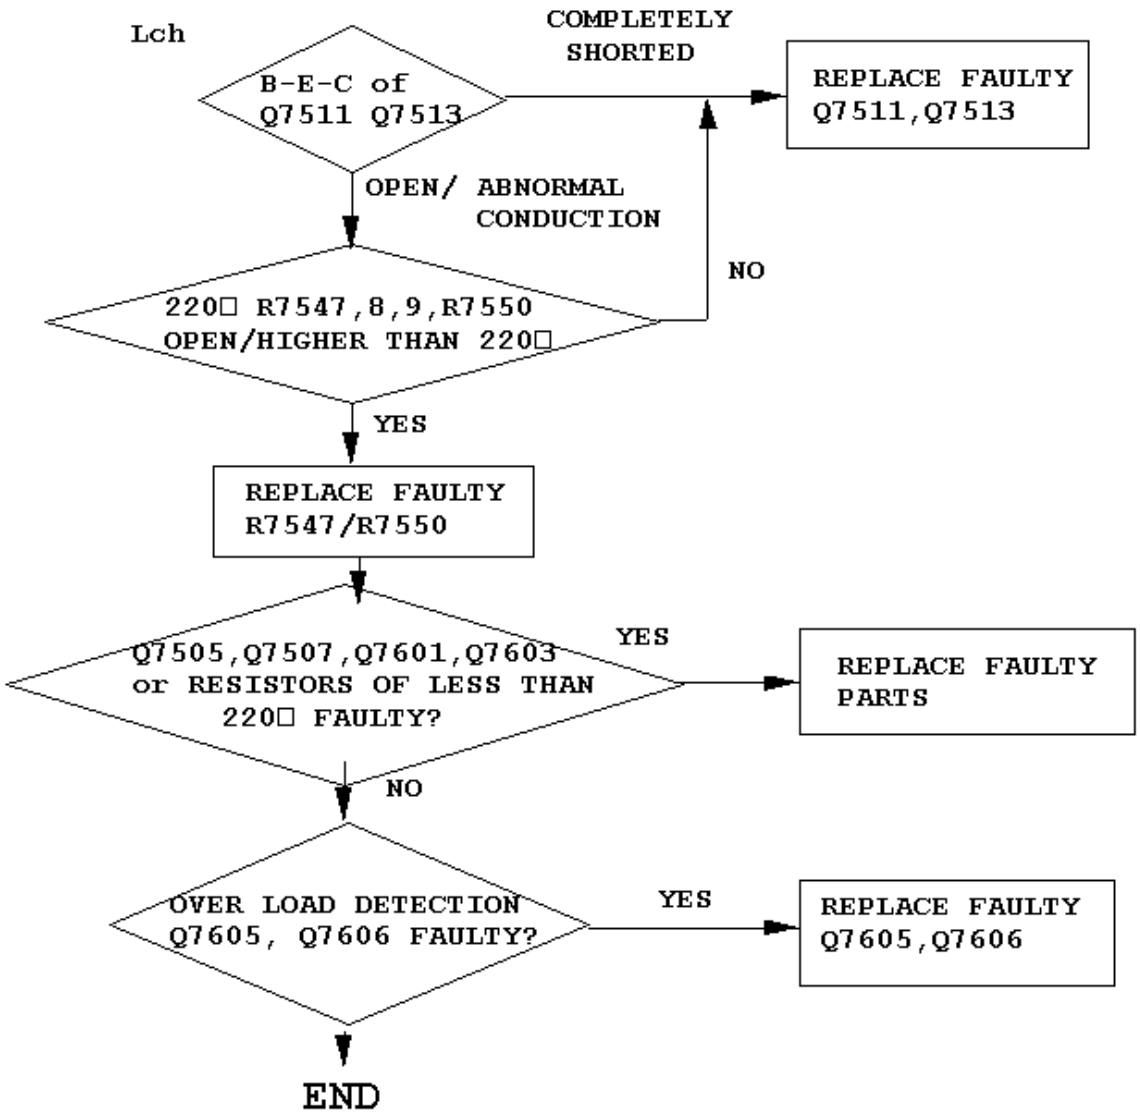
c. SYMPTOM :Fuse keeps blowing.
   CAUSE :Power transistors Q7511,Q7513,R7547,R7548,R7549,R7550
   220□ are faulty.
   REMEDY :As follows;

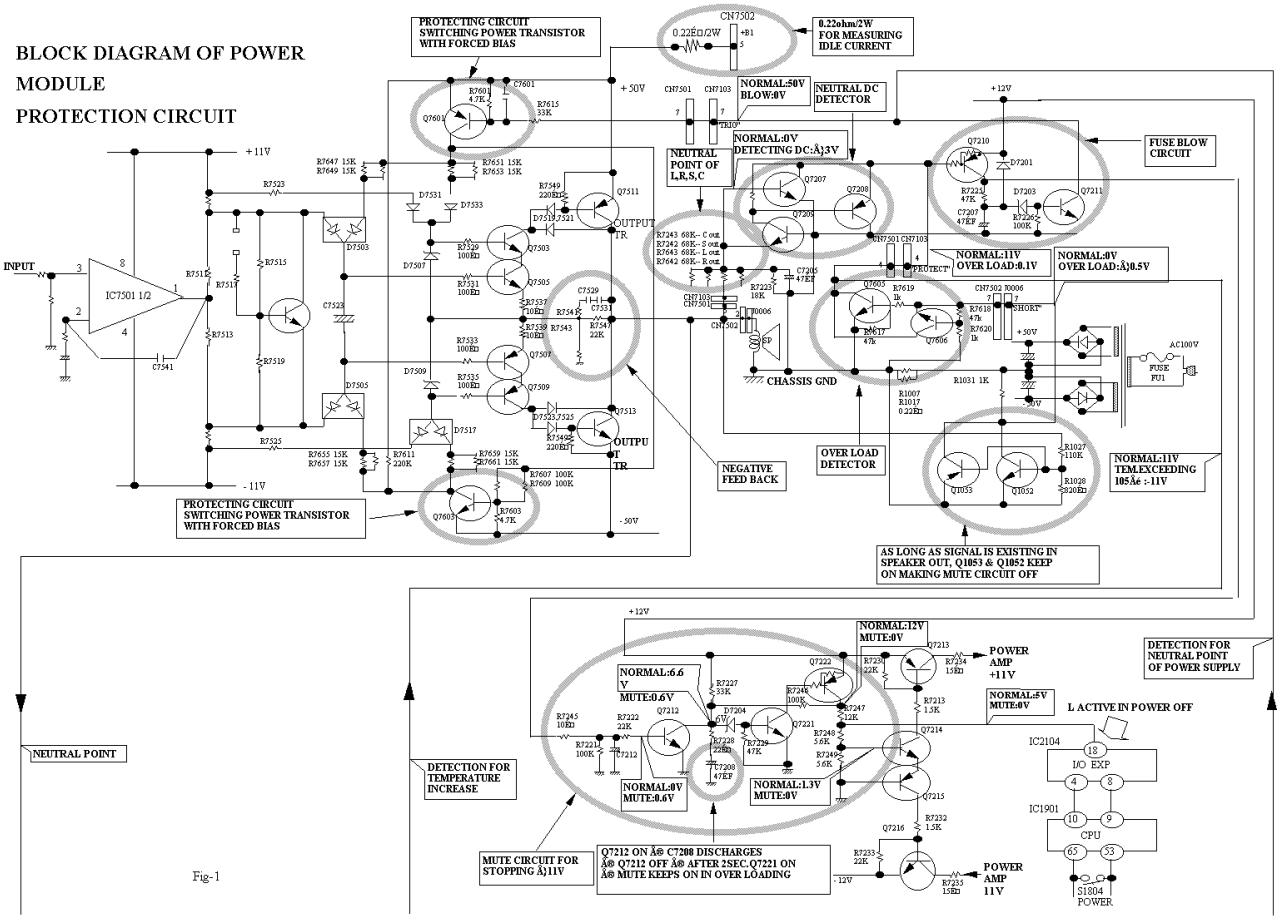
Fig-1

a.DC detector: A circuit operates when neutral voltage at speaker output exceeds DC ±3V.

b.Over load detector : Power supply ±11V for the amp IC7501 is ceased and the signal is muted when speaker terminals are shorted.

c.Thermal detector : A circuit operates when temperature on a heat sink exceeds 105 degree c.

d.Power supply : A fuse blow circuit operates when neutral point of the power supply voltage ±12V, ±25V, ±5.6V or ±12V line exceeds ±0.6V. A fuse is blown immediately without switching mute circuit on.

BLOCK DIAGRAM OF POWER MODULE
PROTECTION CIRCUIT

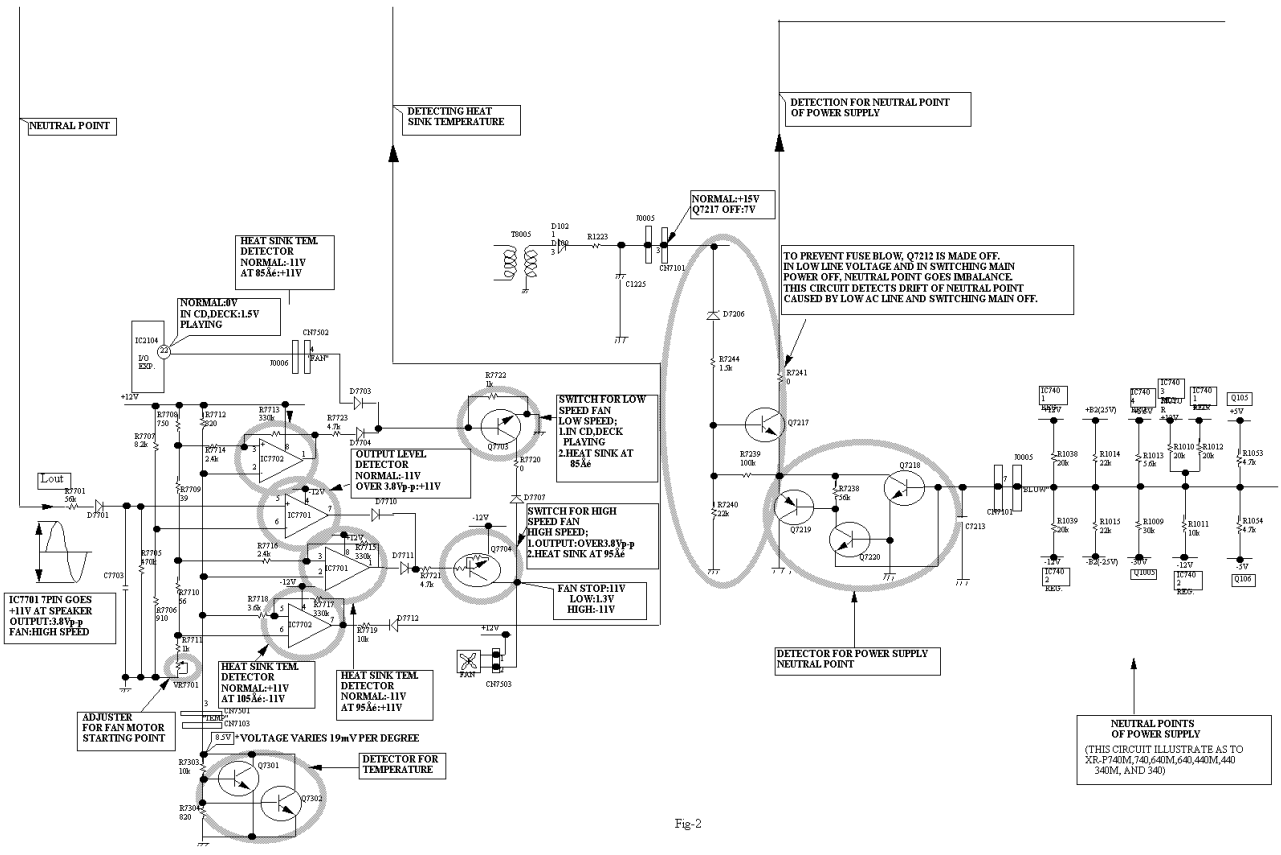
Fig-2

d. SYMPTOM :Fuse keeps blowing.
CAUSE :A primary fuse or a fuse and power transistors are blc
by a fuse-blow circuit.
High tolerance or resistance of the components used ir
power supply-detection circuit caused misoperation.
REMEDY :To minimise drift of potential at the neutal point, tl
type of resistors in power supply-detection are to be
changed from tolerance 5% to 1% and 0,5%.

THE ABOVE RESISTORS ARE LOCATED ON THE RIGHT SIDE OF THE CIRCUIT DIAGRAM FIG-2.

KEY NO		PARTS NO		NEW PARTS NO	TOLERANCE
R1014	FROM	RS1/10S223J	TO	RN1/10SE223D	0.5%
R1038		RS1/10S203J		RN1/10SE203D	"
R1010		RS1/10S203J		RN1/10SE203D	"
R1039		RS1/10S203J		RN1/10SE203D	"
R1011		RS1/10S103J		RN1/10SE103D	"
R1012		RS1/10S203J		RN1/10SE203D	"
R1009		RS1/10S303J		RN1/10SE303D	"
R1053		RS1/10S472J		RN1/10SE472D	"
R1054		RS1/10S472J		RN1/10SE472D	"
R1015		RD1/8PM223J		RN1/4PC2202F	1%
R1013		RD1/8PM562J		RN1/4PC5601F	"
