PIONEER
The Art of Entertainment

No.. SK49006
Date: JAN,25, 1995

SERVICE KNOWHOW

THE CIRCUIT OPERATION OF THE POWER AMP MODULE

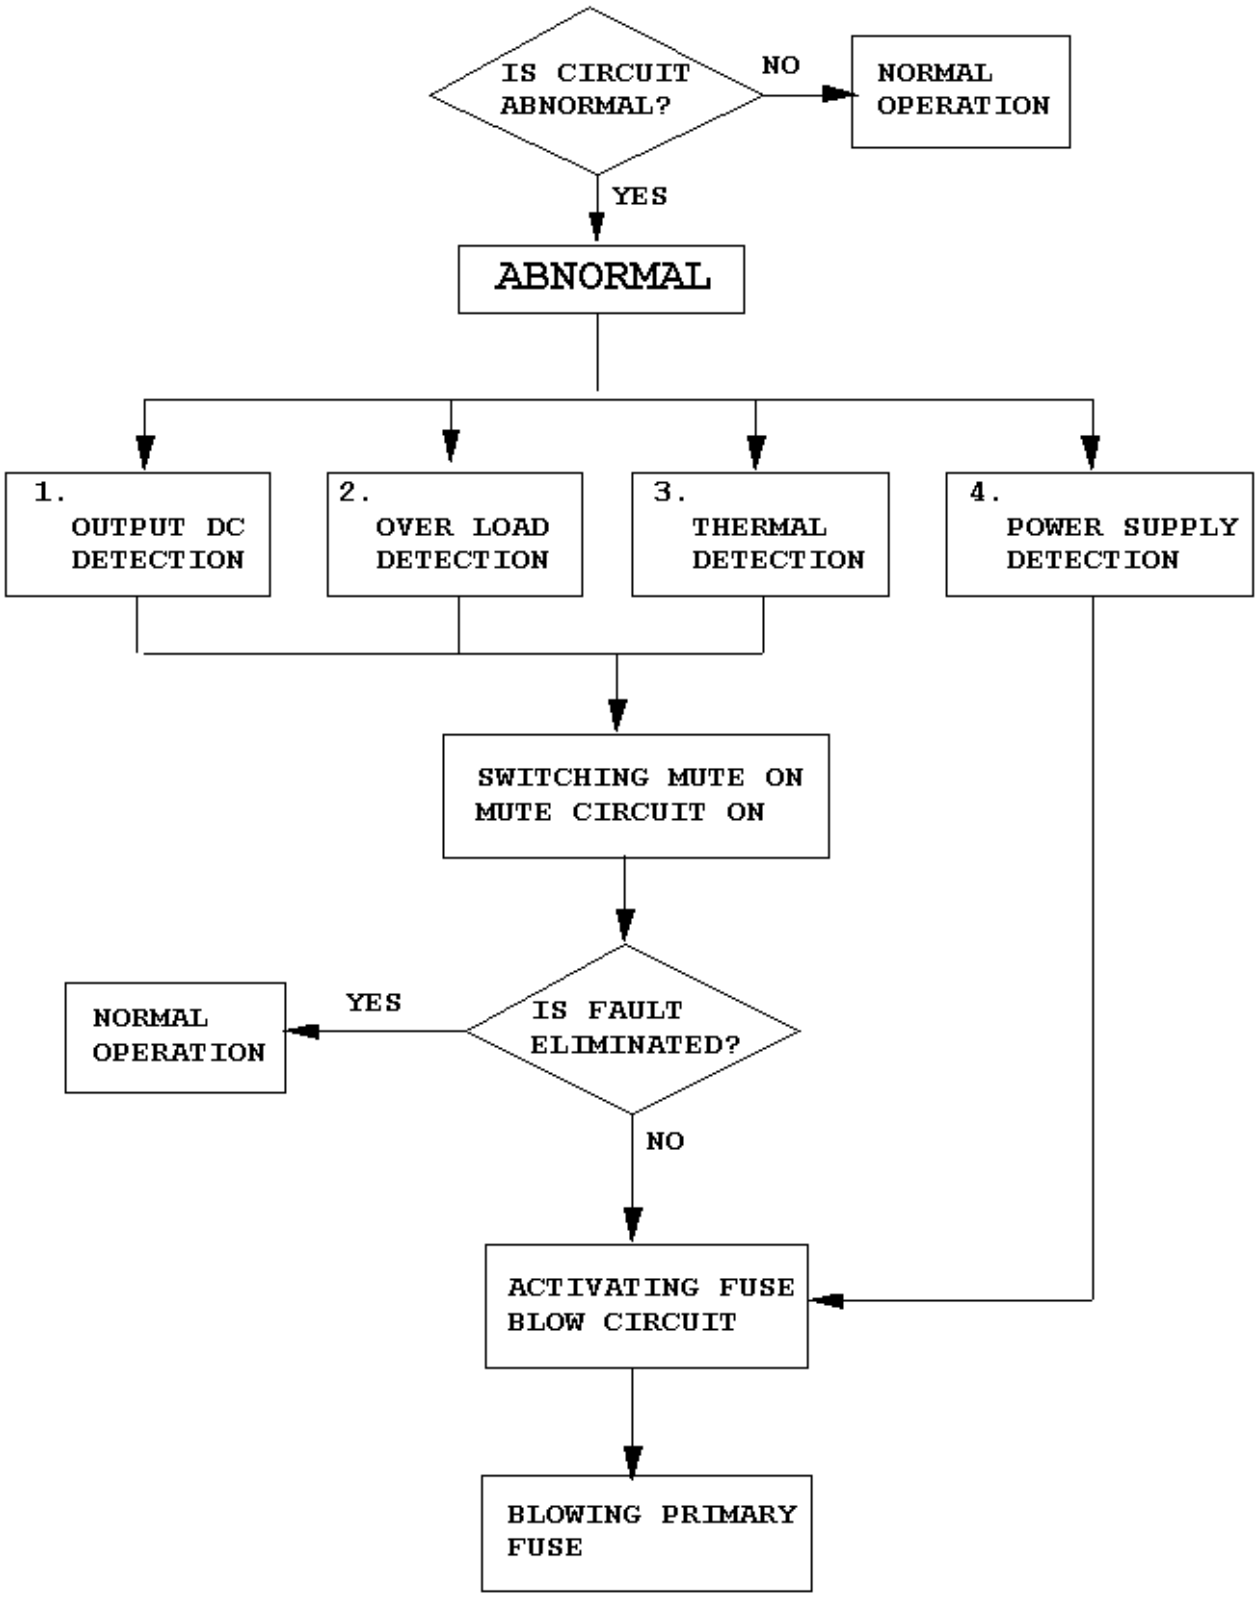
"BLOCK DIAGRAM OF THE PROTECTION CIRCUIT"

a.DC detector: A circuit operates when neutral voltage at speaker output exceeds DC ±3V.

b.Over load detector : Power supply ±11V for the amp IC7501 is ceased and the signal is muted when speaker terminals are shorted.

c.Thermal detector : A circuit operates when temperature on a heat sink exceeds 105 degree c.

d.Power supply : A fuse blow circuit operates when neutral point of the power supply voltage ±12V, ±25V, ±5.6V or ±12V line exceeds ±0.6V. A fuse is blown immediately without switching mute circuit on.

*In case of detecting DC voltage at speaker output, an over load current or excessive heat on a heat sink, the amp circuit is muted by stopping supply of ±11V for an amp IC7501 for two seconds.
If the detection signal is eliminated during muting on, the circuit resumes normal operation, but if the detection circuit keeps on, a fuse is immediately blown.

*In case of detecting abnormal power supply, a fuse is immediately blown.
