SERVICE TECHNICAL INFORMATION

ONE POINT REPAIR

UTSUNOMIYA, NOVEMBER 15, 1995
 REF. NO. : SI-95-036
 CUSTOMER RELATIONS & SERVICE DIV.

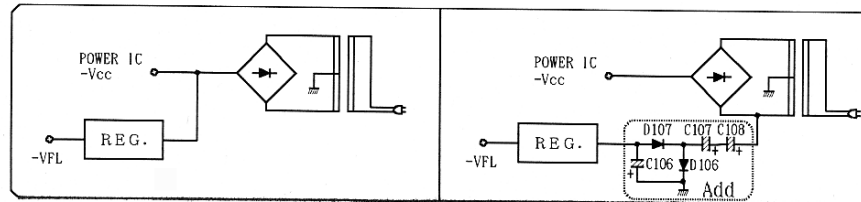
- MODEL : NSX-V30 / V31G / V33 / AP1MK2
 SUBJECT : Changing brightness of FL display
 SYMPTOM : The FL display flickers when T-BASS is ON and the volume is at or beyond the 10 o'clock position. If such a problem is indicated by the customer, perform the remedy described below.
 REMEDY : As shown in the diagram below, add 3 electrolytic condensers and 2 diodes to the MAIN C.B. and remove 1 jumper wire.

Before modification

After modification

Parts No.	Parts Name	Ref No.
87-010-408-010	Electrolytic condenser 47 μ F•50V	C107 / C108
87-017-978-080	Diode IN4003	D106 / D107
87-010-764-080	Electrolytic condenser 47 μ F•63V	C106
