LUX Audio of America Ltd.

SUBJECT: ADJUSTMENT FOR UNSTABLE SPEED ON PD-441/PD-444

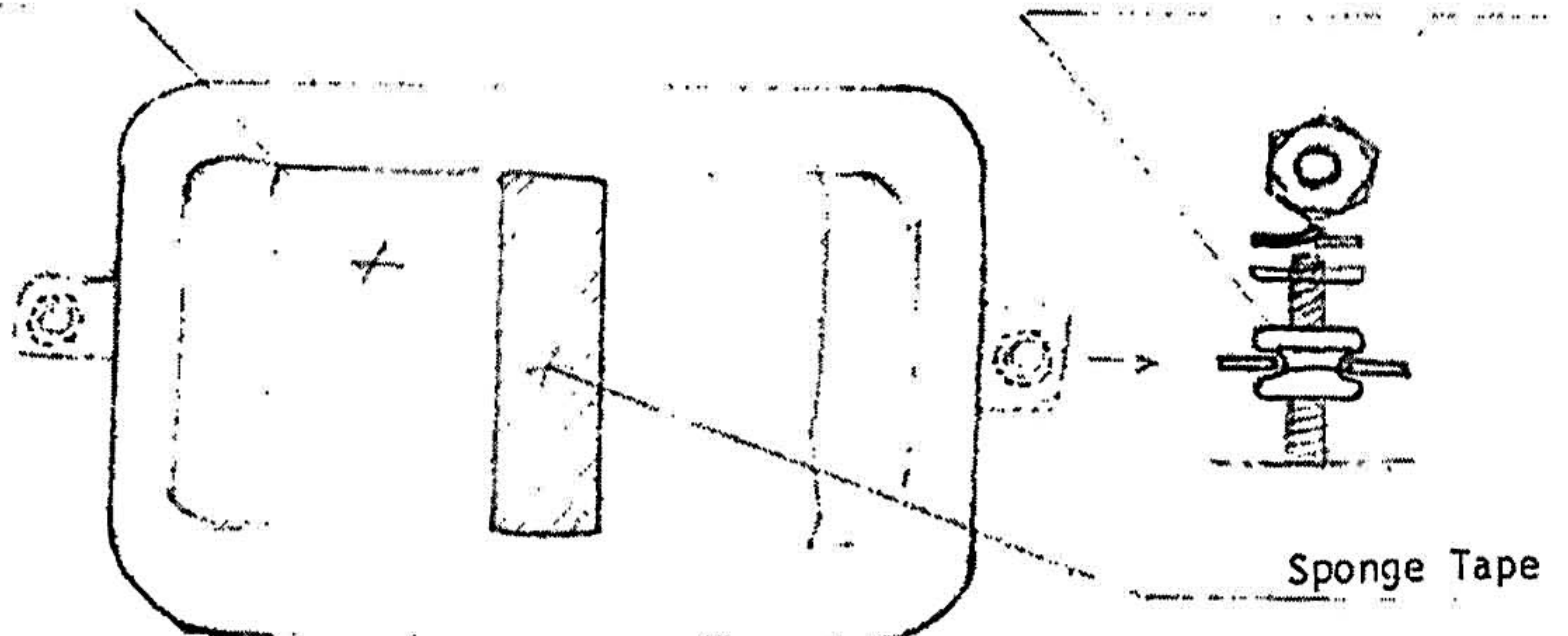
Transformer

Rubber Bushing

1. Remove the name plate from the motor cover located on the under-side of the unit.
2. Remove the motor cover (be careful not to damage the rubber bushing).
3. Adjust the D.C. voltage on both sides of R12 on the circular Printed Circuit Board to equal:
