Service Bulletin

No.: MZ08-051

Model: AV8003

Subject: Change of the XLR connector.

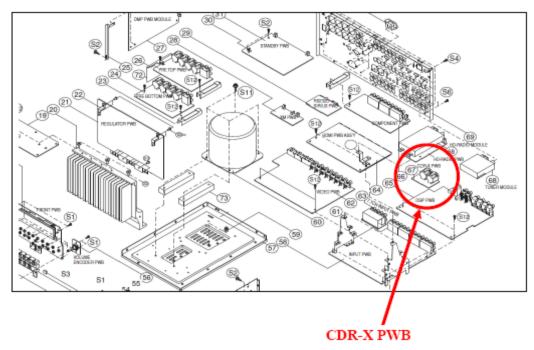
Symptom: Due to the XLR cable (male connector) varying in quality and also to wear, some XLR female jacks manufactured by Dongbo Industries Ltd. are not tight enough to lock when connectors are inserted.

Solution: The supplier of the POS NO. JK13/JK14 (CDR-X PWB) XLR female connector will be switched to Jyetai Precision Industrial Co., Ltd.
