Model: AV8003

Subject: Improvement of audio noise

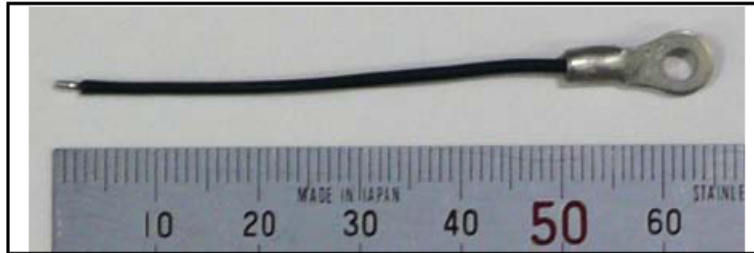
Symptom: The noise level of SBL, SBR, CENTER and SW channel increases when the DSP circuit is active (e.g. Dolby PLIIx, etc...).

Solution: Modify the POS.NO.58 INPUT PWB as follows:

1. Remove the J201, J202, J203 and J204.
2. Add the lead wire (part no.: 997614000110M) with a lug between J202 (outside solder pad of PWB) and chassis.
3. J201 is to be replaced with Ceramic Capacitor 0.1uF. (part no.: 00MDK96104300)
