# Nikko Audio

## SERVICE!! BULLETIN

### MODIFICATION FOR THE ALPHA II AMP. EFFECTIVE

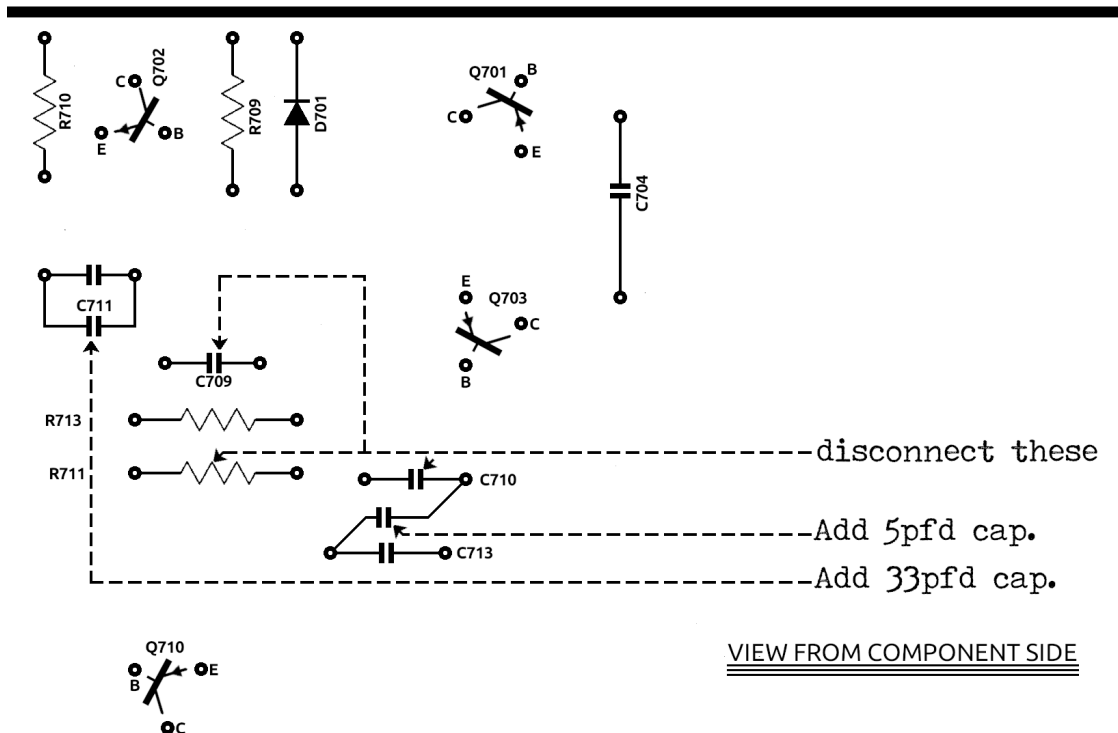
SCHEMATIC DIAGRAM

R711 56Ω  
C710 5pF disconnect these

1. Disconnect (cut) positions C710 and C709 from the circuit.
2. Add 5pfd cap. between test points A and B (see diagram),
3. If C711 is valued at 33 pfd, add one more 33pfd cap.  
in parallel with C711, (test points C and D.)  
another version (replacement of 56ohm res.) of diagram  
follows on the second page of this bulletin.
