Tips & Tricks

No. 20060906

Model: DTR4.6 / 5.6 /6.6/7.6 TX-SR573/TX-SR603X

Subject: XM ANT Jack

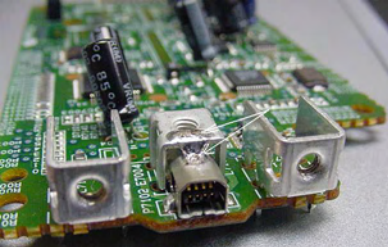
Symptom: XM ANT JACK broken lose from PCB board.

Solution: ADD TRM Terminal support hold Xm Satellite ANT Jack mounting on board. Solder jump wires for connection see next page two pictures.
