TEAC TECHNICAL INFORMATION

TASCAM DA-P1, No Operation with Battery Pack

8th September 1995

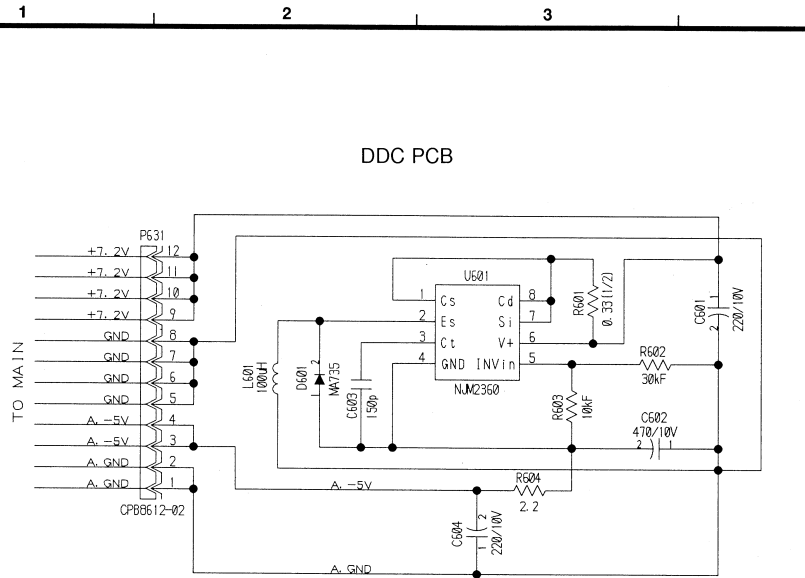
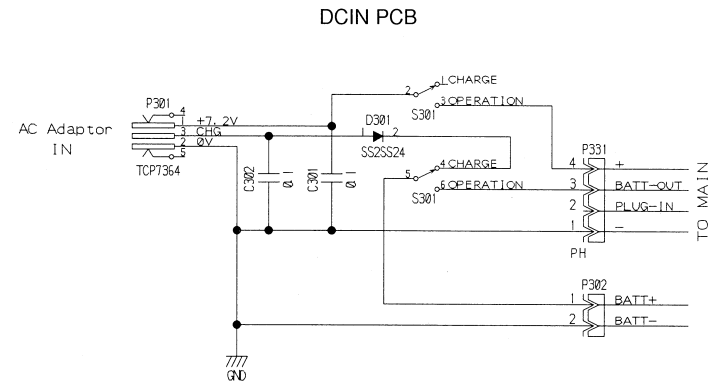
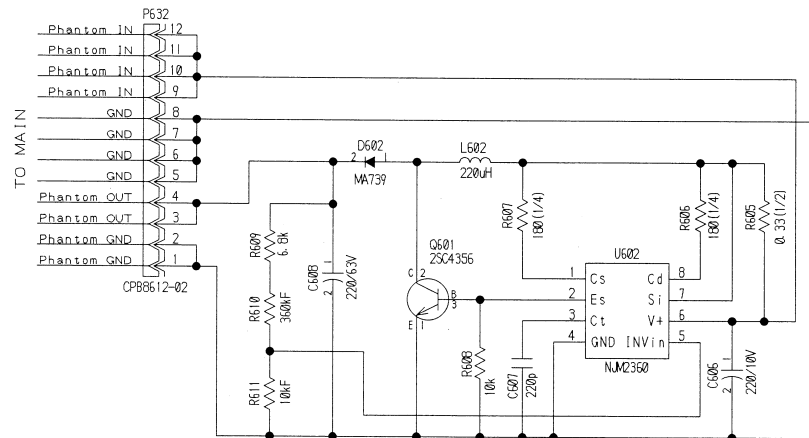
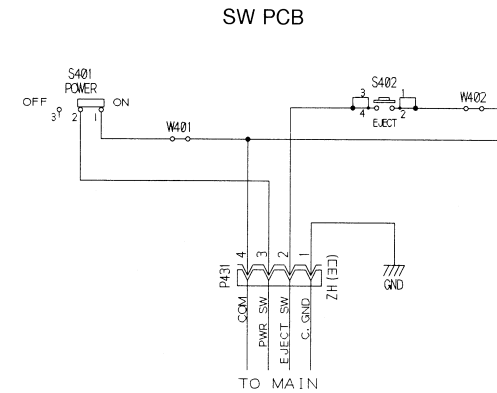
The U5, D/A Converter IC PCM1710U, requires two different voltage supply, Vdd for digital and Vcc2 for analogue. In case a difference of both voltage exceeds a certain amount while powering up, the U5 may go to latch up state. Use of full-charged battery results in the highest prime voltage supply. And it causes a chance that the U5 enters such state. This state allows to draw a huge current of +5V supply circuit. Finally, the foldback current limiting function of the U325, 3 Prong Regulator IC, works and system control is unable to start.

Remove a bottom cover and make a short circuit on R20, 10 Ω chip resistor.

Products serial numbered up to 49999 stocked in TEAC warehouse have been reworked on replacing R20 with chip jumper. They are identifiable with "C" mark stamped at the right side of serial number shown on carton. All products serial numbered 50001 and up have been modified at the production line and have no "C" mark.
