Troubleshooting Guide

Lifestyle® PS-18/28/38/48

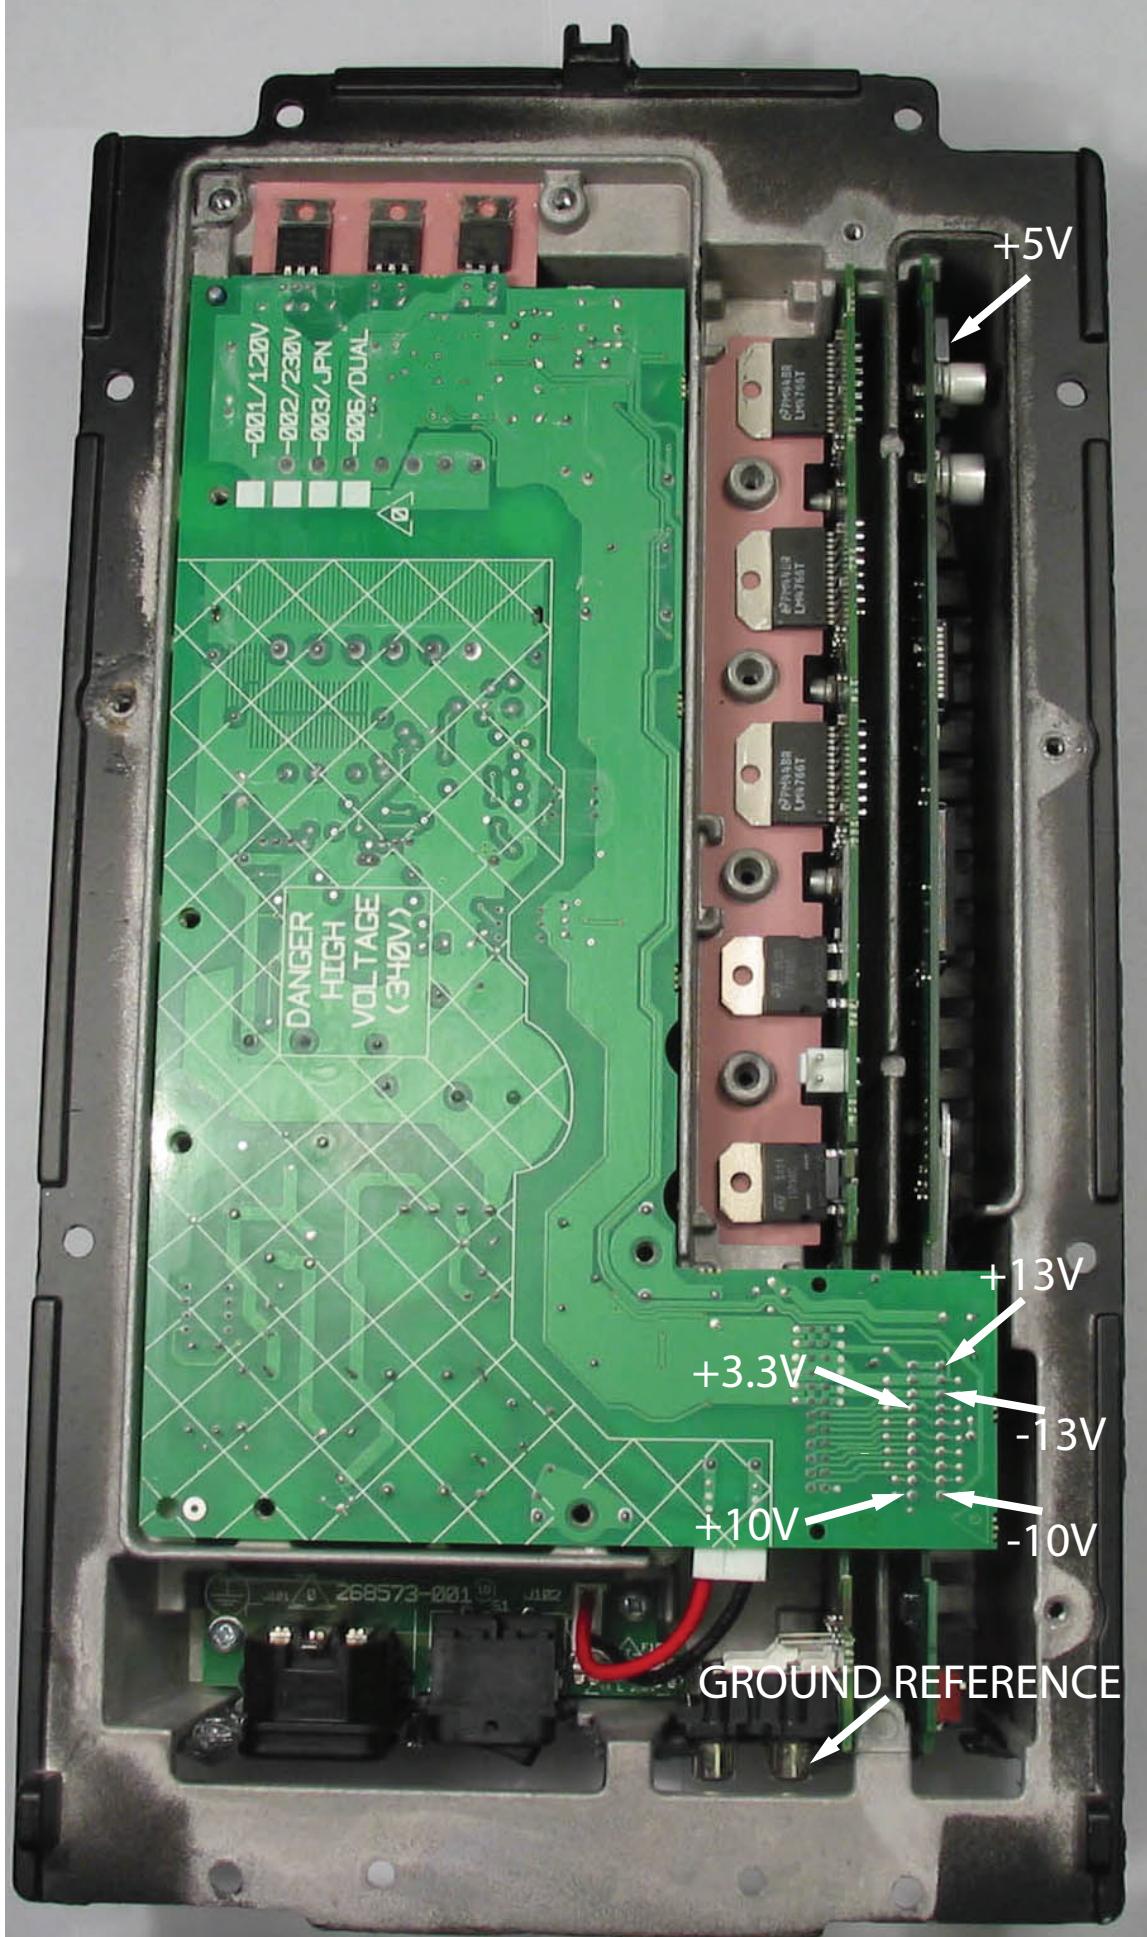
The above diagram can be used as an aid for measuring the power supply voltages with the unit assembled.

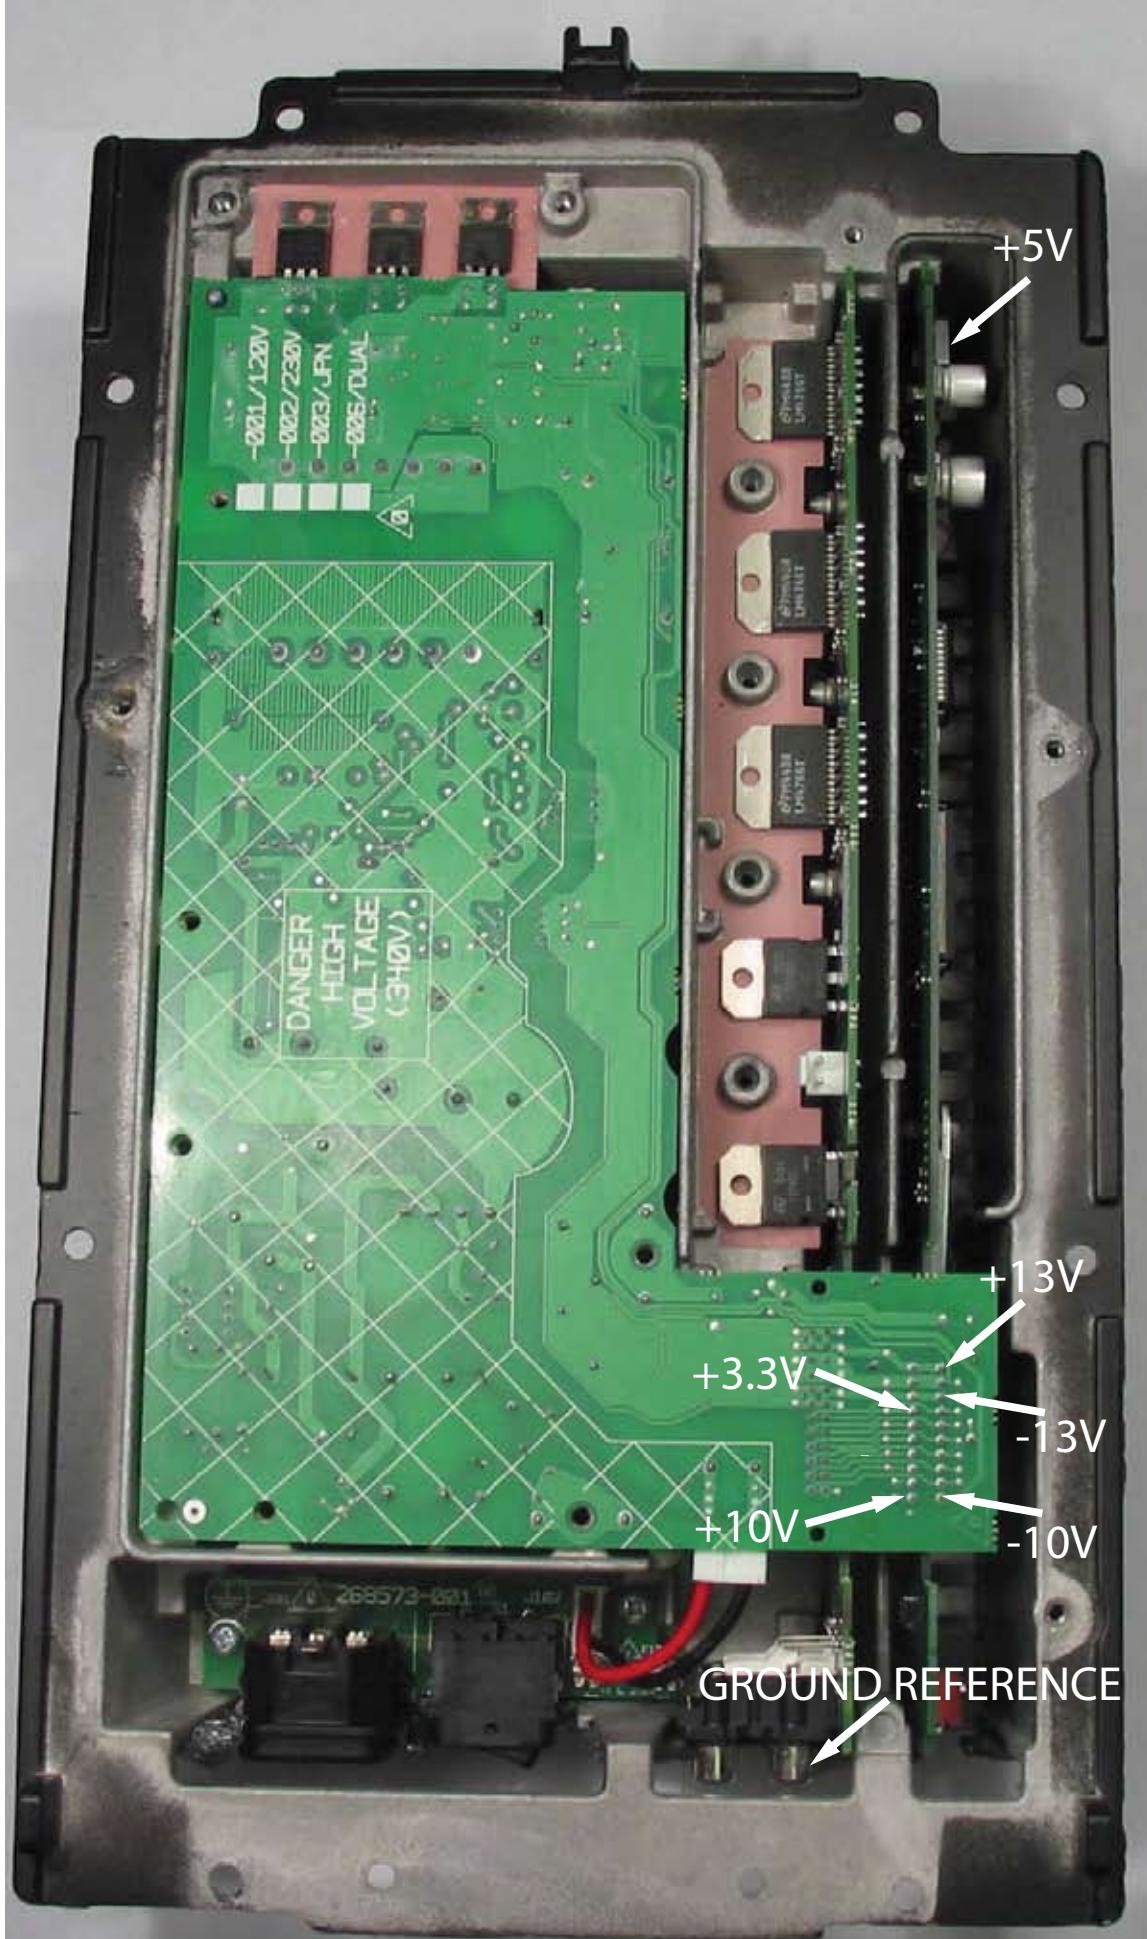
The above diagram can be used as an aid for measuring the power supply voltages with the unit assembled.
