A LOOK AT THE YAQIN MC-10 Series

Les Carpenter G4CNH – Nov 2021

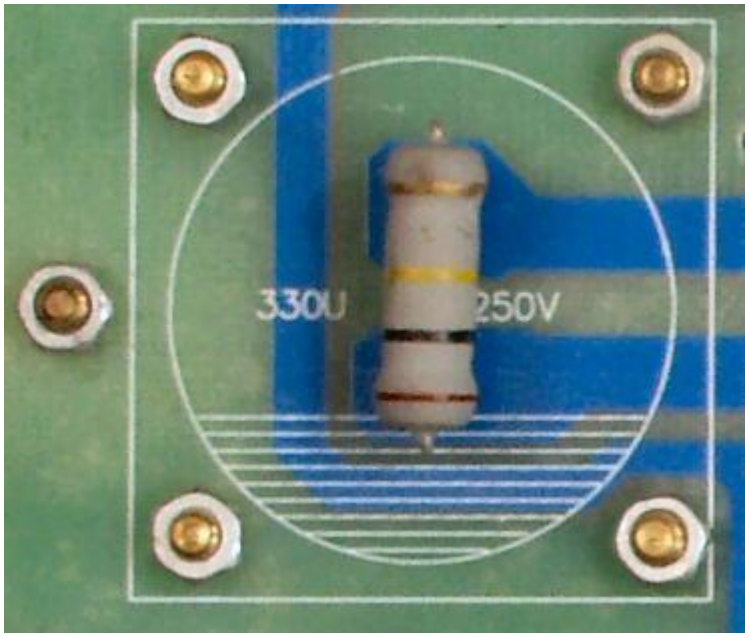
Position of the 100K resistor on later MC-10L amplifiers

Leakage currents within the capacitors C3 and C4 could cause the voltage sharing to go astray with the result that one of the capacitors may have more than 250V across it. This can be prevented by fitting voltage equalising resistors shown as RX1 and RX2. This is a modification that Yaqin now fit on their latest models as shown in the photo on the next page.

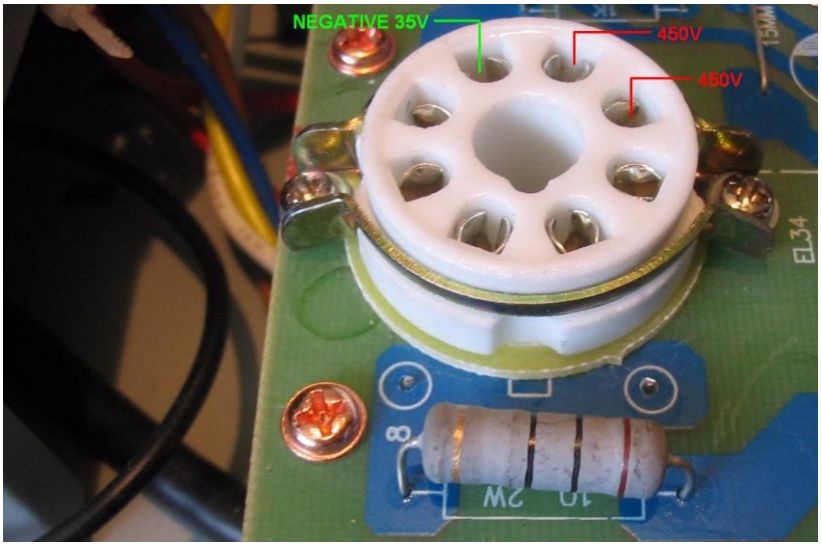
Yes, this does seem to occur a lot in valve amplifiers and not just the MC-10L. The main culprit in the MC-10L seems to be in the output stages and somehow, it occurs more in the left hand channel than the right. This is indeed quite puzzling as there is no apparent reason why the left hand channel should be more prone to such failures. It is possible that the failures may be due to 'tube rolling', a term given to trialling various types of output valve to achieve improvement in sound. As such it is very easy to fit a valve that may have an unknown defect and when it fails the MC-10L gets the blame. It could however be R6 - see page 27.

The above photo shows a poorly soldered connection between an EL34 base and the circuit board, cause was a very poorly tinned wire prior to soldering. There are a number of similar connections around each EL34 and are definitely worth a check, perhaps the loss of one of these could cause dramatic failure around this part of the amplifier.
Another possibility is the lack of screen resistors as previously mentioned. The worst case scenario here is failure of the actual grid structure causing it to short to the adjacent control grid. Because the screen grid is at a very high potential you definitely don't want it shorting to the control grid where its effect may also disturb the bias to the other valves. The increase in valve current produces a failure contest between the cathode resistor (the one you measure the bias at) and the output transformer. Some owners have shorted out the cathode resistor in order to get a little more from the amp! The improvement (if any) would be extremely small and takes away the safety feature of the cathode resistor, which is a metal film resistor and acts like a fuse, hopefully blowing open circuit and saving the expensive output transformer. If you used the special bias setting up box (described on Page 36), you do not need accurate cathode resistors and you could replace them with 150mA quick blow fuses. The Author has not tried fitting fuses here, it is just another of his 'food for thought' ideas.

Let's get back to the scenario then where one channel has smoked and the cathode resistor has burnt out.

The first thing to do is remove both EL34's for that channel and treat them as suspect, totally guilty until otherwise proven innocent!

By all means keep the EL34's in the working channel as this will help keep the HT from rising too high due to light loading. Now on the faulty channel, check both empty valve holders and confirm that the following voltages can be obtained. **DO TAKE CARE AS THERE IS AT LEAST 450v ON SOME CONNECTIONS!**

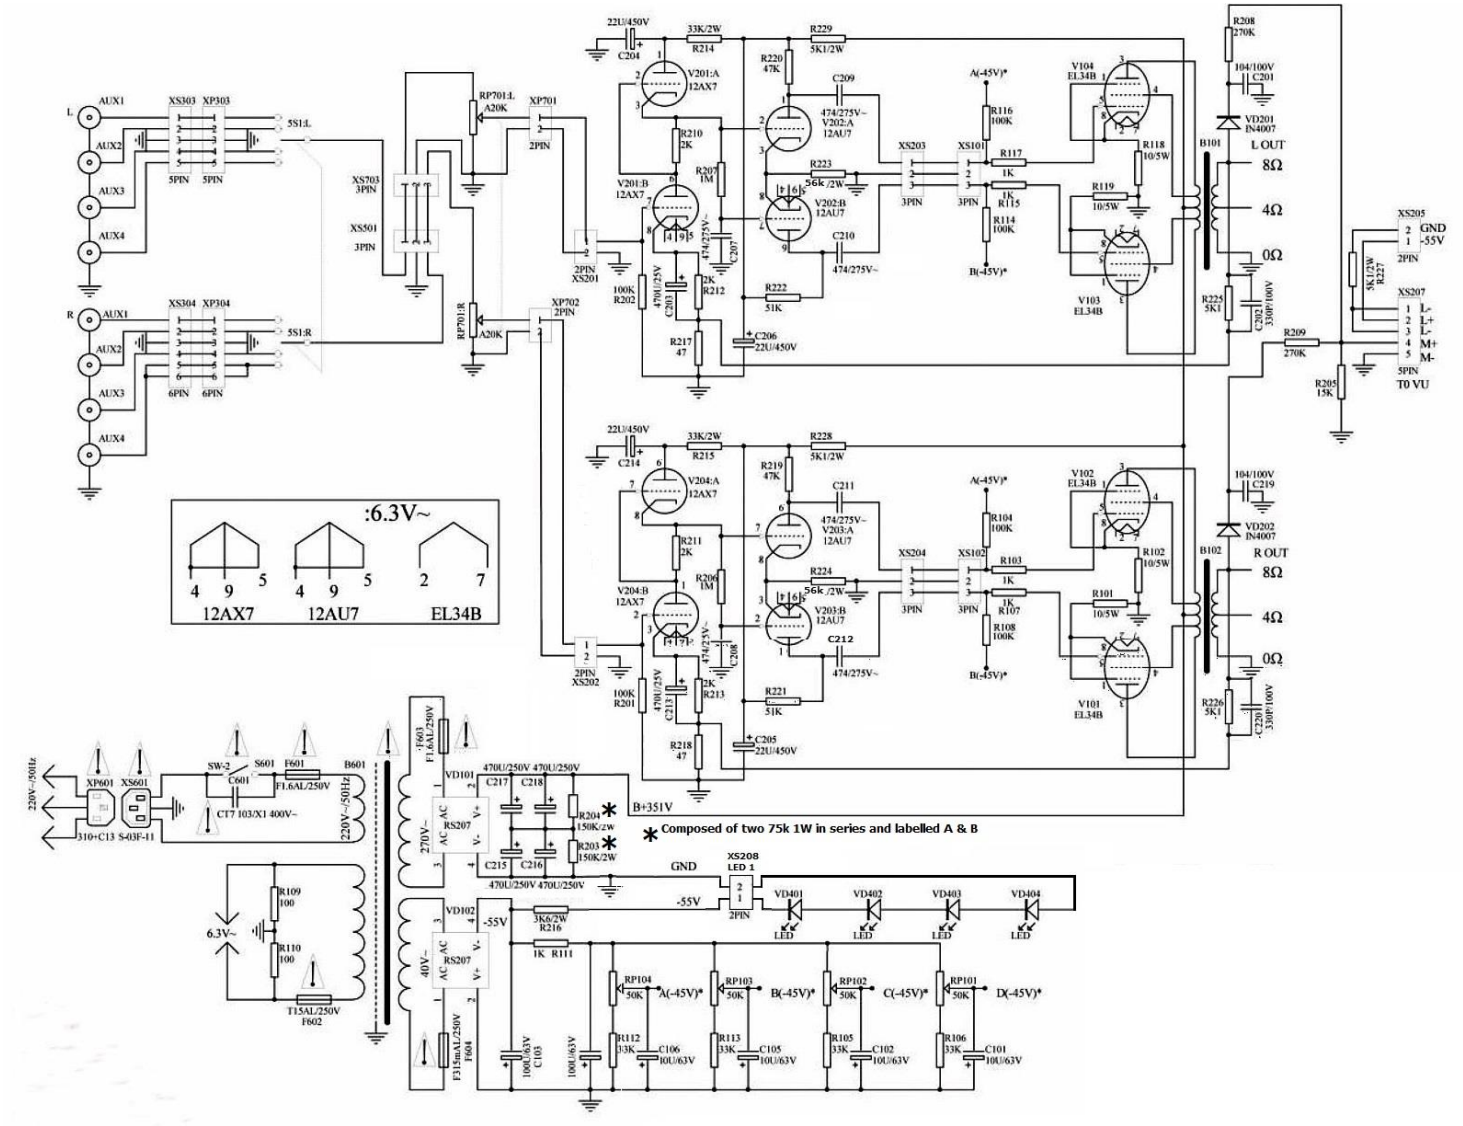
This came in for repair because the fuse for the Right channel kept blowing and due to its intermittency, the owner could not narrow the fault down. All the valves were tested but the valve tester hinted at slight leakage on output valve V3.

The rear 500mA fuse for the Right Channel was found blown. After replacing the amp was slowly brought up on a Variac and all seemed OK. The output valves settled down at just over 30mA but I noticed the valve currents acting strange when the input signal was quickly applied or shut down. The Author had this before on a MS10-T and had to fit high voltage Zener diodes on the front end to get it all to work as it should. The cathodes of the phase splitters are around 190V and should be around 120V.
This is discussed earlier in this document on Pages 35 - 36 and there is a video link, repeated here for convenience.

In the meantime the very elusive 6CA7 that was Red plating and blowing the HT fuse was found.
It was V3, the very same valve that showed some leakage on the valve tester at the very start of this investigation.
