A LOOK AT THE YAQIN MC-10 Series

Les Carpenter G4CNH – Nov 2021

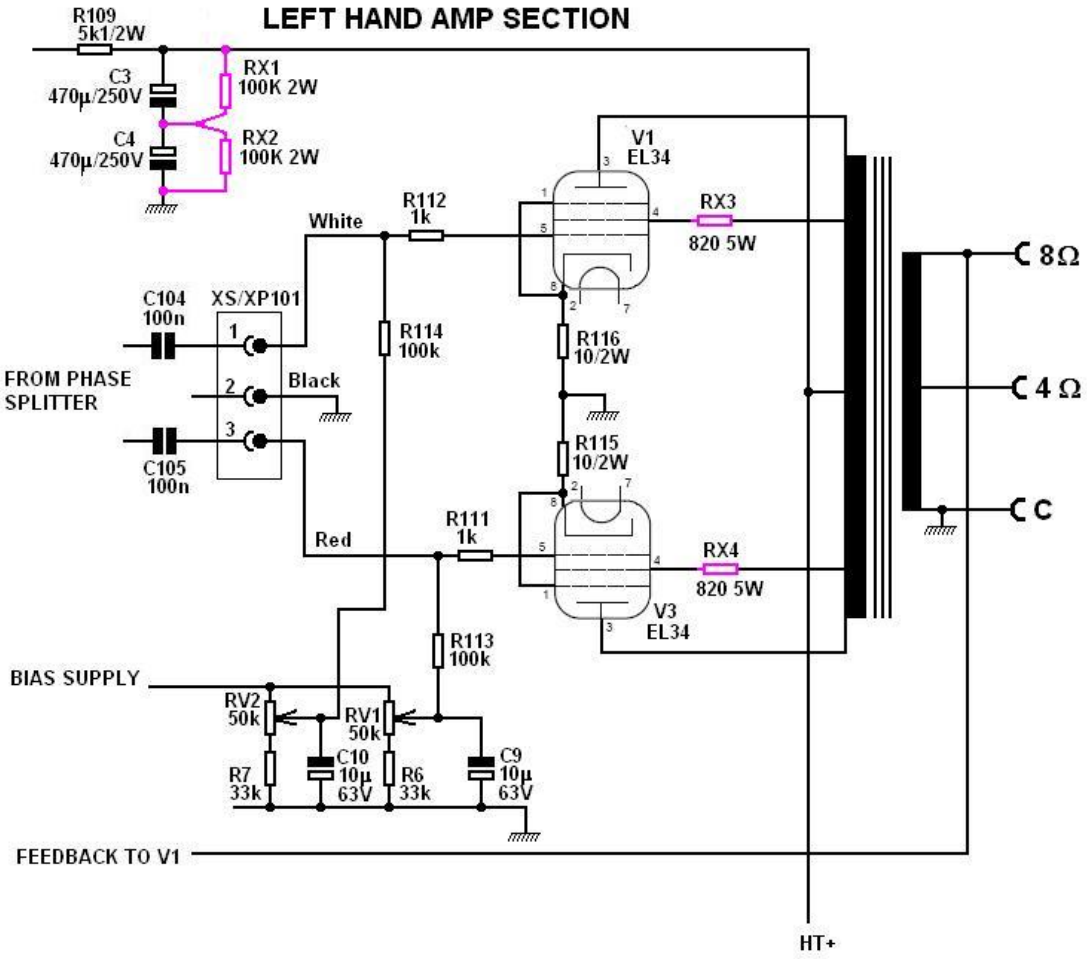
Voltage Equalisation Resistors

Leakage currents within the capacitors C3 and C4 could cause the voltage sharing to go astray with the result that one of the capacitors may have more than 250V across it. This can be prevented by fitting voltage equalising resistors shown as RX1 and RX2. This is a modification that Yaqin now fit on their latest models as shown in the photo on the next page.

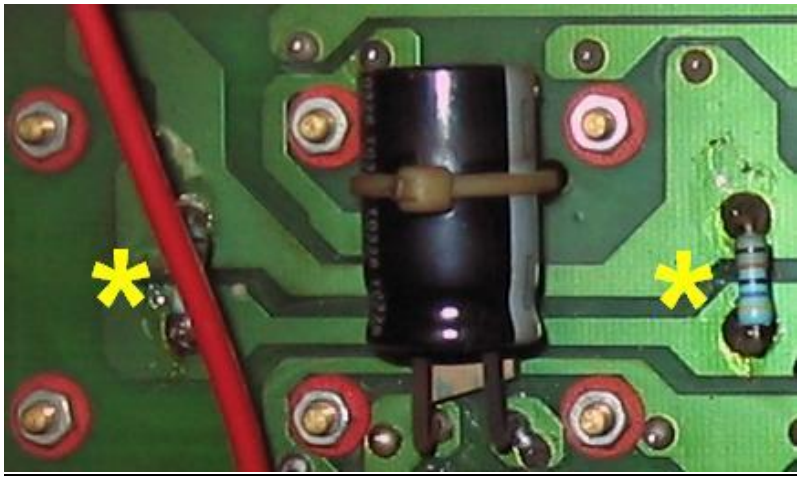
Position of the 100K resistor on later MC-10L amplifiers

On older models, these resistors have to be mounted beneath the pre-amp board.

The left most resistor is partly hidden by the Red wire. By using a higher value of resistance the Author was able to use 1 Watt resistors that were to hand at the time. He would probably use the 100k 2 Watt resistors if he was fitting them now because there is an additional advantage.

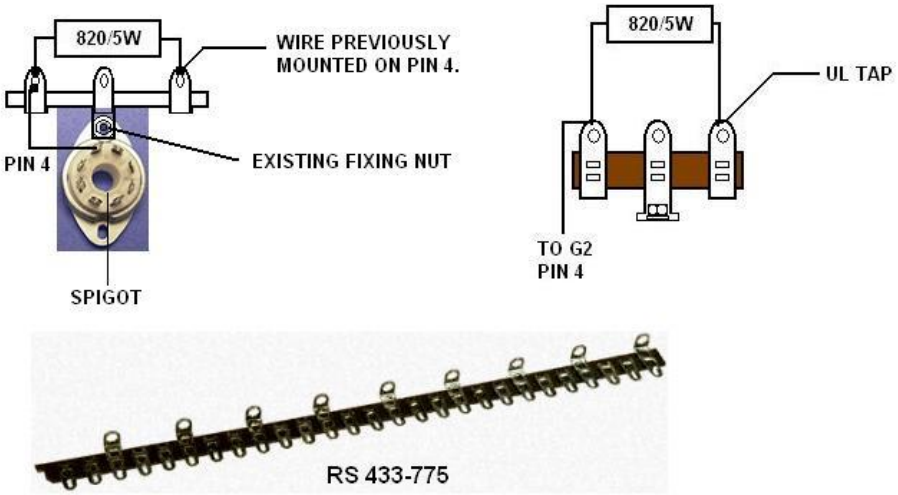
In the diagram on Page 10, RX3 and RX4 as far as the Author can tell, are not fitted to latest models and was a modification he decided to do after reading about failures in EL34 valves due to excess screen currents. The articles concerned recommended the fitting of limiting resistors but he had also read that they assist in the stability of amplifiers and help reduce the chance of parasitic oscillations. Later he found some documentation on the internet that was produced by Philips (Mullard) that recommends the fitting of 470 Ohm to 1k Ohm resistors in series with the screens of EL34's. One particular high end amplifier that came his way had a very similar output stage to the MC-10L, using ultra linear screen taps on the output transformers, but including a 750 Ohm screen resistor on each EL34. He modified his MC-10L using the more easily obtainable 820 Ohm resistors.
They are not so easy to install on the MC-10L so he mounted his on four small tag strips.

You can buy the tag strip in one length and just cut it to suit. He used the outer most screws of each valve holder as they were easier to get to and also meant the least disturbance to wiring. Hopefully these rather crude sketches will give you some idea of fitting.

Having mounted a tag strip at each valve position, simply remove the wire from pin 4 of each EL34 and connect it to one end of the resistor.
In one of the above sketches it is marked as UL TAP.
Then using a short piece of insulated wire, connect the other side of the resistor to Pin 4, i.e. the pin you removed the original wire from.

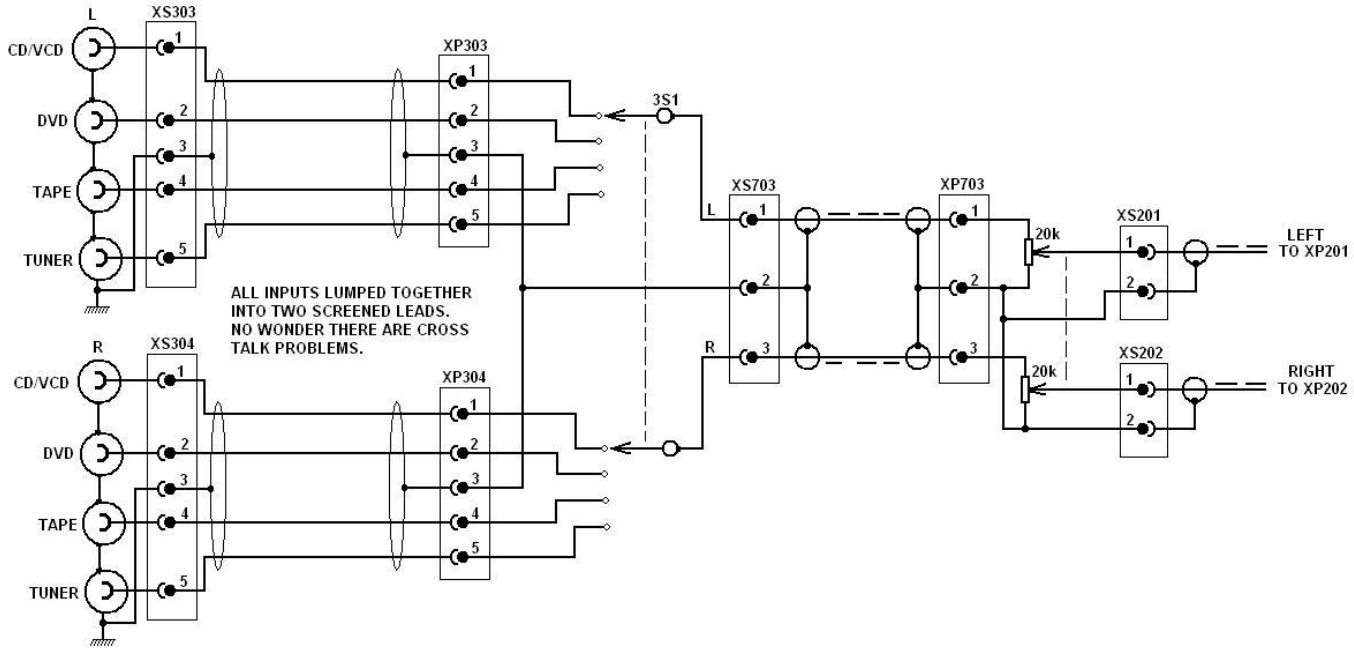
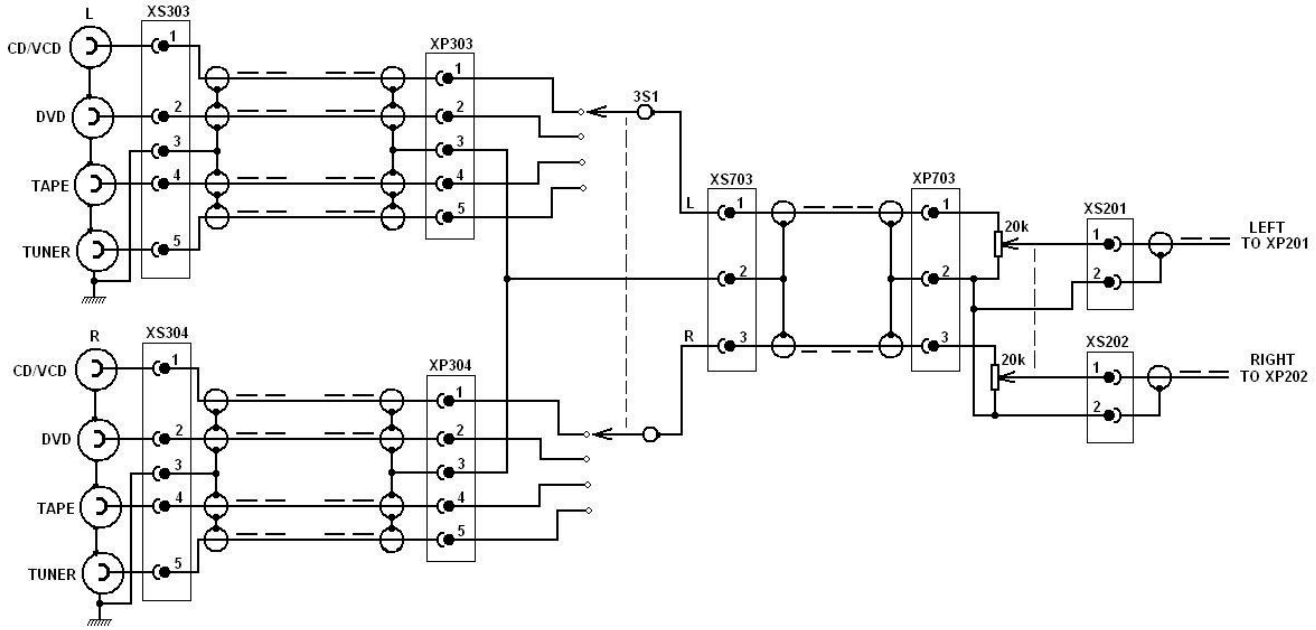
Cross Talk

Another weakness in design no doubt brought about by cost saving especially in the wiring stages of construction. All four inputs of each channel are combined into one screened cable instead of being separate. This is bound to cause cross talk on such a high impedance circuit.

If you suffer from cross talk (and you probably do) then this may provide at the very least a reduction to acceptable levels.

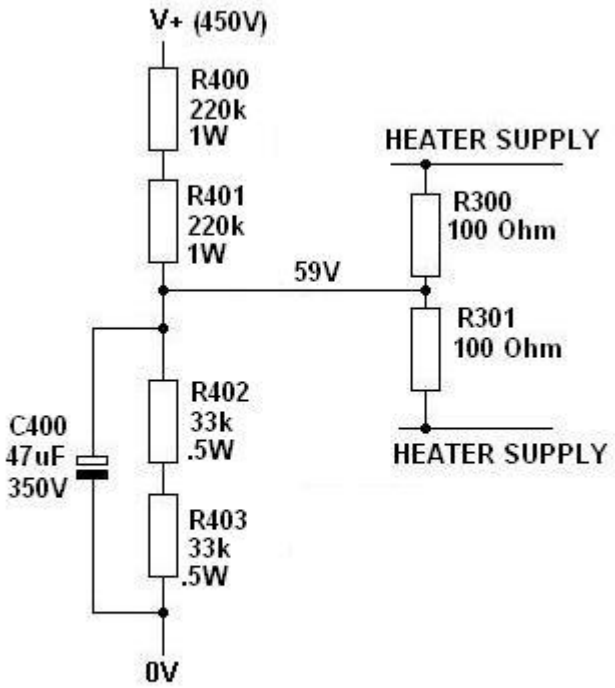
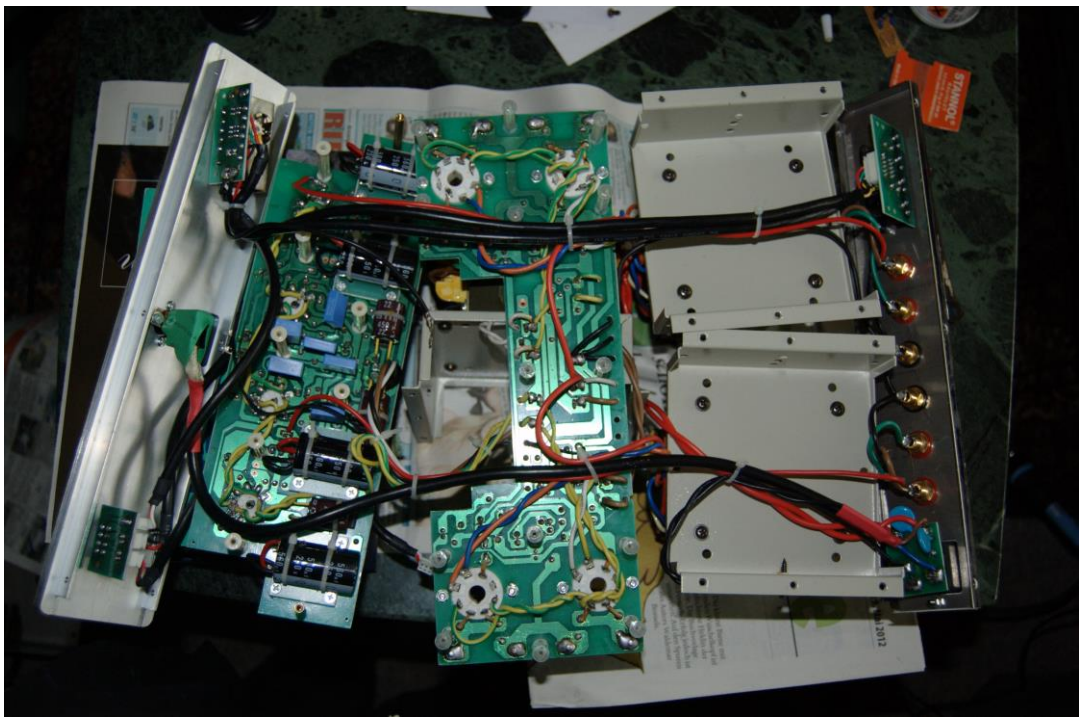
The Circuit

Not too many problems seem to have beset the pre-amplifiers and phase splitters apart from defective 6N1's producing nasty crackling on the output or mains hum due to defective cathode/heater insulation. The cathode/heater insulation is really pushed hard in the MC-10L and looking at the specifications of the 6N1 makes one feel that the design is really asking a lot of these valves. It has been suggested that a potential divider should be constructed from the HT line such as to float the heater supply at a fixed voltage,

say 60V. You would have to lift the fixed resistors presently fitted on the heater lines from earth (these are shown as 100 Ohm resistors R300 and R301 on the page 9 schematic) prior to doing the modification. The 60V float would effectively do the job of hum reduction and reduce the potential difference between cathode and heater of the 6N1's. The Author has only tried this modification once himself as it does require quite a bit of work and besides, he has not had any 6N1 failures in the years he has owned his MC-10L.
However, **Matthias Günther** has sent me some information on how he implemented this modification.
Many Thanks Matthias.

Power dissipation in R400+R401 = 0.35W
Power dissipation in R402+R403 = 0.05W

It does require complete removal of the base panel in order to access the power supply section of the rear board.

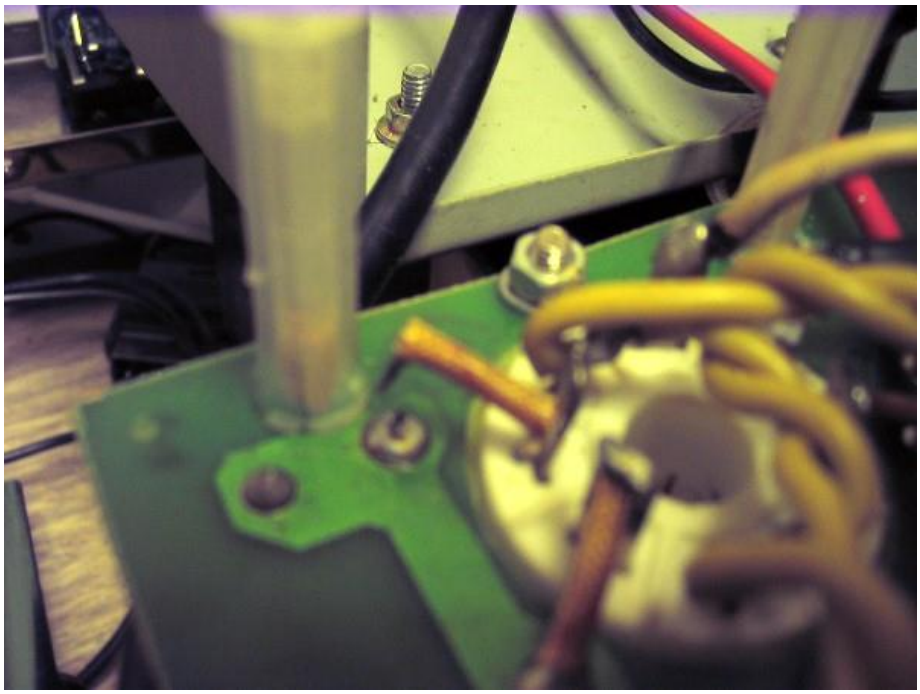
Yes, this does seem to occur a lot in valve amplifiers and not just the MC-10L. The main culprit in the MC-10L seems to be in the output stages and somehow, it occurs more in the left hand channel than the right. This is indeed quite puzzling as there is no apparent reason why the left hand channel should be more prone to such failures. It is possible that the failures may be due to 'tube rolling', a term given to trialling various types of output valve to achieve improvement in sound. As such it is very easy to fit a valve that may have an unknown defect and when it fails the MC-10L gets the blame. It could however be R6 - see page 27.

The above photo shows a poorly soldered connection between an EL34 base and the circuit board, cause was a very poorly tinned wire prior to soldering. There are a number of similar connections around each EL34 and are definitely worth a check, perhaps the loss of one of these could cause dramatic failure around this part of the amplifier.
Another possibility is the lack of screen resistors as previously mentioned. The worst case scenario here is failure of the actual grid structure causing it to short to the adjacent control grid. Because the screen grid is at a very high potential you definitely don't want it shorting to the control grid where its effect may also disturb the bias to the other valves. The increase in valve current produces a failure contest between the cathode resistor (the one you measure the bias at) and the output transformer. Some owners have shorted out the cathode resistor in order to get a little more from the amp! The improvement (if any) would be extremely small and takes away the safety feature of the cathode resistor, which is a metal film resistor and acts like a fuse, hopefully blowing open circuit and saving the expensive output transformer. If you used the special bias setting up box (described on Page 36), you do not need accurate cathode resistors and you could replace them with 150mA quick blow fuses. The Author has not tried fitting fuses here, it is just another of his 'food for thought' ideas.

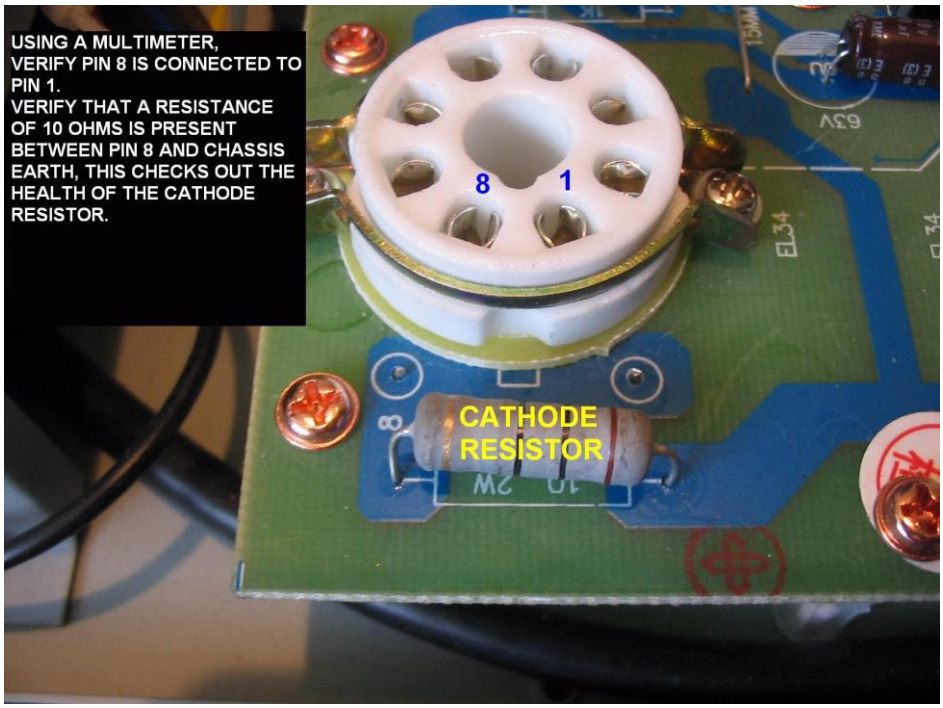
Finally, with all power removed from the amplifier, check out the remaining pins of both valve holders which are pins 1 and 8, located either side of the spigot as shown in the photo. They should be connected together and then go to chassis earth via the cathode resistor. This should measure 10 Ohms though you may find it open circuit if there has been a large surge current through it.
Only by taking off the top cover will you be able to see if it has become a charred relic.

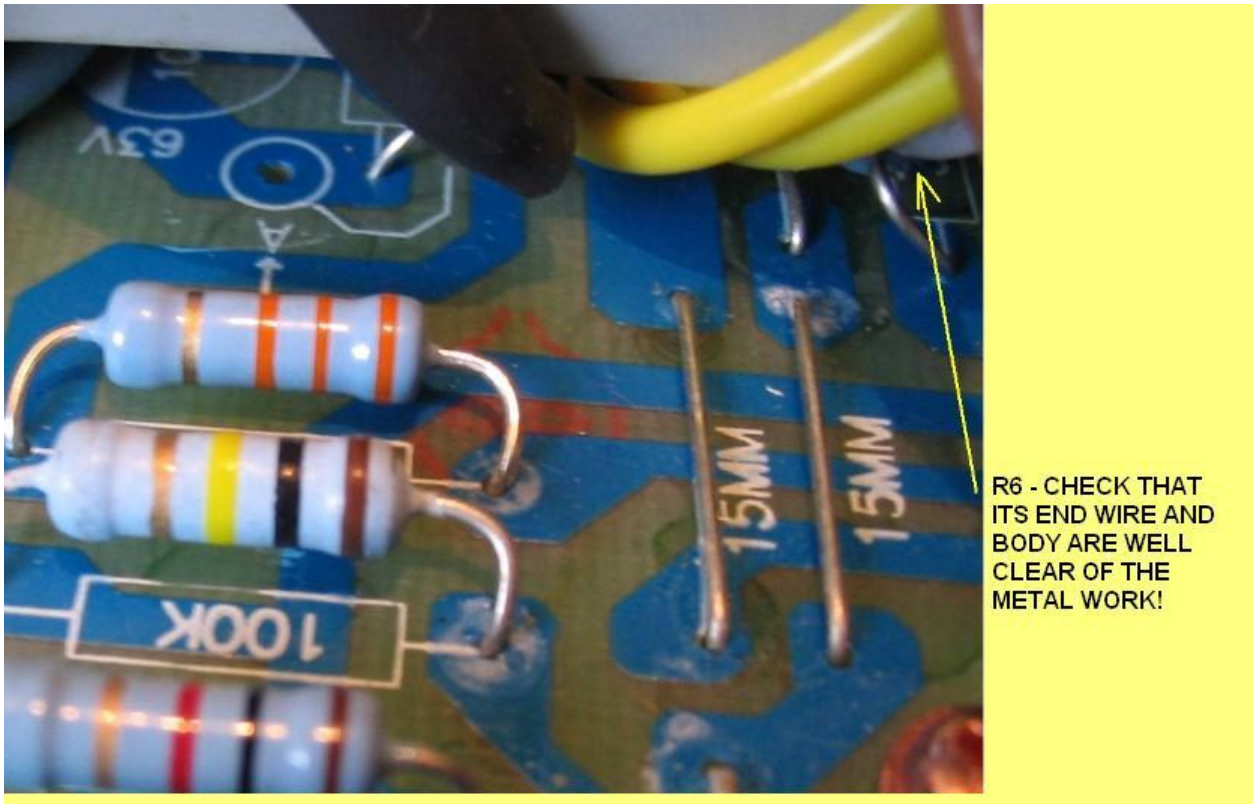
R6 (And it being a suspect for LH Channel failure).

Yes, R6 is part of the bias circuitry and that associated with V3, the lower EL34 on the left hand channel. This resistor is not mounted in the visible area of the circuit board but rather mounted beneath the power transformer. You can just see one end of it in the following photo.

If R6 (33k) was shorted to chassis the grid bias voltage could be dropped from say -35V to -23V. Looking at the EL34 graphs, the EL34 anode current could rise from 35mA to over 200mA and places the anode dissipation very much over the dissipation curve. It only takes a few moments to check and could save you a lot of bother later on.

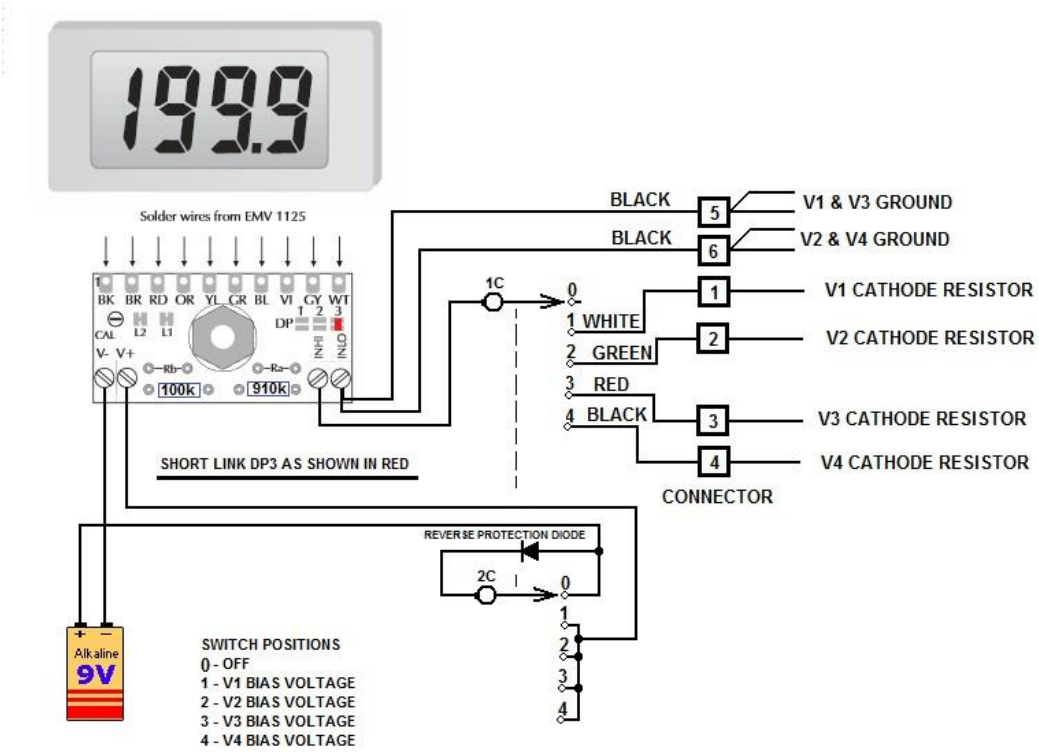
NOTICE ON THIS EARLY 10L BOARD THAT THERE ARE TWO SETS OF HOLES (RINGED) CLOSE TO R102 AND R202.
THESE WILL ACCEPT THE EXTRA CAPACITORS REQUIRED FOR THE LATER MC13.

YAQIN MUST HAVE PLANNED FOR THIS WHEN THEY BUILT THE MC10L.

After doing this work, each channel will look like this schematic wise. All you have to do now is fit a 12AX7 at V1, 12AX7 at V4, 12AU7 at V2 and a 12AU7 at V3.

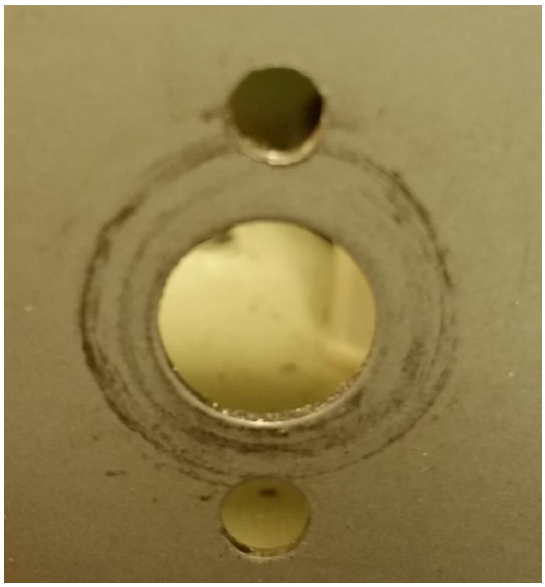
Keyway hole is drilled on the opposite side

When refitting the assembly it was found that the cable feeding Right output to V4 was very tight.
The answer is to remove the front panel (four Allen bolts) using a 3mm key.
A 4mm keyway hole is drilled on the opposite side to the present one so that the whole assembly can be mounted 180 degrees from the original position.
This removes the need for the cable to lose length by having to go around the board.

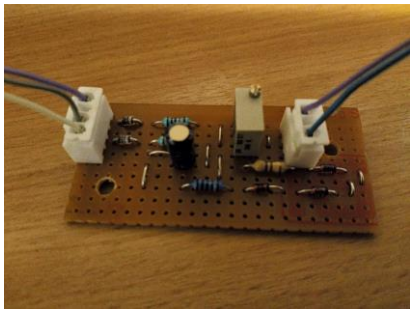
At low volumes the diodes D3 to D5 will be non-conducting and thus all of the available output voltage would be present to drive the meter via the adjustment RV1. As the volume of the amp increased then D3 will start to conduct and introduce a 470 Ohm load at the summing point of R1 and R2. As the volume increased more, then diodes D4 and D5 will conduct and introduce a further 100 Ohm load at the summing point. So the diodes will allow maximum sensitivity at low volume but in effect apply a brake as the volume increases.
The one annoying thing is that the VU meter has no information as to its full scale voltage or current sensitivity. Looking on eBay, one possible match has a full scale deflection of 200 uA and internal resistor of 630 Ohms but the actual parameters are required to be confident of a proper working circuit.
A 100uA 1750 Ohm meter was trialled, shunted with a 2k2/8k2 in parallel which made it a 200uA meter at 830 Ohms. This requires 175mV for full scale deflection and was put to use as a temporary substitute.

This was connected to the Output wires whilst the Input wires were wired together and connected to a Sine Wave Generator set to 1 kHz.

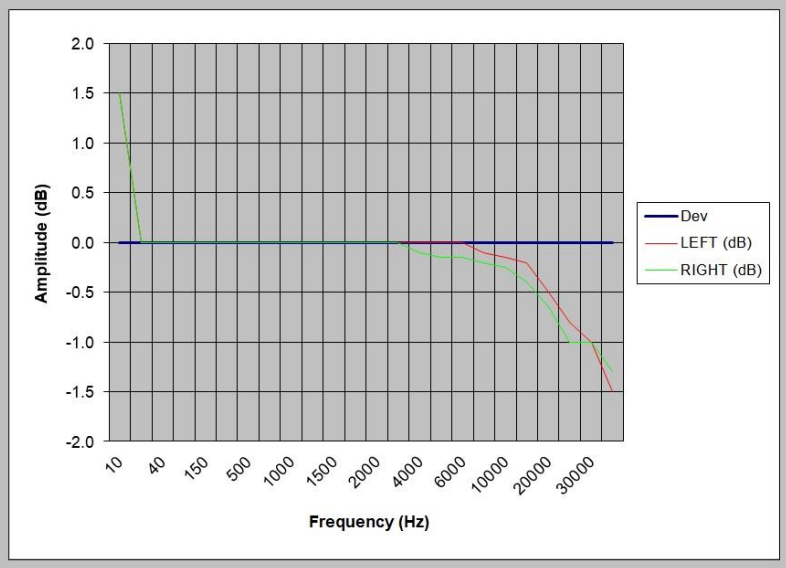
Done at 8 Watts - VU approximately at 0

Left -3db point is 47kHz

Right -3db point is 49kHz

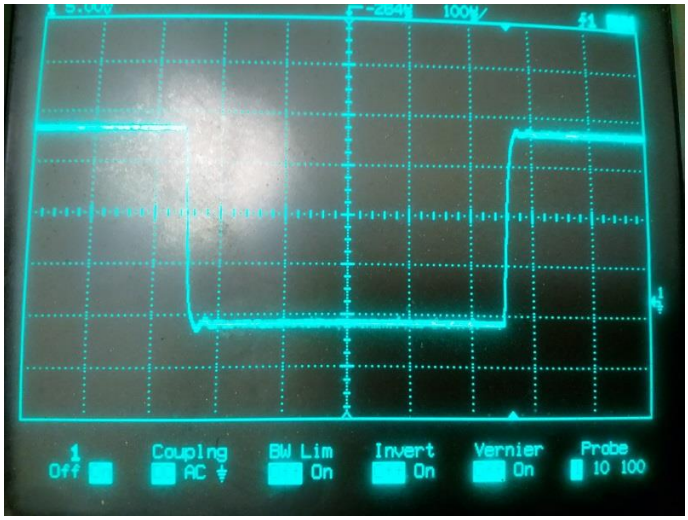
Not sure if this should be better? Perhaps feedback needs checking? Could it be the valves?
Square wave views, 1 kHz and same setting as for Frequency response tests, i.e. 8 Watts.
It looks like the front edges could do with sharpening up, the Right being worst which probably accounts for its early start to dropping off at 4kHz . The scope display has been shifted to give a better view of the front edge.

LEFT

RIGHT

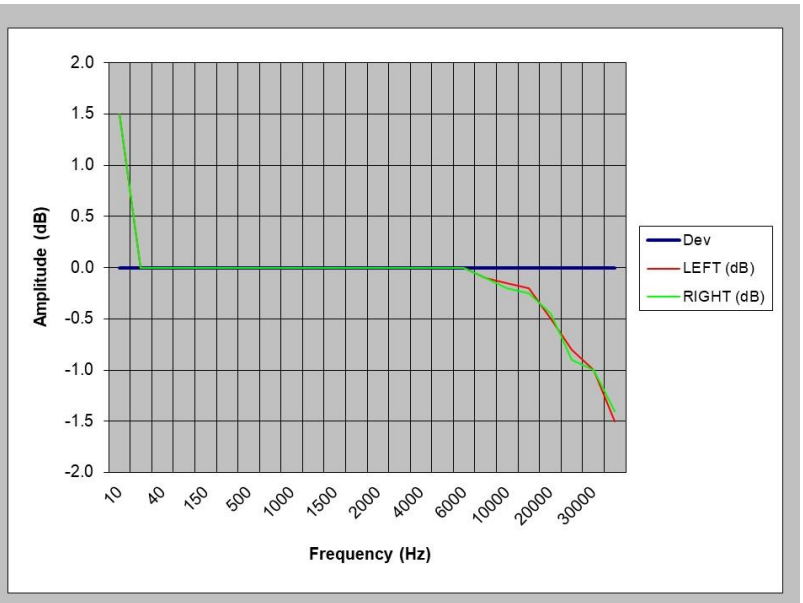
The -3dB points are the same and adding more feedback has improved the flatness of the Right channel and brings it close to the Left channel.

The designers probably have a swing jig for the board wired to a bench fixture to emulate the output stages.
They can alter components at will, a different story to working on a fully wired chassis.
There are design aspects that could be improved, especially those high front end voltages.
Choice of feedback capacitor? It is 300pF with a reactance of 21.2k Ohm at 25 kHz.
The more usual 50pF has a reactance of 127.3k Ohm but again not easy to experiment with due to the inability to easily try different feedback components, so things were left with 150k across R226. As mentioned, swapping valves around made only small differences and nothing like the +1dB error seen earlier. The owner can easily remove this resistor later if required.
