**Service Bulletin**

**No.**: DZ10-121 **Date:** August 30, 2010

Model: AVR-3311CI, AVR-991

Subject: Correction of the Firmware via DPMS (D&M Product Management

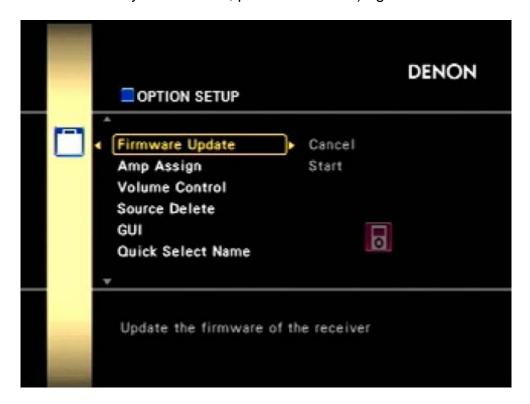
- 7) Press "CURSOR" button.
- 8) The GUI indicates, "MANUAL SETUP" > "OPTION SETUP" > "Firmware Update".

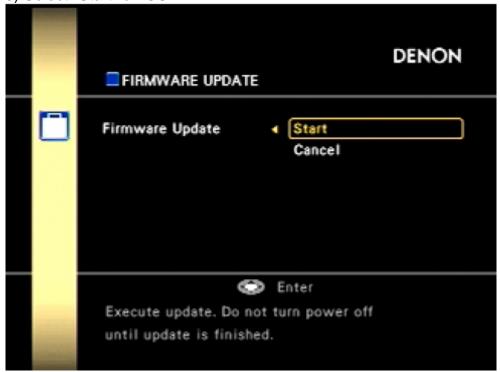
9) Select "Start" on GUI.
