SERVICEANLEITUNG

BRD Player 230- 98287.012

BLUTECH VISION Art.-Nr. 67501

SERVICE MANUAL

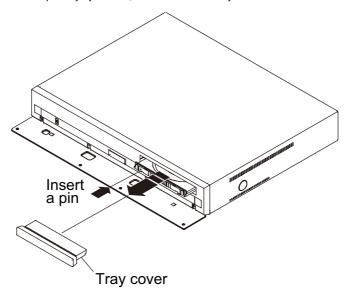
1. Removing the tray cover

1. Eject the tray by inserting a pin into the compulsory eject hole, then remove the tray cover.

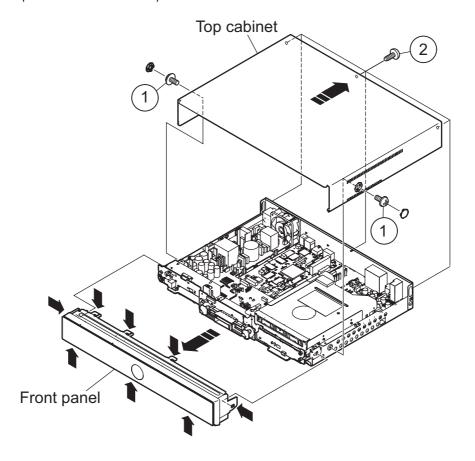
2. Removing the cabinet and the panel

- 1. Remove two screws ① and three screws ② from the top cabinet.
- 2. Unhook claws of the front panel and remover the front panel.

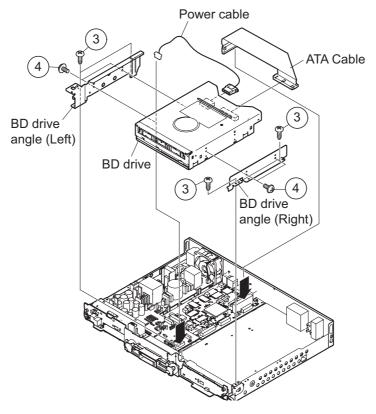
3. Removing the BD drive

- 1. Disconnect the ATA cable and power cable.
- 2. Remove four screws ③ and remove the BD unit (with the angle) upward.
- 3. Remove four screws ④ and remove the BD unit.

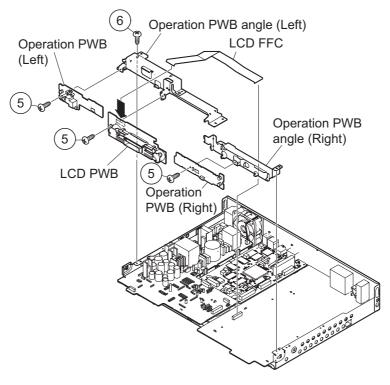
4. Removing the front PWB

- 1. Disconnect the LCD FFC between the LCD PWB and analog PWB.
- 2. Remove three screws ⑤ .
- 3. Remove one screw 6 .
- 4. Remove the operation PWB angles (left and right).

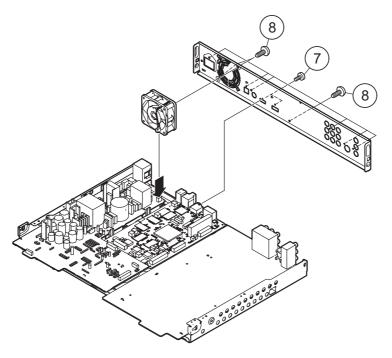
5. Removing the fan and the rear terminal board

- 1. Remove two screws ${ \ensuremath{ \mathbb T} }$.
- 2. Remove nine screws ® .
- 3. Disconnect the fan cable connector and remove the fan.

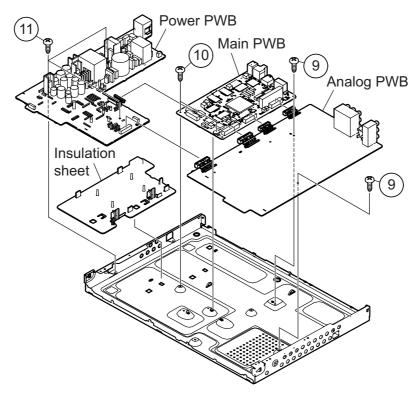
6. Removing each PWB

- 1. Disconnect the board to board connectors from each PWB.
- 2. Disconnect the board to board connectors (three) from the main PWB and analog PWB, then remove two screws ^③ . Disconnect the board to board connector (one) between the analog PWB and power PWB.
- 3. Remove two screws ¹⁰ .
- 4. Remove three screws ① .
- 5. Remove the insulation sheet.

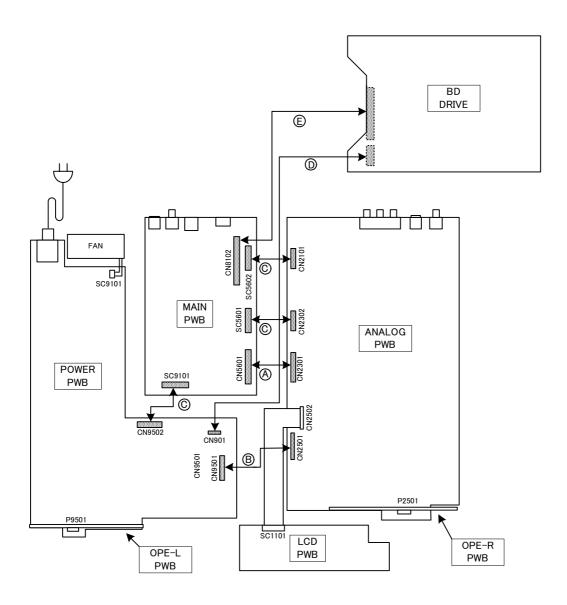
[2] EXTENSION CABLE CONNECTION DIAGRAM

Parts Code	Name/Description	Pin
A	QCNW-E227WJPZ	CN5601 <=> CN2301	23
B	QCNW-E228WJPZ	CN2501 <=> CN9501	19
©	QCNW-E229WJPZ	SC5601 <=> CN2302, SC5602 <=> CN2101, SC9101 <=> CN9502	15
(D)	QCNW-E573WJPZ	CN901 <=> BD DRIVE	4
E	-	ATA66 Cable (Commercially available) CN8102 <=> BD DRIVE	40
